IN THE CIRCUIT COURT OF THE 15TH JUDICIAL  
CIRCUIT IN AND FOR PALM BEACH COUNTY, FLORIDA

**COMPLAINT**

<sup>4</sup> The three independent reports include: Structural Construction Defect Evaluation – Prepared by Summit Design and Forensics, Inc. (attached hereto as **Exhibit C**); Forensic Investigation Report – Prepared by ECS Florida, LLC (attached hereto as **Exhibit D**); Property Evaluation Report – Prepared by Pistorino and Alam Consulting Engineers, Inc. (attached hereto as **Exhibit E**); J.R. Inspections Services, Inc. – Mold Inspection Report (attached as **Exhibit “F”**) (collectively, the “**Engineering Reports**”)

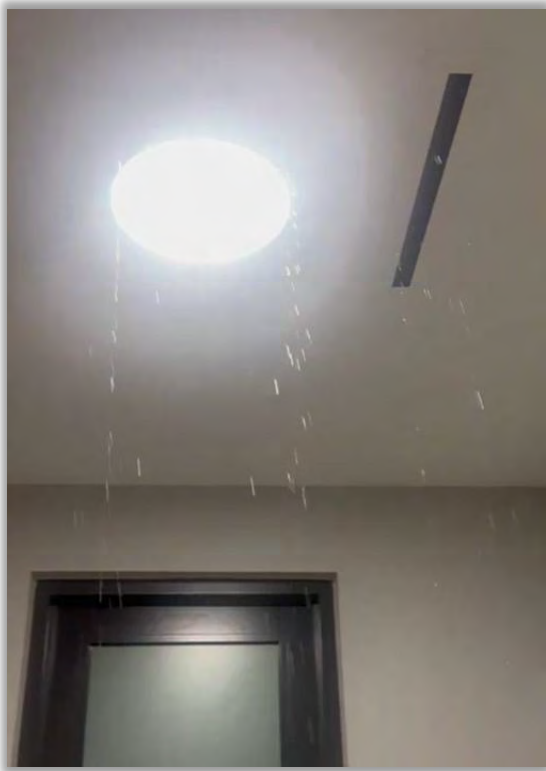
*Figure 1: Water leaking from light fixture and air conditioning diffuser in laundry room.*

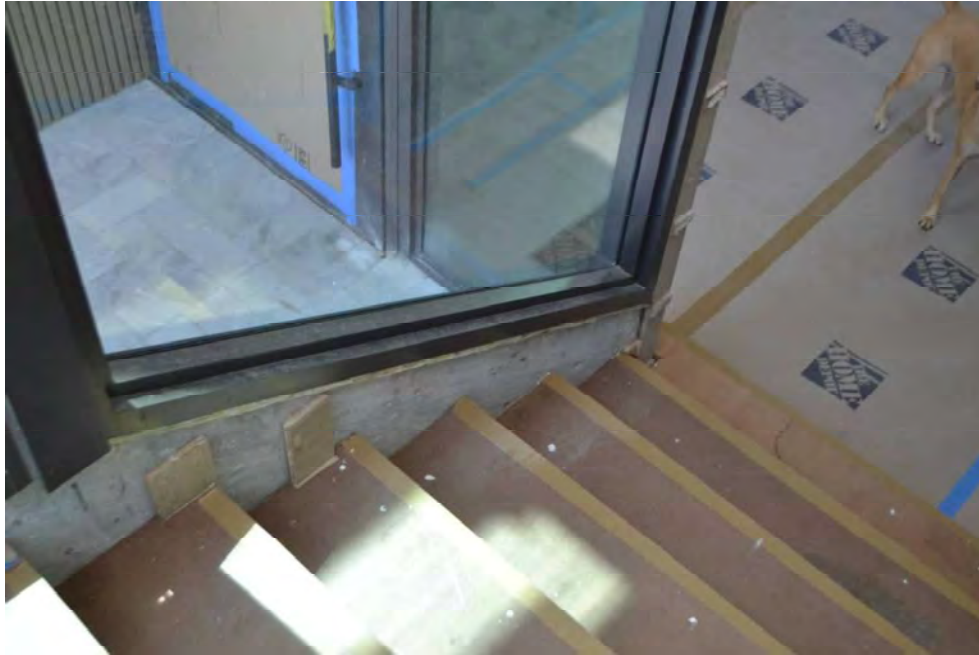
Figure 3) View of reported water damaged removed wall finish at the main stair.

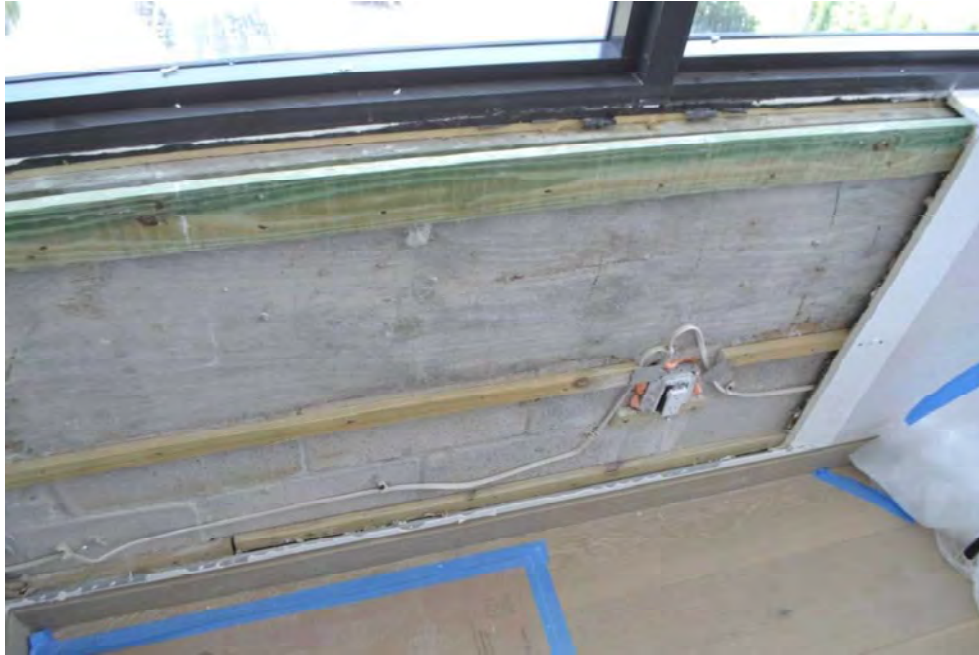
Figure 5) View of reported water damaged wall finish removed at the office.

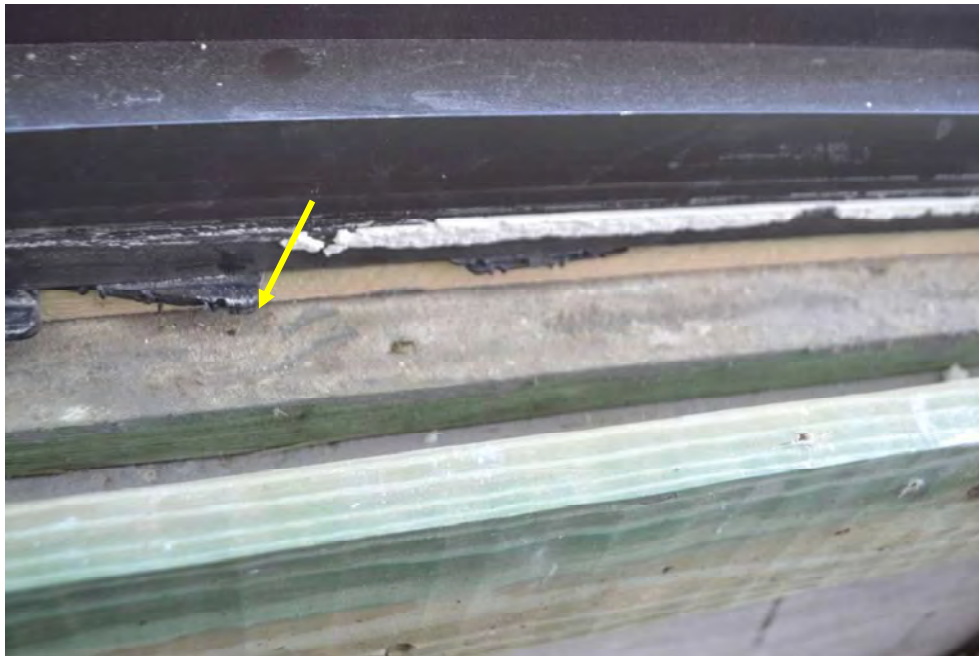
Figure 6) View of water staining observed to the window buck in the office.

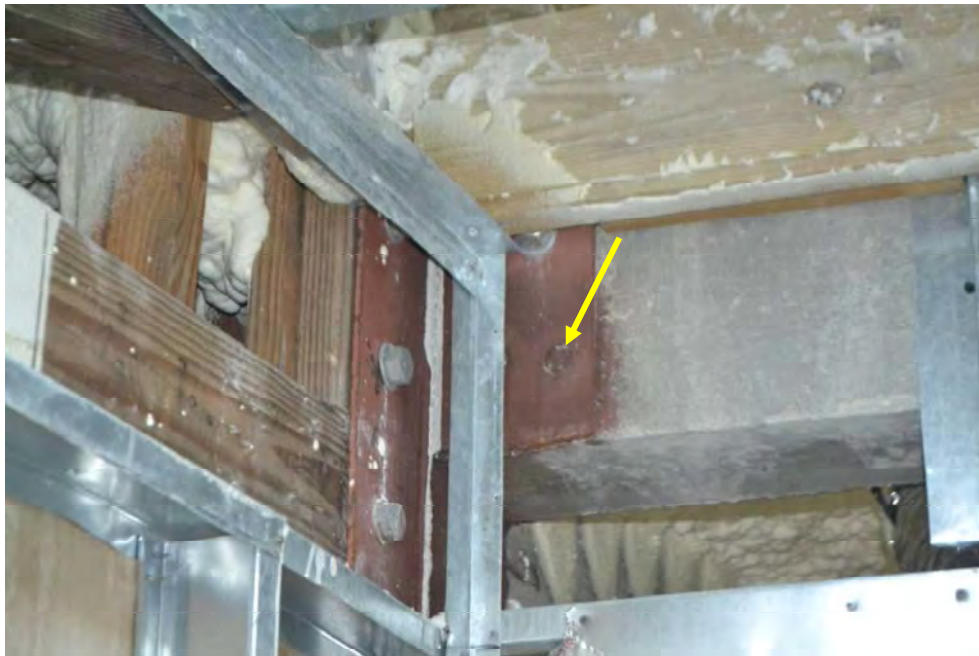
Figure 8) View of a missing anchor at a girder truss connection above the stair to the third floor.

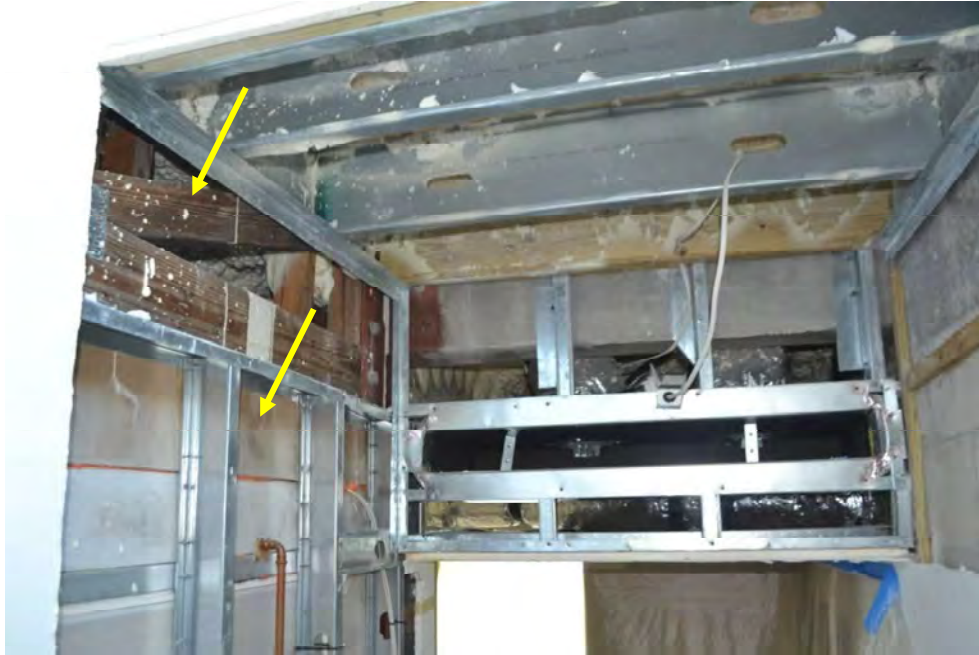
Figure 9) View of water damage and/or apparent fungal growth observed to the wall finish and truss at the stair to the third floor.

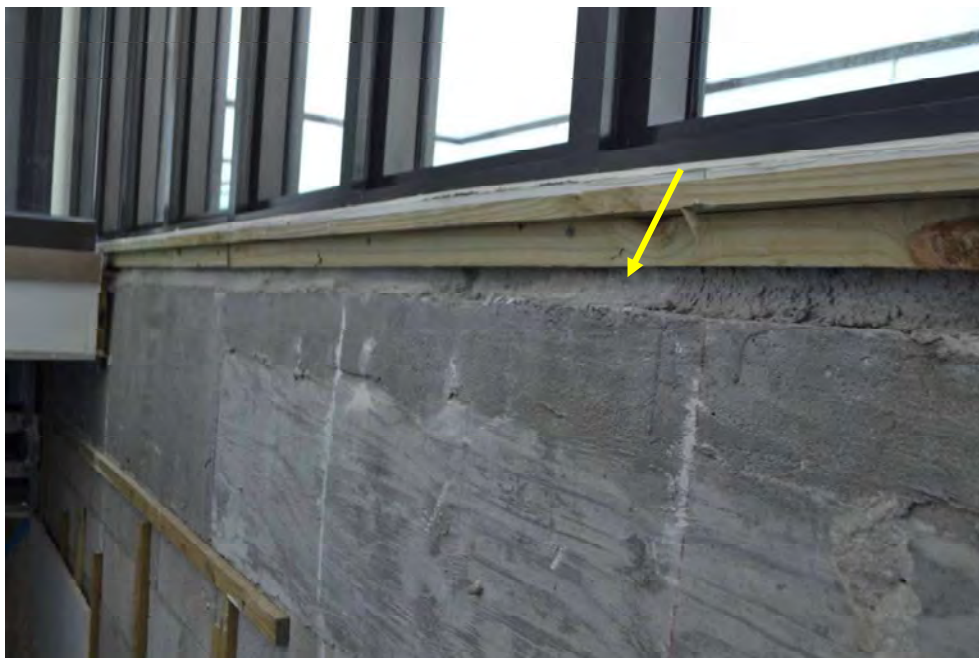
Figure 10) View of low-strength grout installed between the window buck and concrete beam at the stair to the third floor.

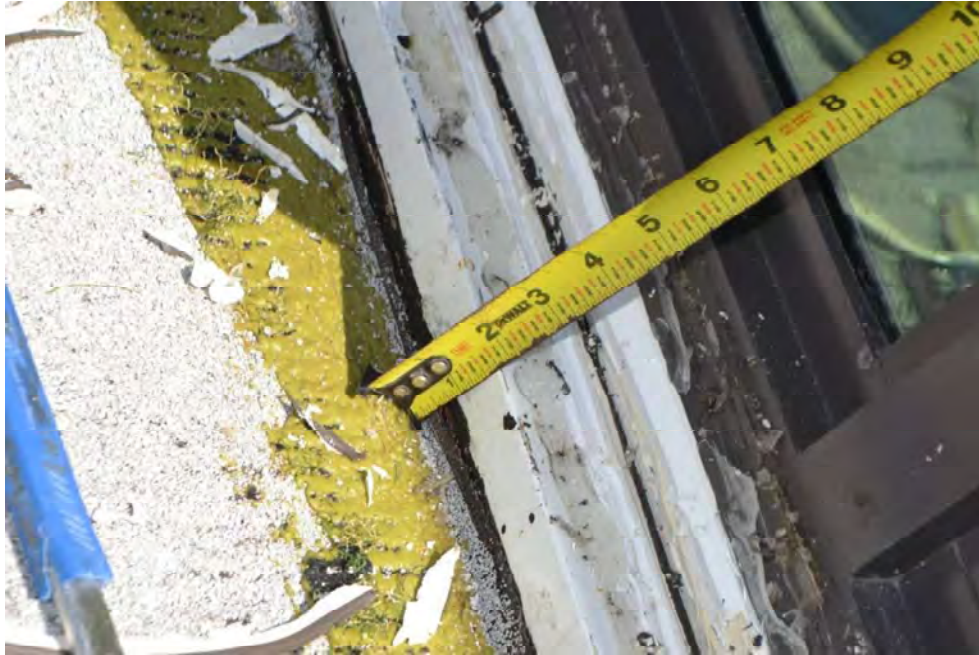
Figure 23) Exemplar view showing inadequate flashing height at the front third floor roof.

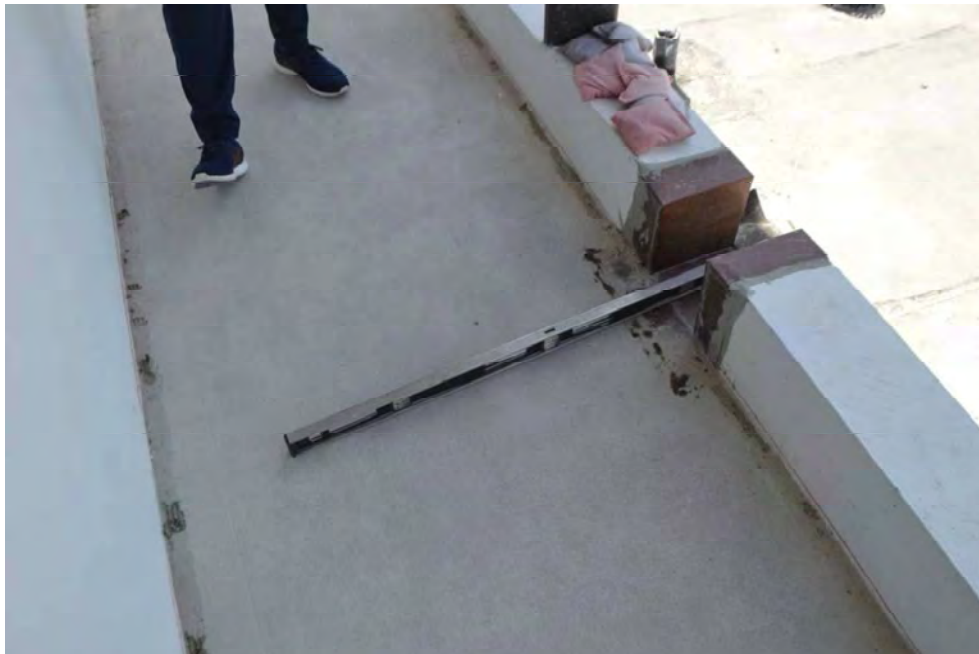
Figure 24) View showing the front third floor balcony with improper slope.

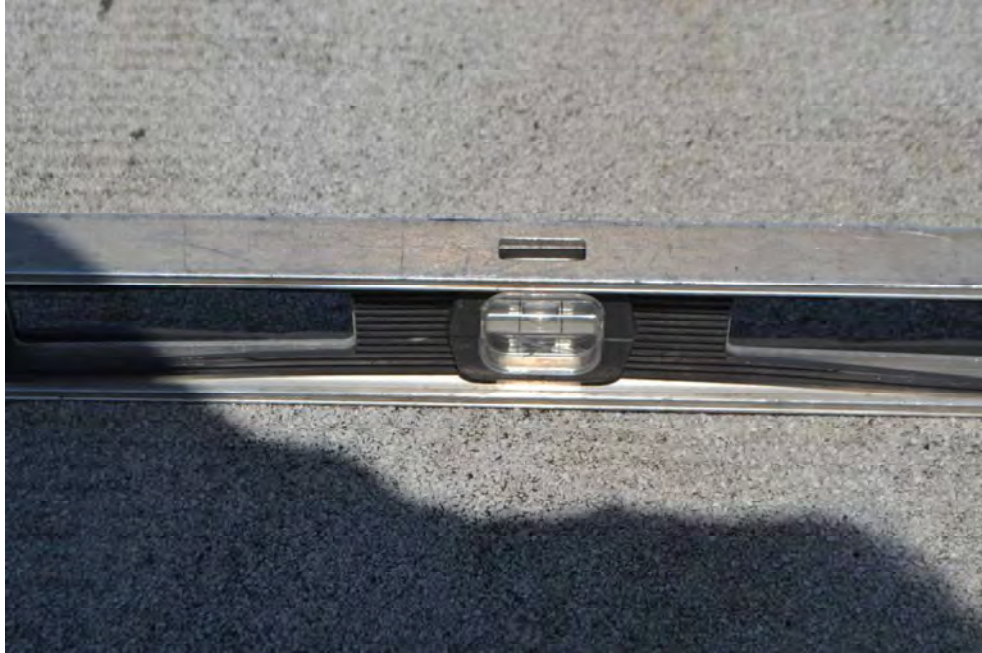
Figure 25) Exemplar view showing the front third floor roof with improper slope.

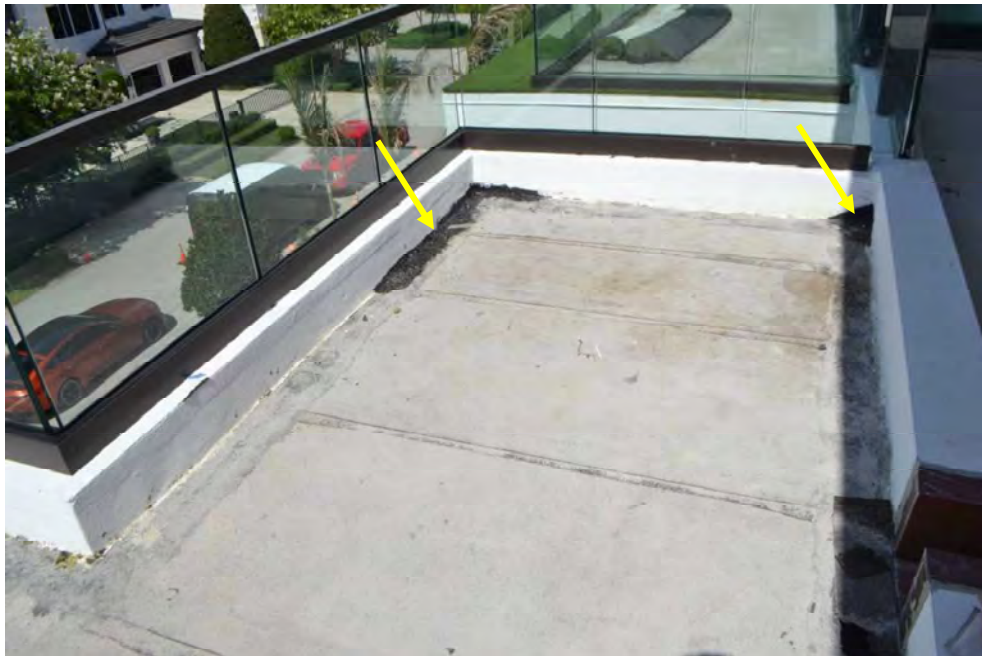
Figure 26) Exemplar view of recent roof repairs observed at the front third floor roof.

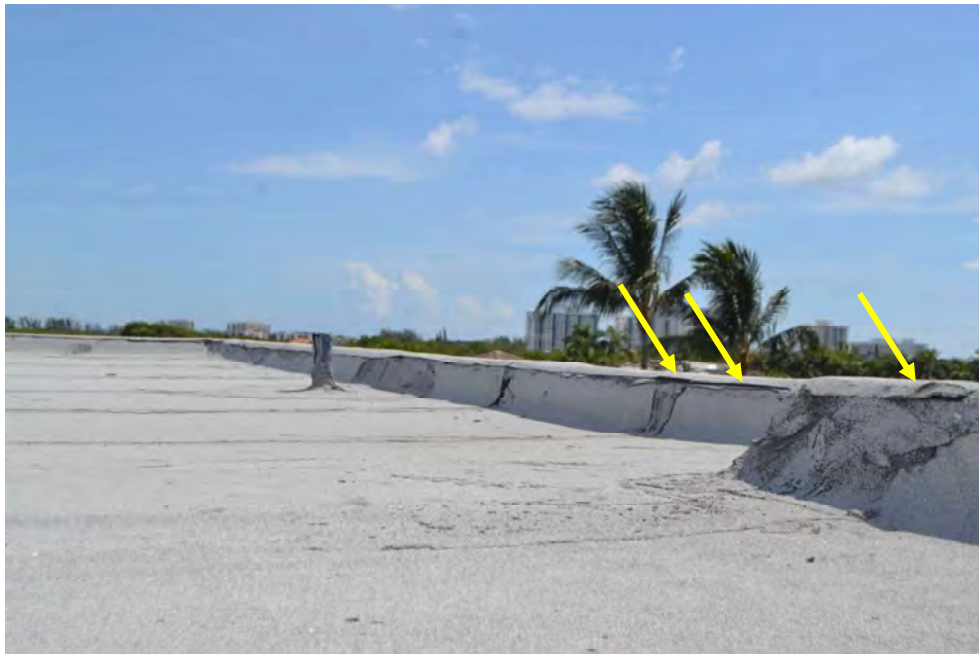
Figure 28) Exemplar view of apparent openings observed in the upper roof covering along the perimeter curb.

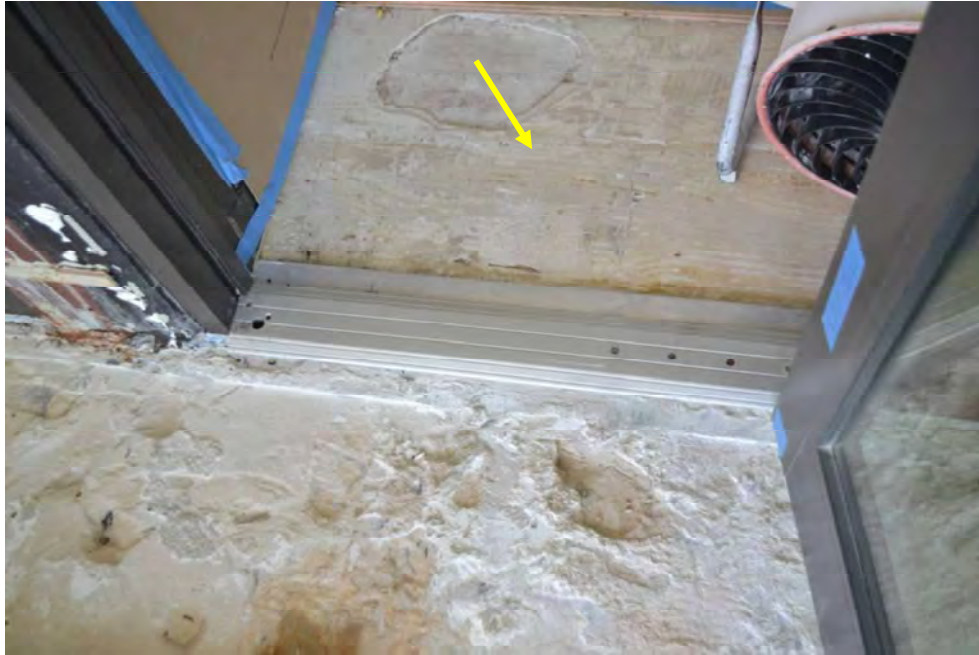
Figure 33) View showing the interior wood flooring removed at the door to the second floor rear balcony reportedly due to water damage.

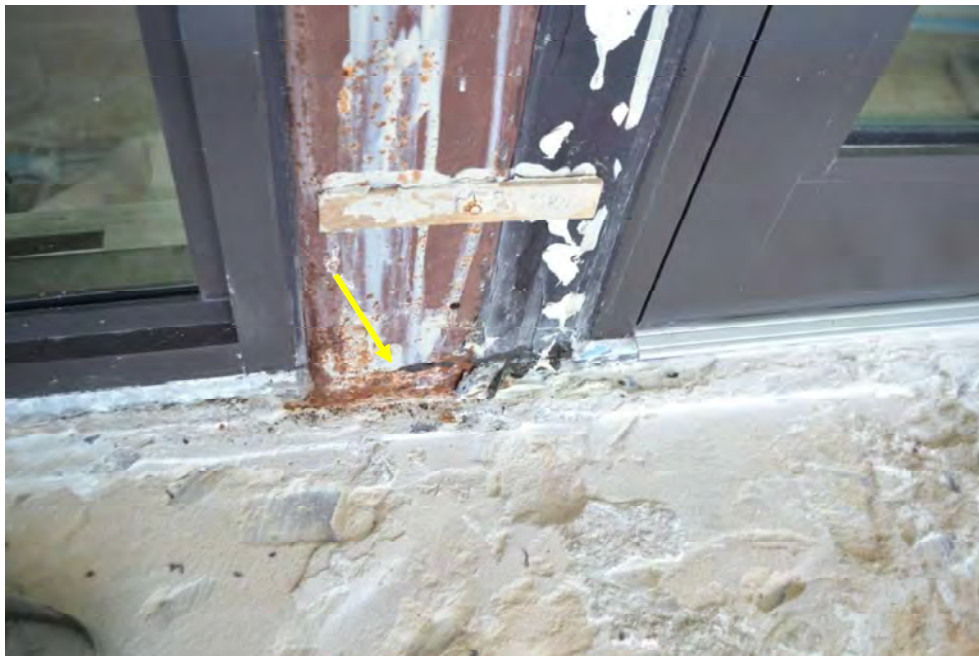
Figure 34) Exemplar view of corrosion observed to the steel column base at the second floor rear balcony.

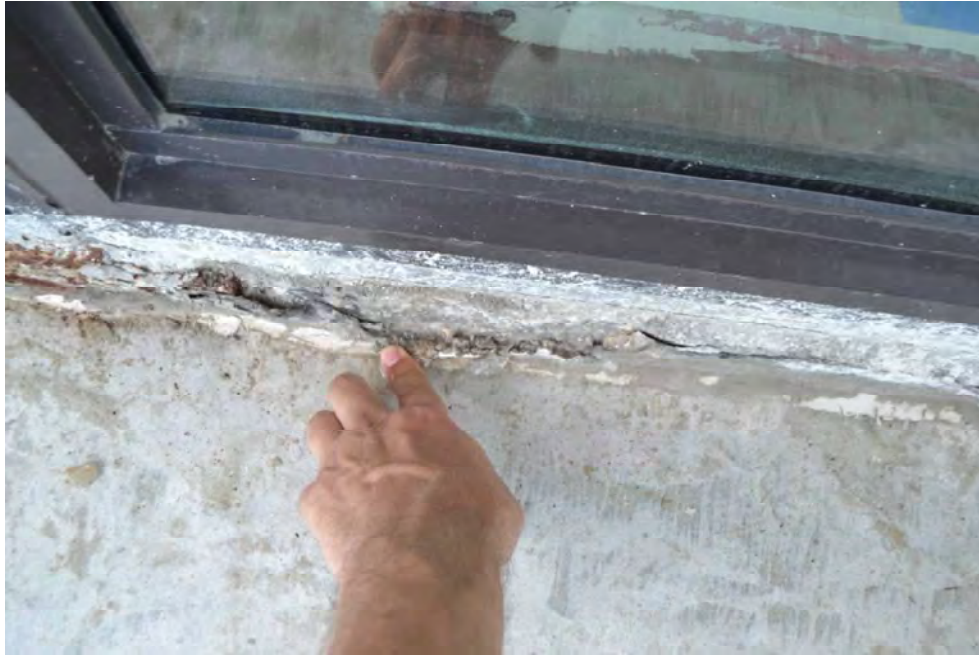
Figure 35) View showing no waterproofing or flashing observed at the second floor rear balcony.

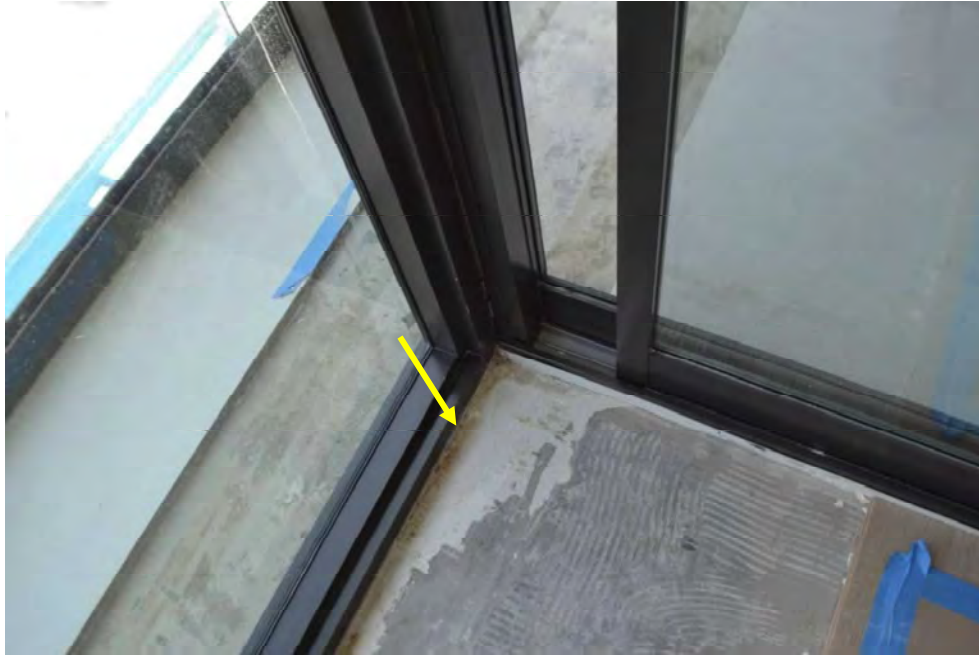
Figure 37) Exemplar view of water staining observed to the concrete in the master bedroom near the exterior windows.

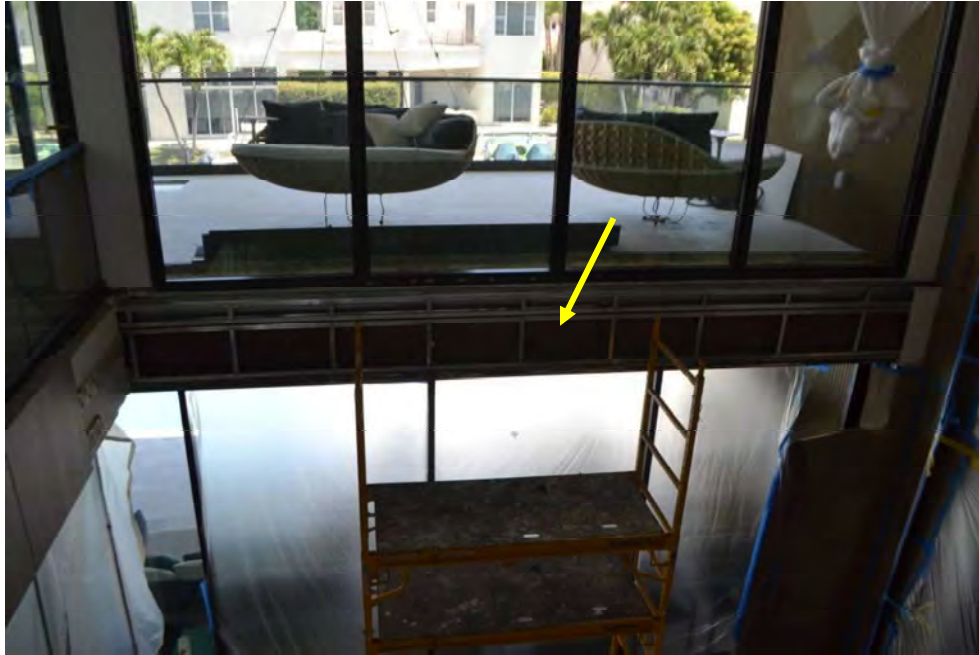
Figure 39) View showing the reportedly water damaged wall finish removed in the family room below the exterior windows.

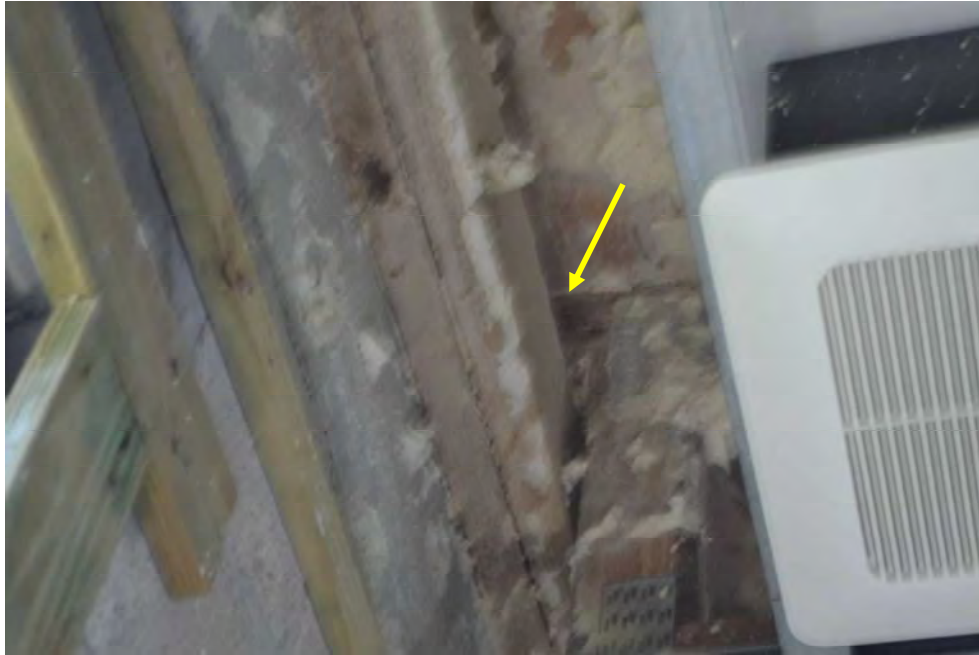
Figure 41) View of water staining observed to the floor framing above the daughter's bathroom.

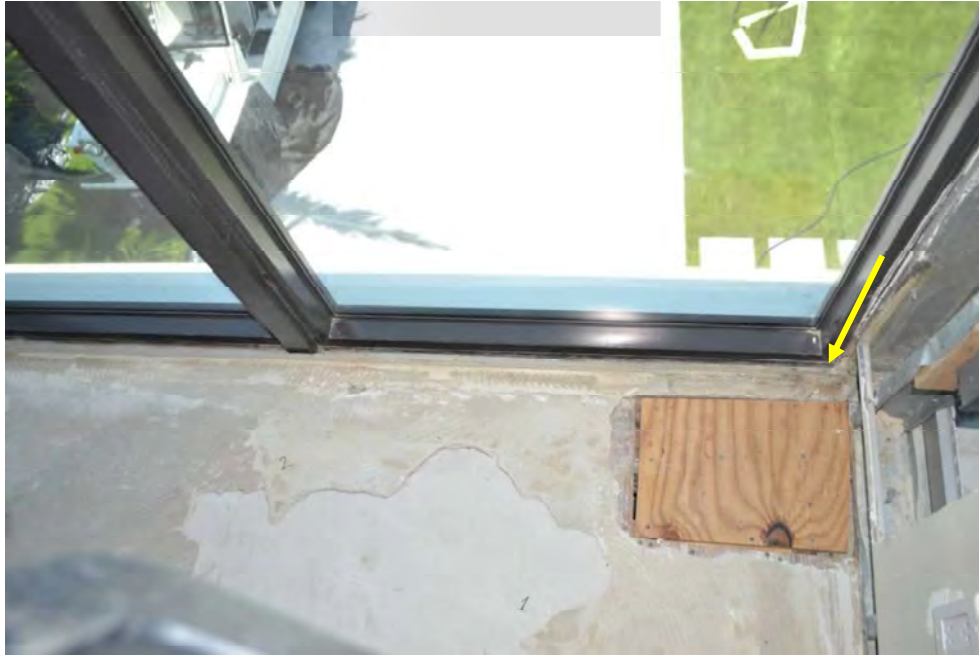
Figure 43) View of water staining observed to the concrete in the daughter's bedroom.

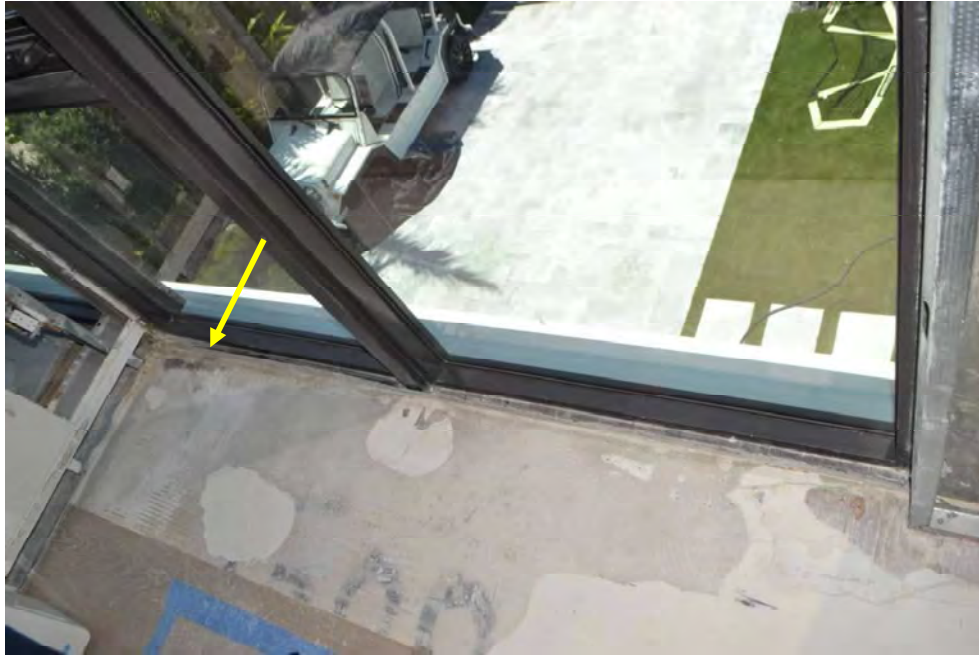
Figure 45) View of water staining observed to the concrete in the son's bedroom.

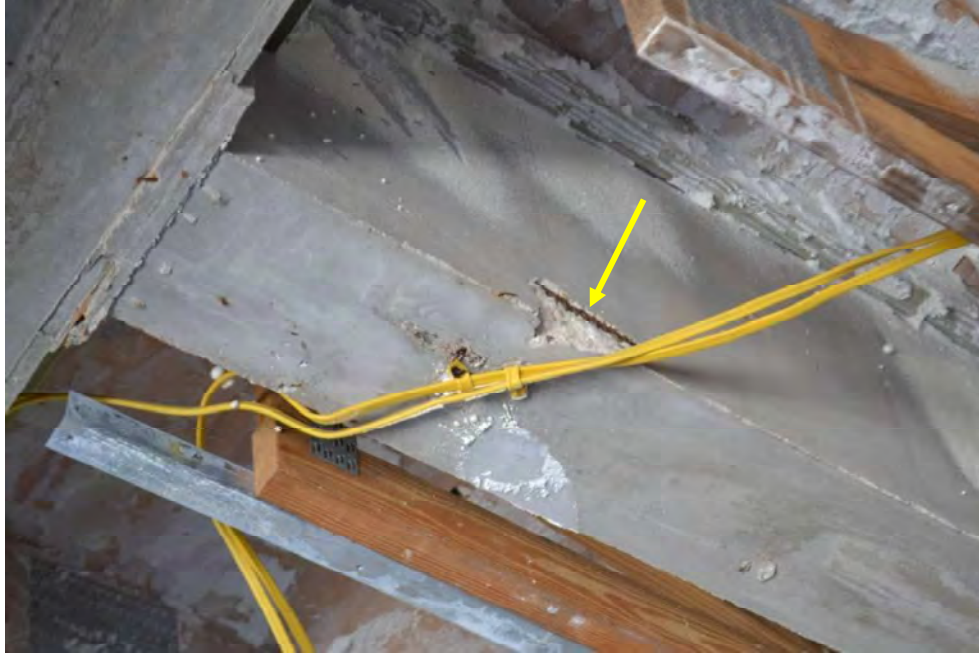
Figure 49) View of spalled concrete and inadequate rebar clearance at a beam above the garage.

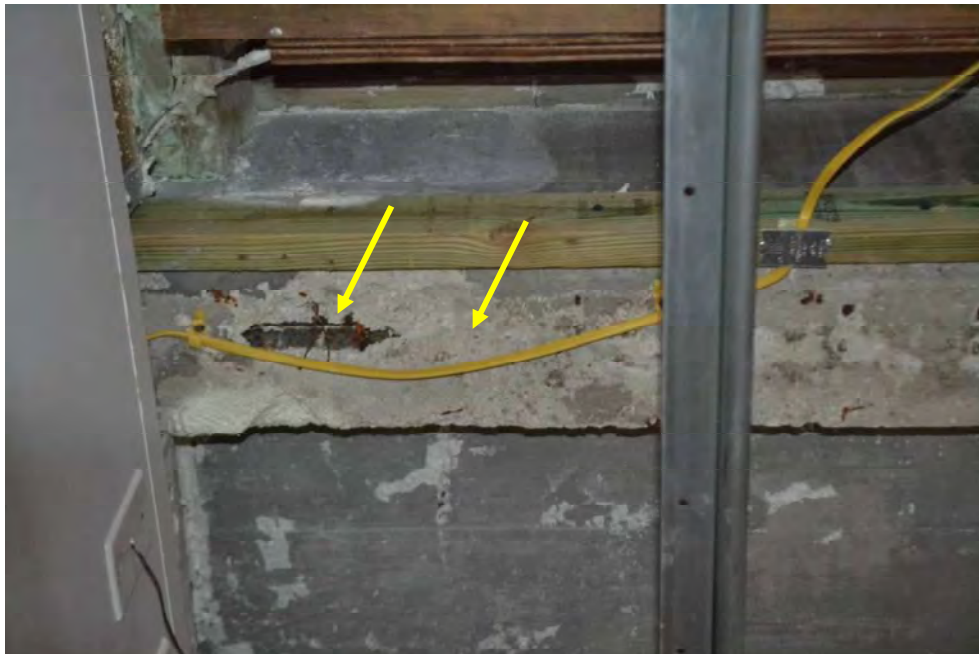
Figure 50) View of spalled concrete and inadequate concrete strength at a beam above the garage.

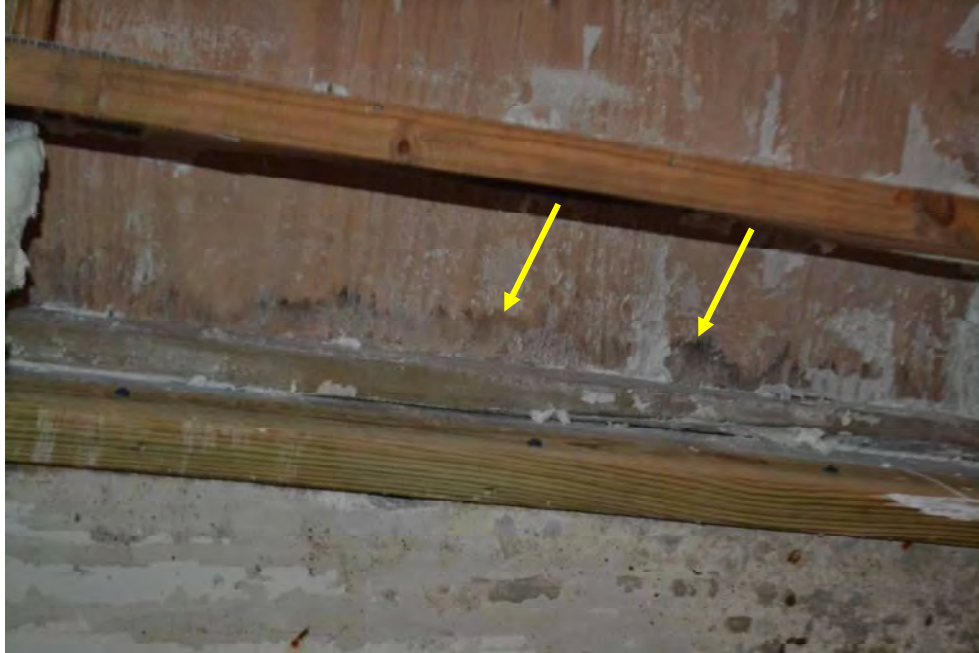
Figure 51) Exemplar view of water staining observed to the floor sheathing above the garage near the exterior planter.

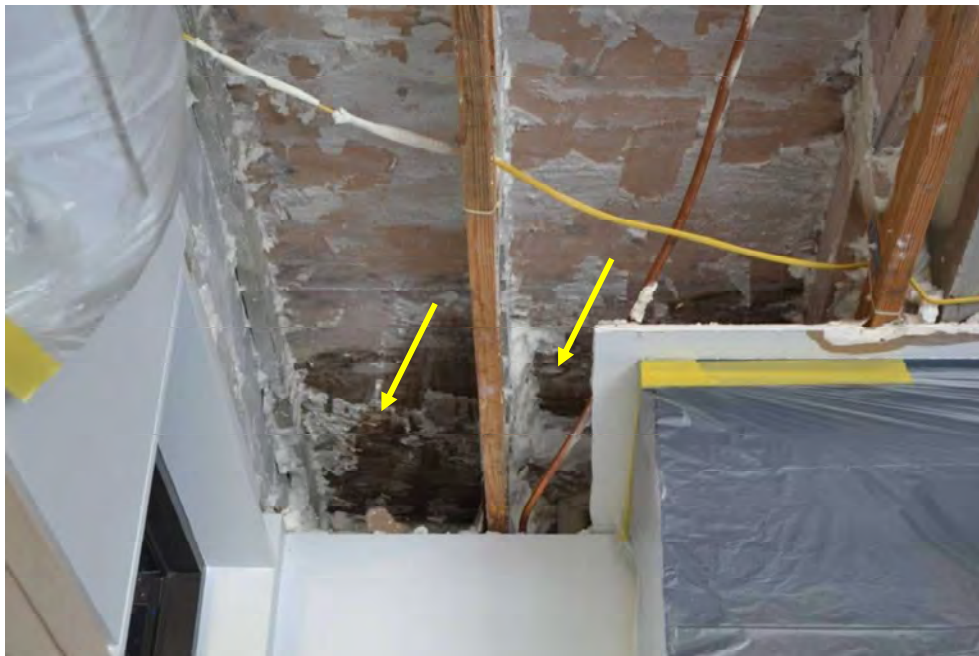
Figure 52) View of water damage and deterioration observed to the floor sheathing above the garage.

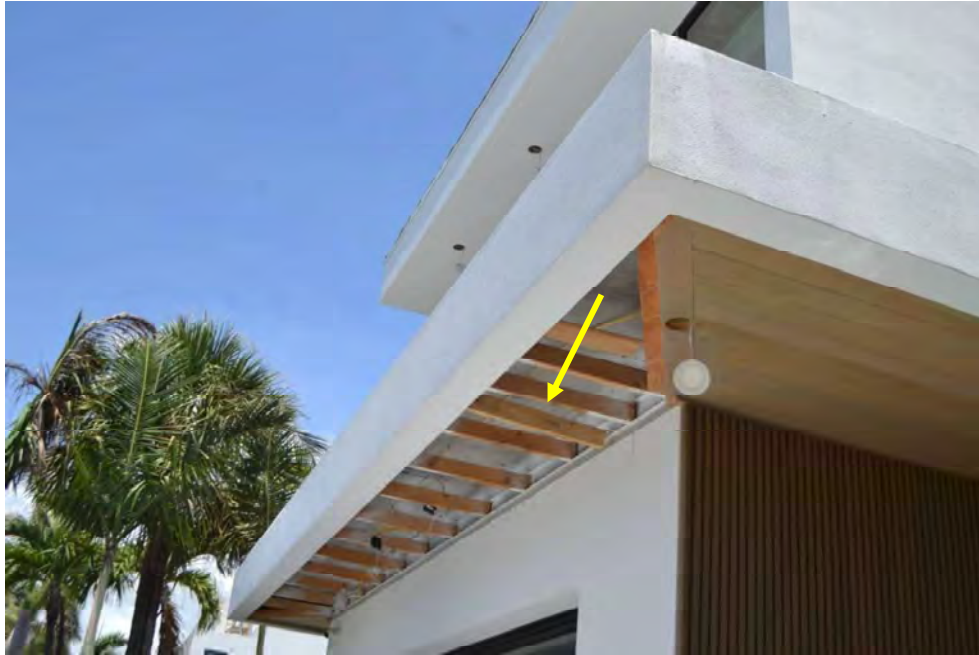
Figure 53) View showing the reportedly water damaged soffit finish removed at the garage.

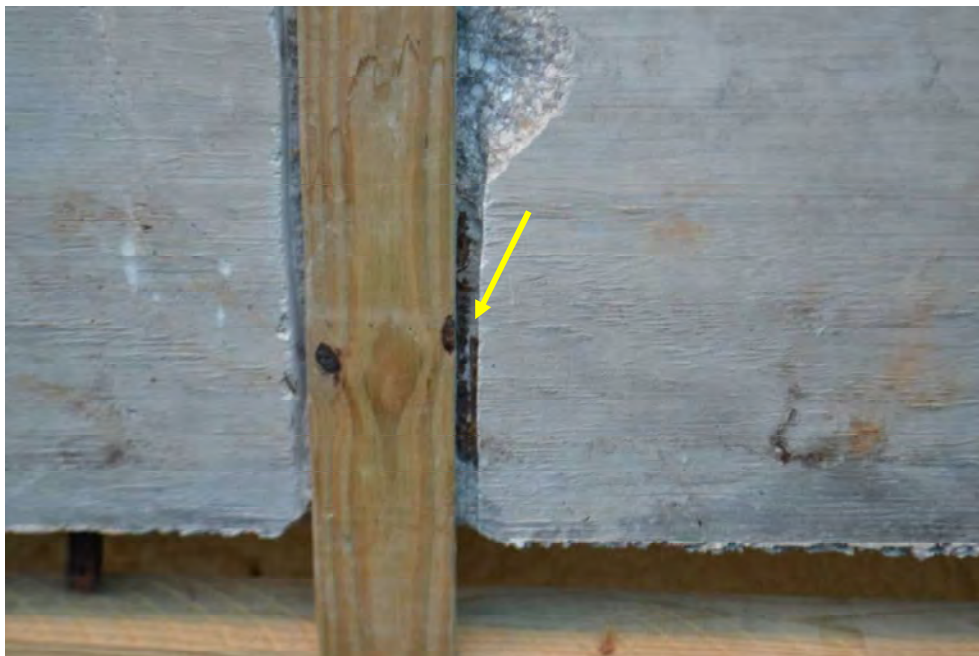
Figure 56) View of exposed reinforcing observed at the removed concrete at a beam at the ceiling furring strips above the rear porch.

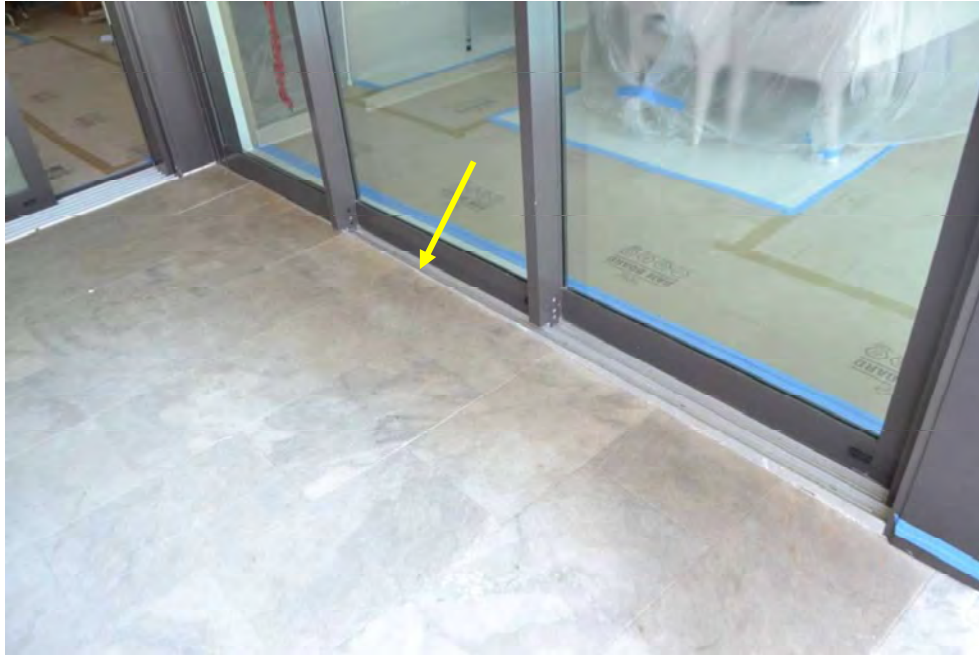
Figure 57) View showing pavers covering the slider track weep holes at the rear porch.

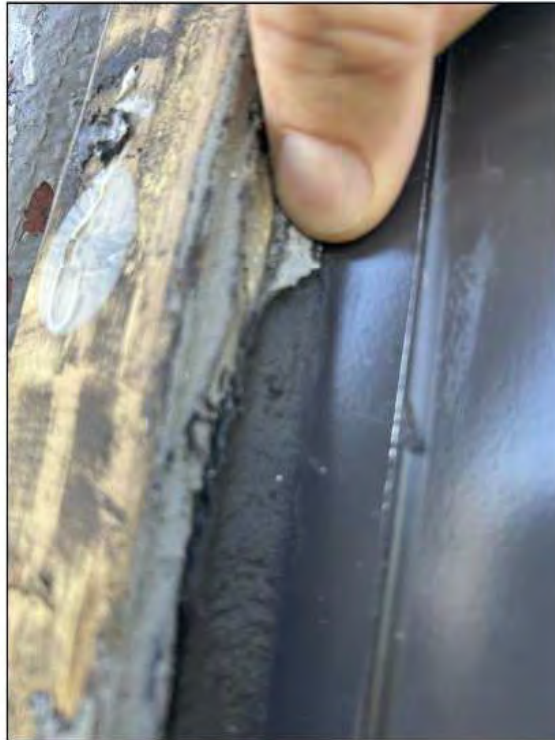
**ECS Photo 22:** General view of damaged sealant at window (exterior).

**Criteria:** The existing conditions are not in compliance with FBC, the applicable Notice of Acceptance (NOA) and acceptable industry standards requiring project building components to perform as intended.,

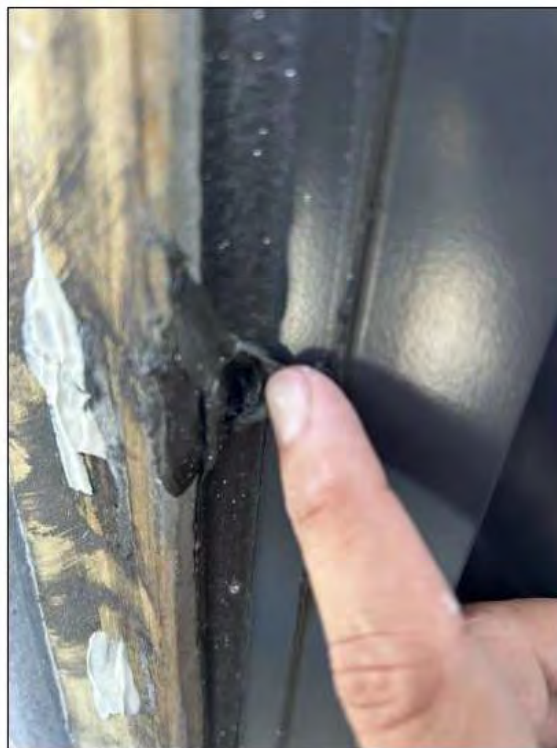
**ECS Photo 23:** General view of damaged sealant at window (exterior).

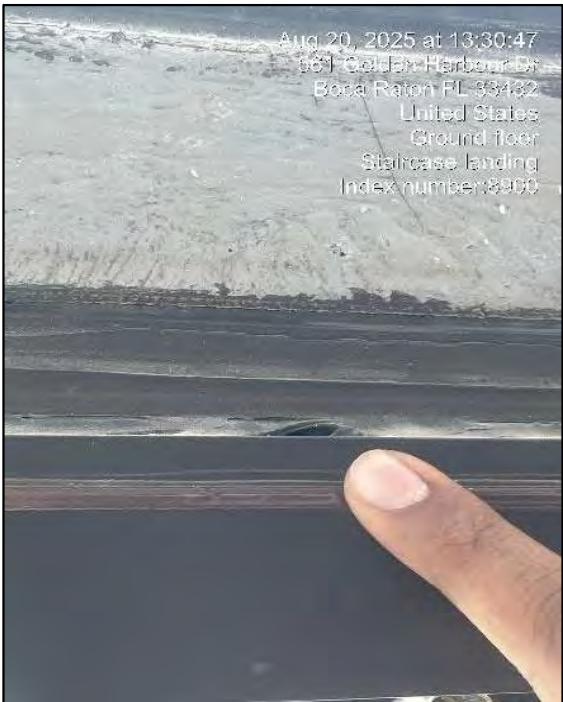
**Photo 8900:** General view of debonding sealant at of storefront/fixed glass window at the staircase landing (interior).

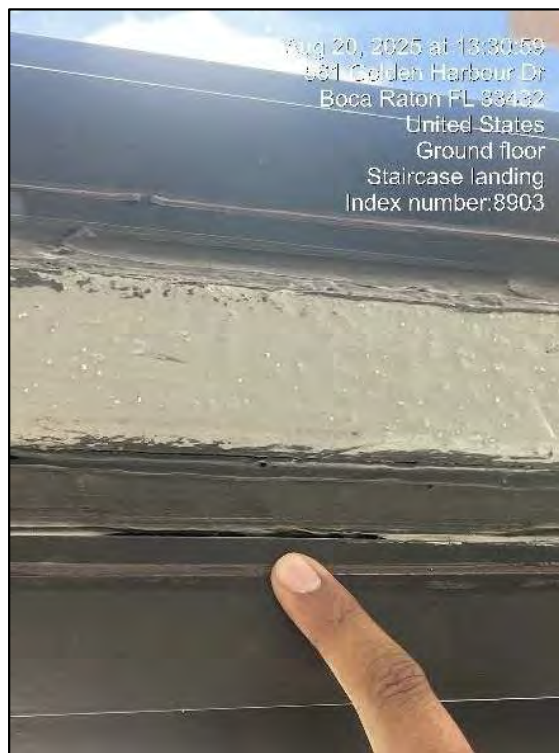
**Photo 8903:** General view of debonding sealant at of storefront/fixed glass window at the staircase landing (interior).

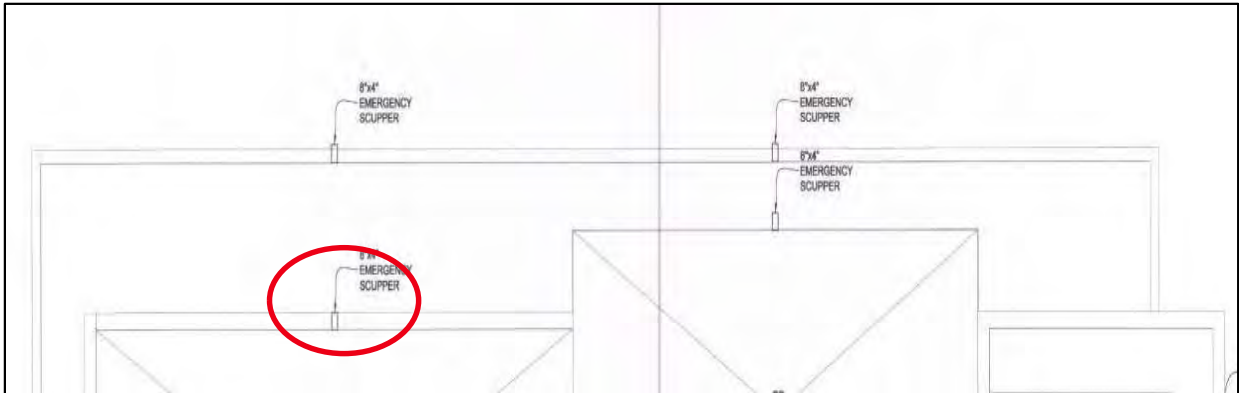
*Third Floor Plumbing Plan Sheet P-03 – Showing emergency scuppers. However, no scuppers were found in the parapet wall/curb during the field visit. No curb was constructed at the far north terrace slab edge.*

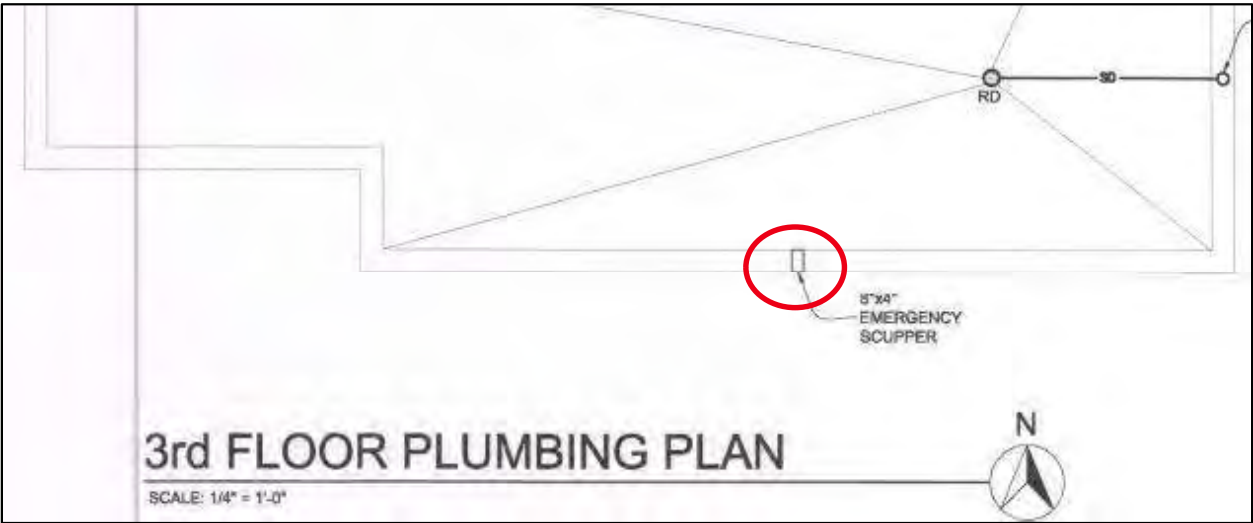
*Third Floor Plumbing Plan Sheet P-03 – Showing emergency scupper. However, no scupper was observed in the curb during the field visit.*

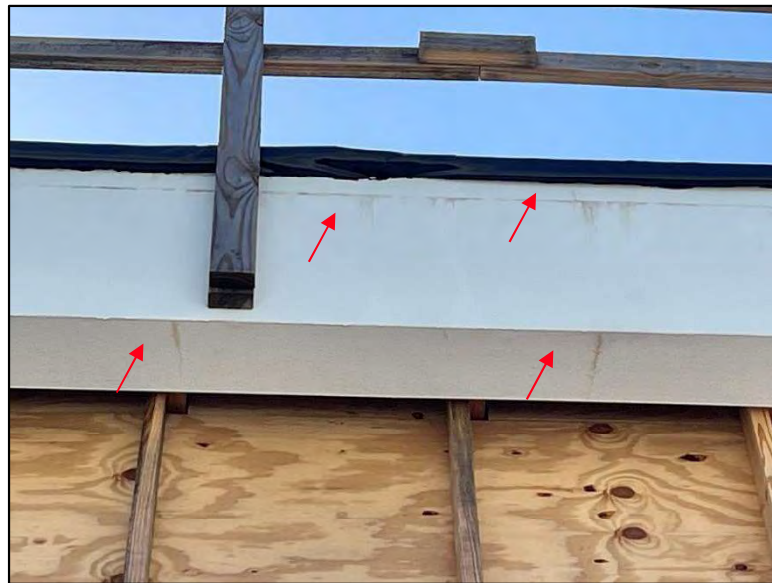
**Photo 6095** – Cracks in Stucco at exterior parapet wall at Level-3.

**Criteria:** The existing conditions are in violation of sections of the Florida Building Code (FBC) listed below. Additionally, the existing conditions are in violation of Industry Standards. The cracks/delamination can originate from inadequate curing process of the different applied layers that comprise the stucco and from inadequate application of stucco. The existing condition will also become a portal for moisture ingress permitting moisture accumulations between the back plane of stucco and the area between stucco and structural substrate.

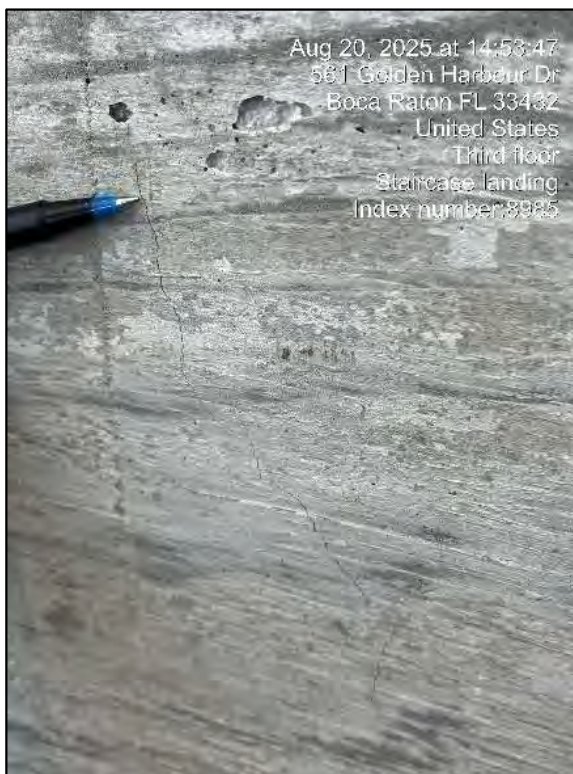
**Photo 8985** – Crack at the beam at Staircase landing – 3<sup>rd</sup> Floor.

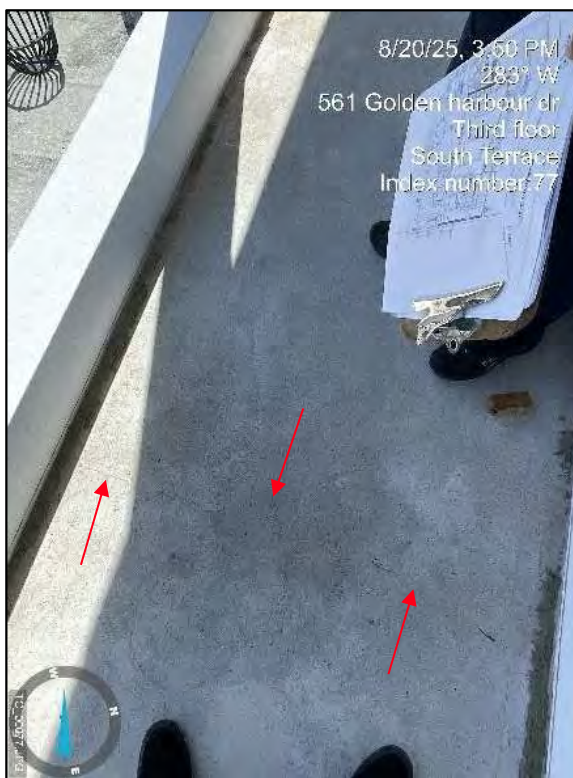
**Photo 77**– Crack at the floor slab at South Terrace – 3<sup>rd</sup> Floor.

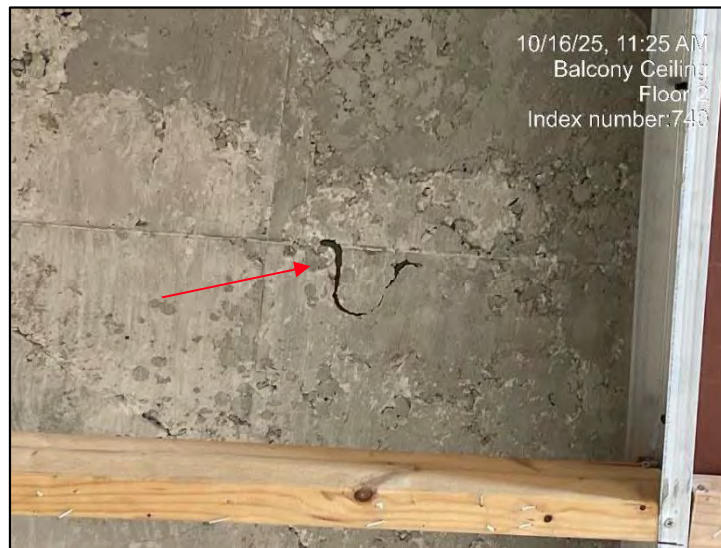
**Photo TC\_00740** – Corroded metal embedded in balcony ceiling at the second floor.
