IN THE CIRCUIT COURT OF THE 15TH JUDICIAL  
CIRCUIT IN AND FOR PALM BEACH COUNTY, FLORIDA

**COMPLAINT**

<sup>4</sup> The three independent reports include: Structural Construction Defect Evaluation – Prepared by Summit Design and Forensics, Inc. (attached hereto as **Exhibit C**); Forensic Investigation Report – Prepared by ECS Florida, LLC (attached hereto as **Exhibit D**); Property Evaluation Report – Prepared by Pistorino and Alam Consulting Engineers, Inc. (attached hereto as **Exhibit E**); J.R. Inspections Services, Inc. – Mold Inspection Report (attached as **Exhibit “F”**) (collectively, the “**Engineering Reports**”)

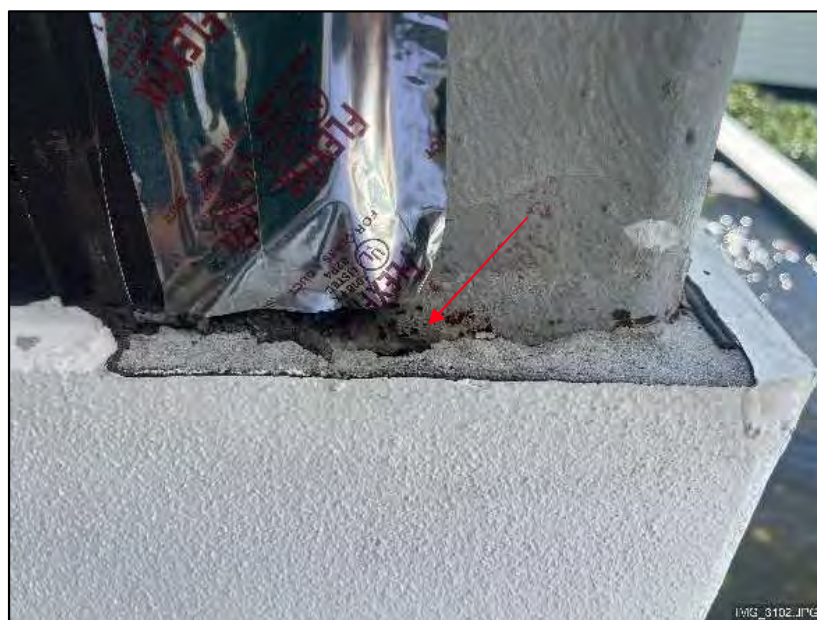
**Photo 3102** – Corroded metal column potentially embedded in staircase landing floor slab at the second floor.

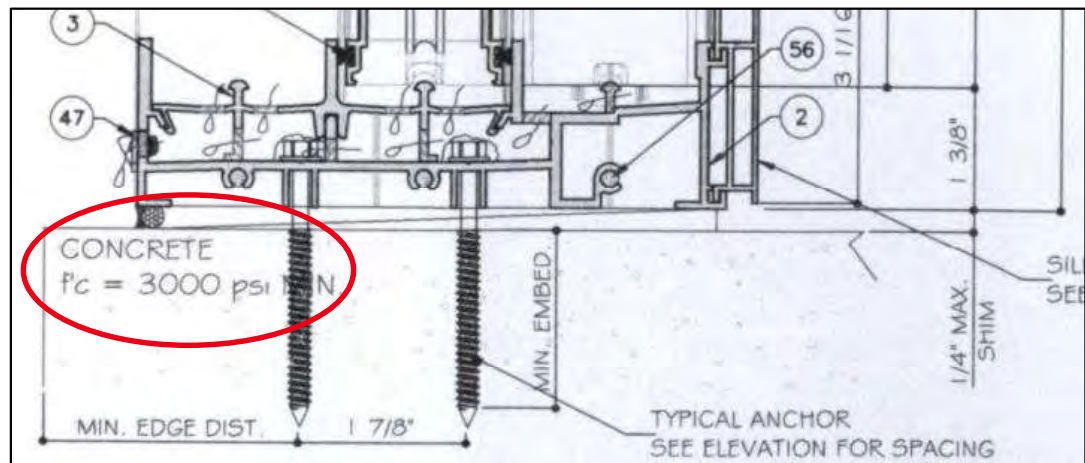
4. In accordance with the approved NOAs the maximum shim space allowed is  $\frac{1}{4}$ " , whereas the existing gaps are more than specified on the permitted documents. Excessive gaps reduce the unbraced length of the fastener securing the aluminum frame to the concrete structural members. The existing condition reduces the structural capacity of the fasteners therefore compromising the lateral load resisting capacity of the glazing systems.

The existing conditions are a result of inadequate construction and are in violation of Record Set Drawings, industry standards and Florida Building Code, 2020 7<sup>th</sup> Edition, Chapter 24 Glass and Glazing, Section 2410.4 High-Velocity Hurricane Zones - General and Windows, Doors, Glass and Glazing.

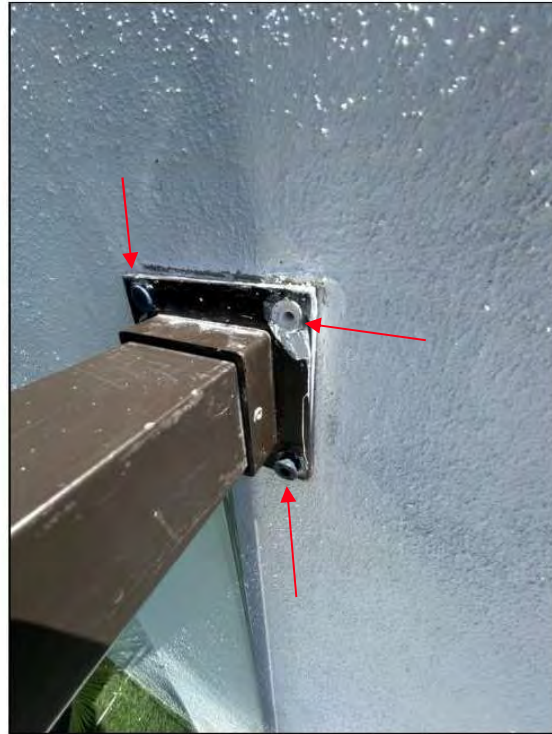
**Observation:** The railing system was not installed adequately. The review of ECS Florida, LLC (ECS) report shows that at many locations fasteners at the railing system were missing, fasteners were not sealed, the handrails were not anchored and layout of some handrails was incorrect as the same were not properly supported/installed. Additionally, review of photos and videos taken during the demolition of the railing system reveal that many of the fasteners securing the base of the railing system to the slab were not provided with sealant and water had accumulated inside and below the system..

***ECS Photo 12 – Unsealed and missing fasteners.***

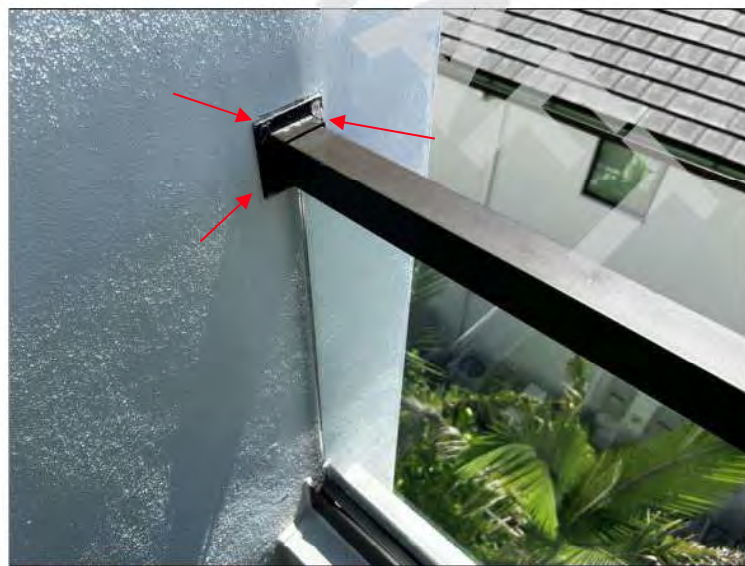
***ECS Photo – Unsealed and missing fasteners at the balcony railing.***

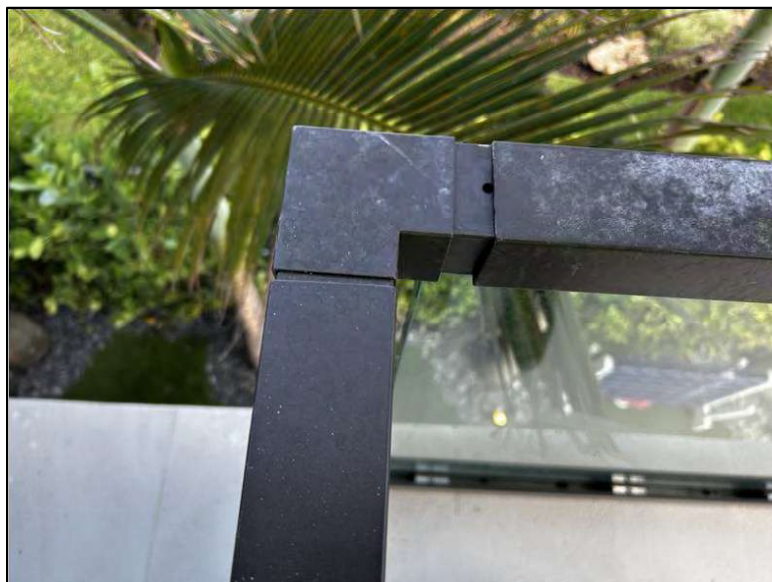
**ECS Photo** – Unsecured balcony railing system cap components.

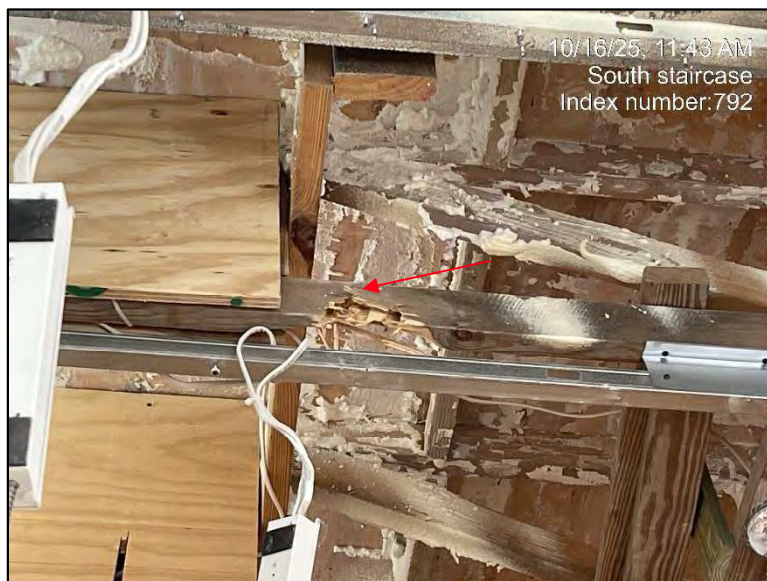
**Photo TC\_00792** – Damaged/broken truss member at south staircase ceiling (3<sup>rd</sup> level).

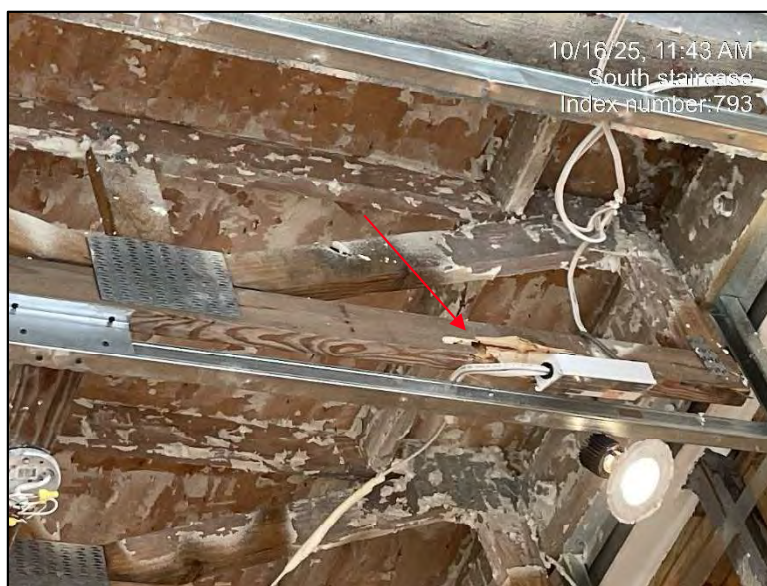
**Photo TC\_00793** – Damaged/broken truss frame at south staircase ceiling at Level-3.

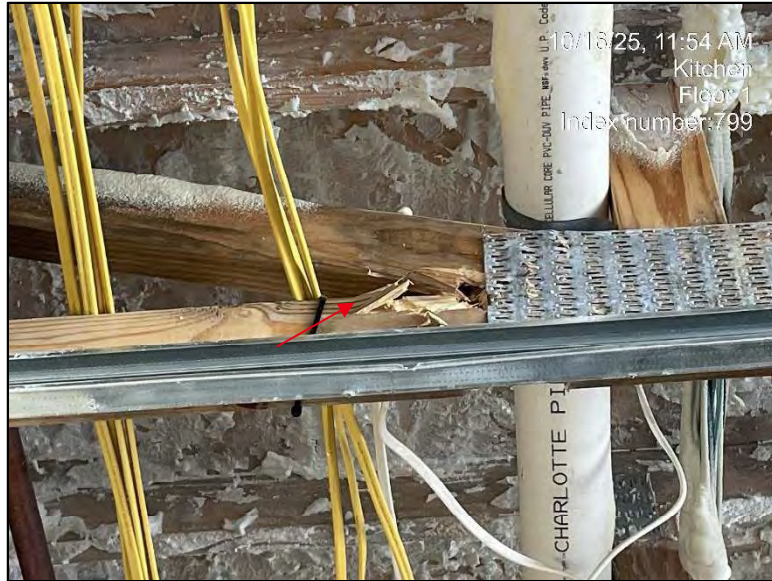
**Photo TC\_00799** – Damaged/broken truss member is visible at kitchen at Level-2.

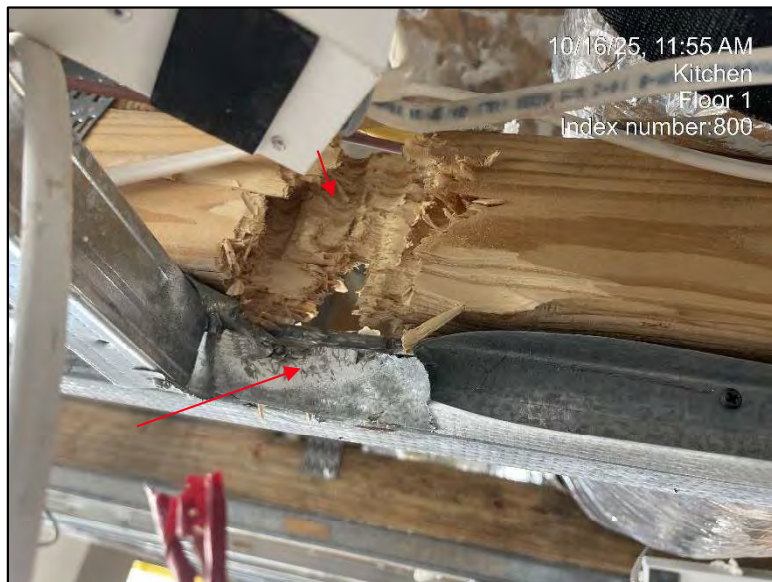
**Photo TC\_00800** – Damaged/broken truss member is visible at kitchen at Level-2.

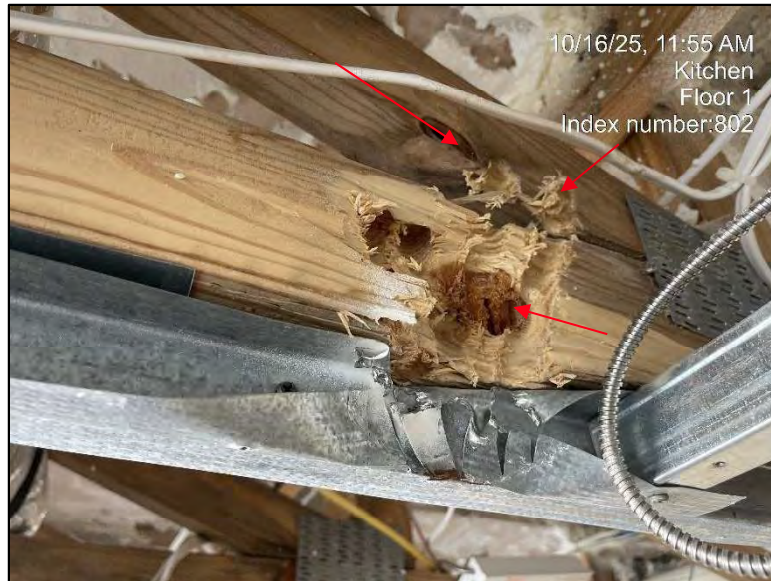
**Photo TC\_00802** – Damaged/broken truss member is visible at kitchen at Level-2.

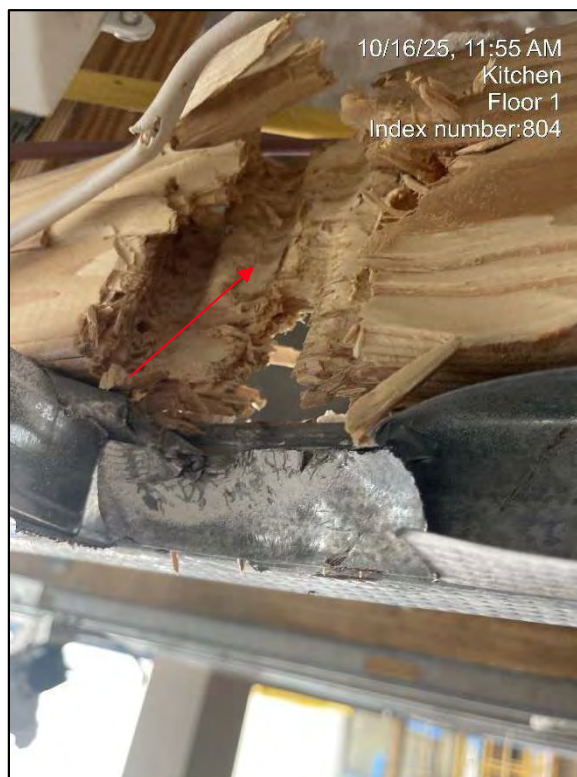
**Photo TC\_00804** – Damaged/broken truss member is visible at kitchen at Level-2.

**Criteria:** The existing conditions are in violation of FBC section 107.4.

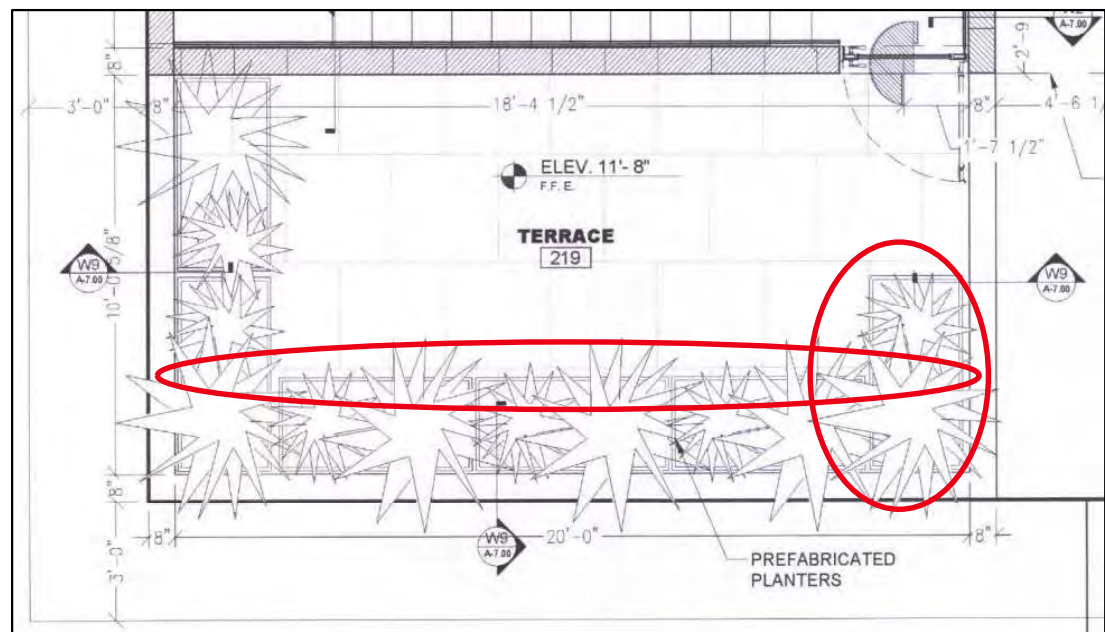
**Criteria:** The existing conditions are not in compliance with *Drawings A-1.01 & S-3:*

**Drawing A-1.01** – Planter at second floor on the southwest corner adjacent to the office/terrace area.

**Recommendations:** The request for information must be submitted to the Engineer of Record (EOR) for verification of design capacity of existing structure with inclusion of additional planter loads and a letter must be issued to the Homeowner confirming the adequacy of structure with additional load.

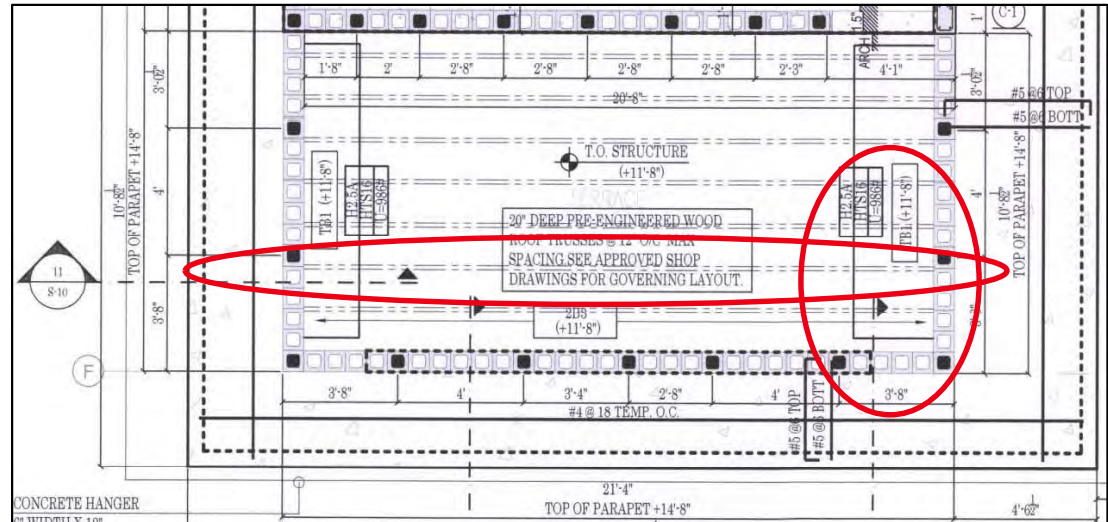
**Drawing S-3** – Planter is not shown at second floor on the southwest corner adjacent to the office/terrace area.

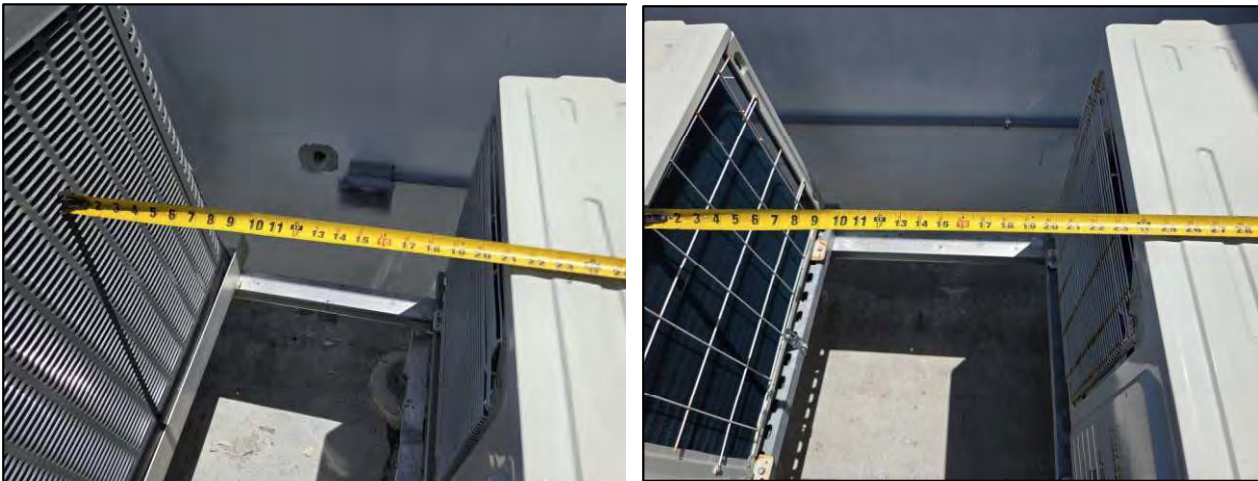
*Typical conditions of insufficient clearance around equipment.*

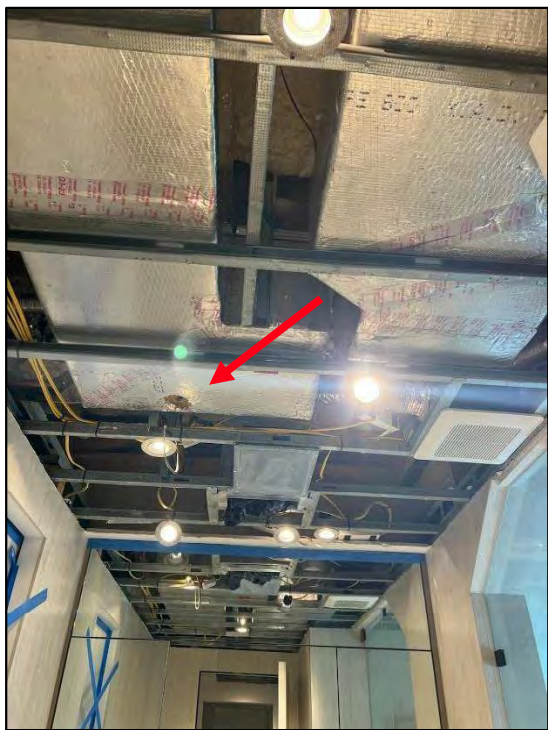
*Opening in duct above Master Bathroom due to light fixture installation (photograph provided by renovation contractor)*

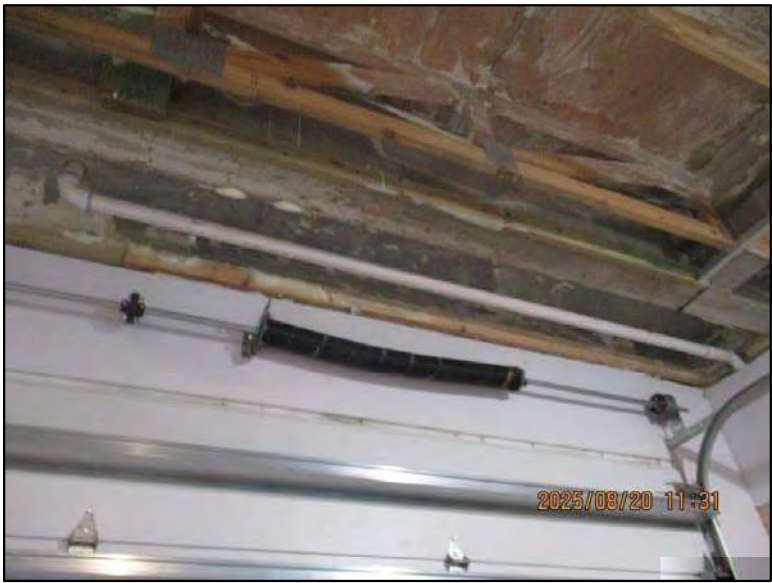
*Piping hangers missing to properly support the piping*

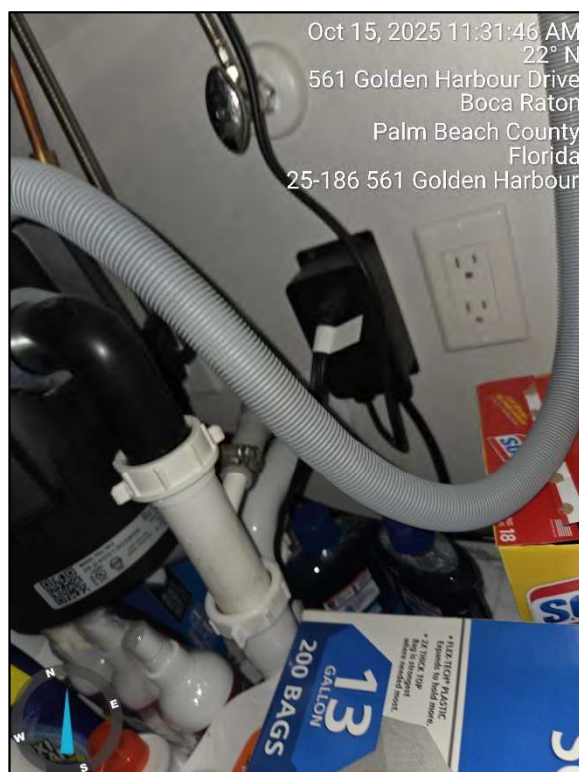
*Kitchen sink fixture drainage piping missing specified AAV*
