IN THE CIRCUIT COURT OF THE 15TH JUDICIAL  
CIRCUIT IN AND FOR PALM BEACH COUNTY, FLORIDA

**COMPLAINT**

<sup>4</sup> The three independent reports include: Structural Construction Defect Evaluation – Prepared by Summit Design and Forensics, Inc. (attached hereto as **Exhibit C**); Forensic Investigation Report – Prepared by ECS Florida, LLC (attached hereto as **Exhibit D**); Property Evaluation Report – Prepared by Pistorino and Alam Consulting Engineers, Inc. (attached hereto as **Exhibit E**); J.R. Inspections Services, Inc. – Mold Inspection Report (attached as **Exhibit “F”**) (collectively, the “**Engineering Reports**”)

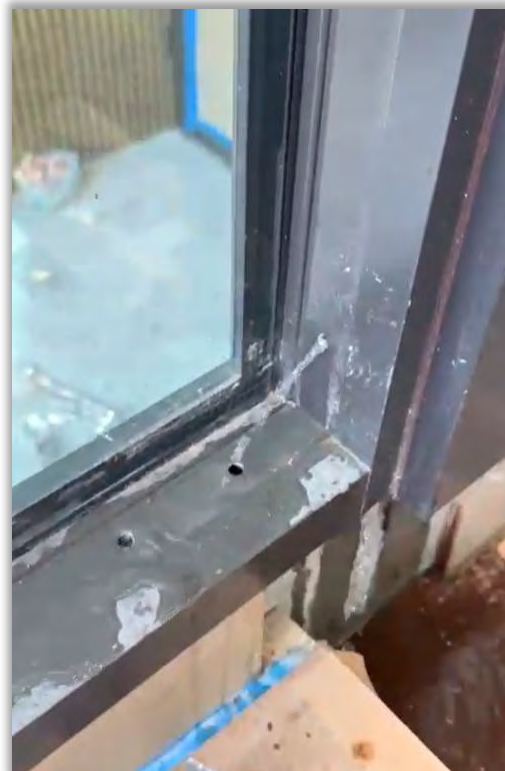
*Figure 2: Water spouting from window frame in main staircase after screw removal.*

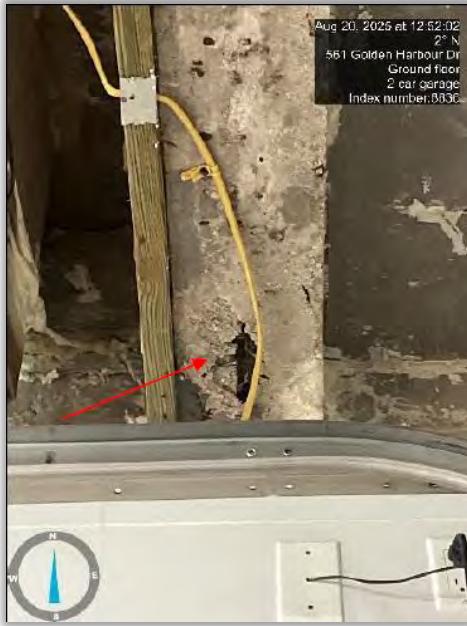
*Figure 7: crumbling concrete over exposed rusting rebar*

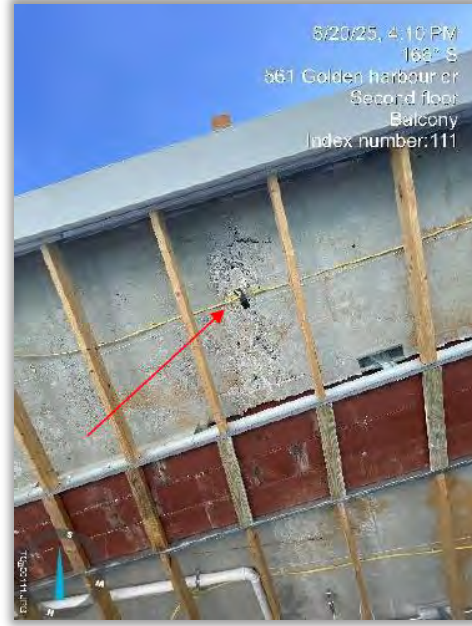
*Figure 8: honeycombing concrete on balcony slab and exposed rusting rebar*

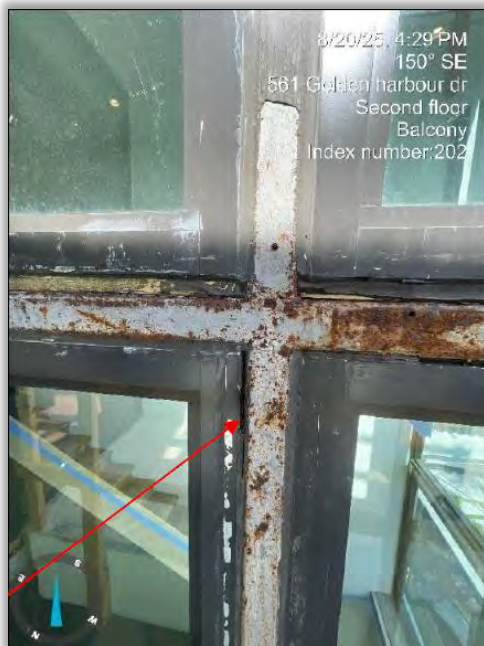
*Figure 9: corroded metal column and window mullion at main staircase with excessive water intrusion*

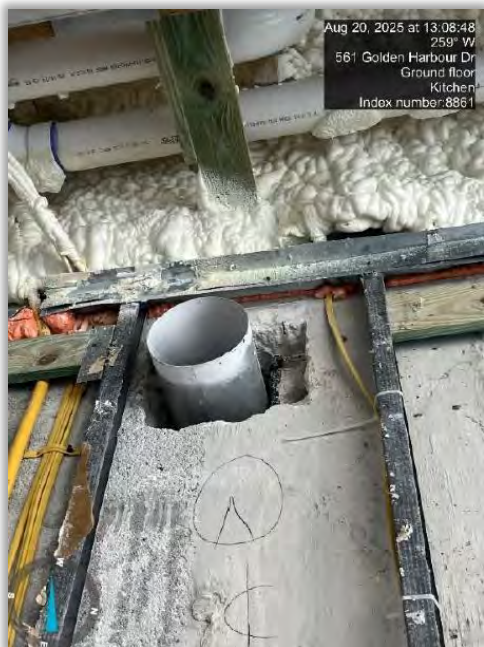
*Figure 11: kitchen air vent penetrating structural reinforced concrete column*

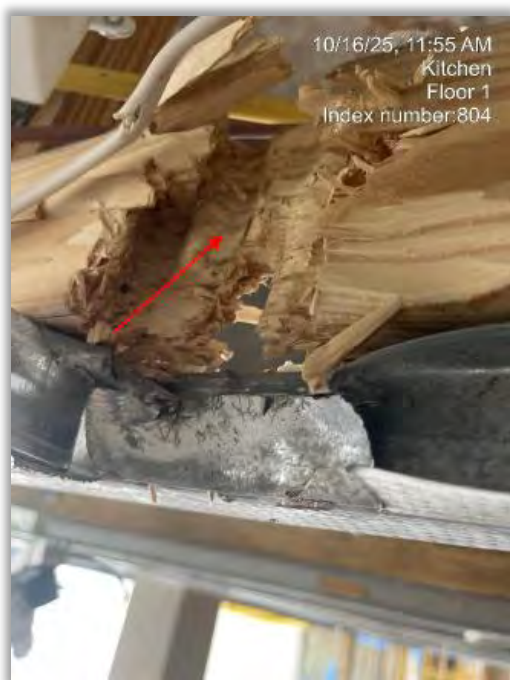
*Figure 13: broken roof trusses*

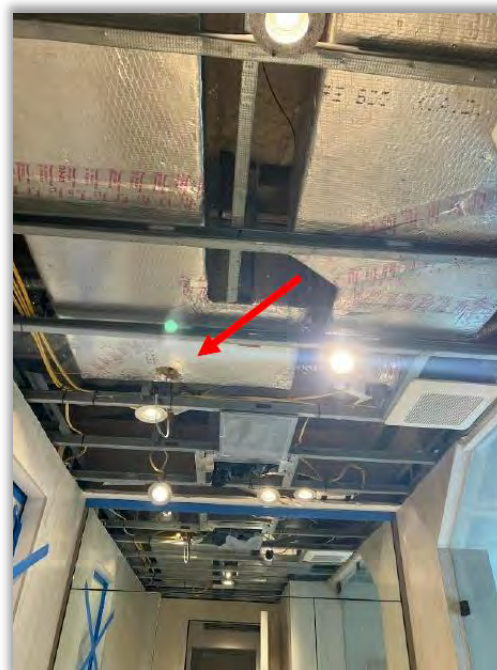
*Figure 14: hole drilled through air duct due to light fixture installation*

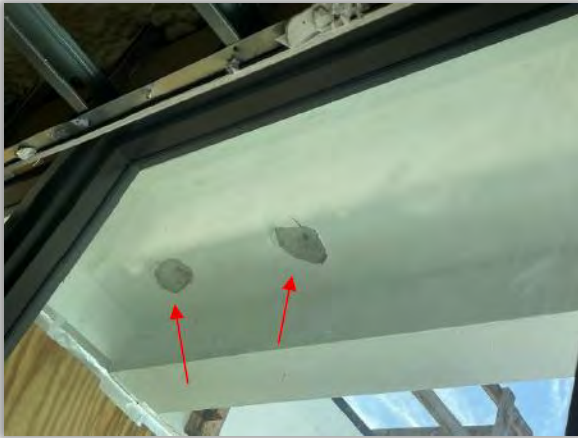
*Figure 15: holes drilled through balcony slab to drain ponding water*

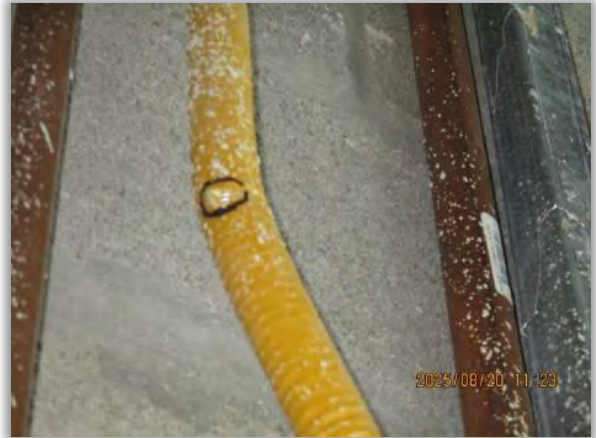
*Figure 16: screw hole in unprotected gas line*

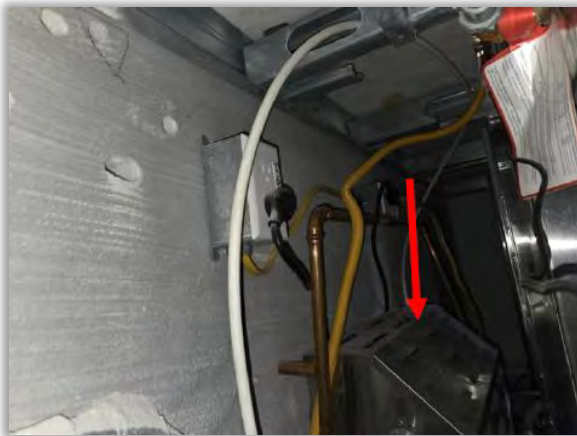
*Figure 17: steam generator equipment installed behind gas cooking equipment; fire hazard*

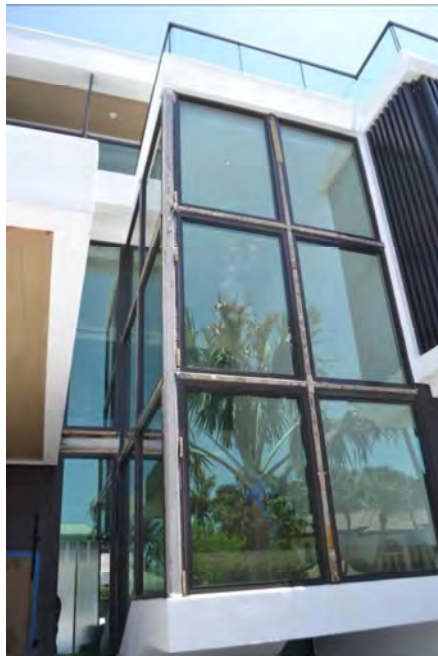
- The exterior wall structure consisted of fixed glass with supporting structural steel tubes (**Figure 2**). The tubes were reportedly wrap with aluminum.

Figure 2) View of the exterior walls of the main stair.

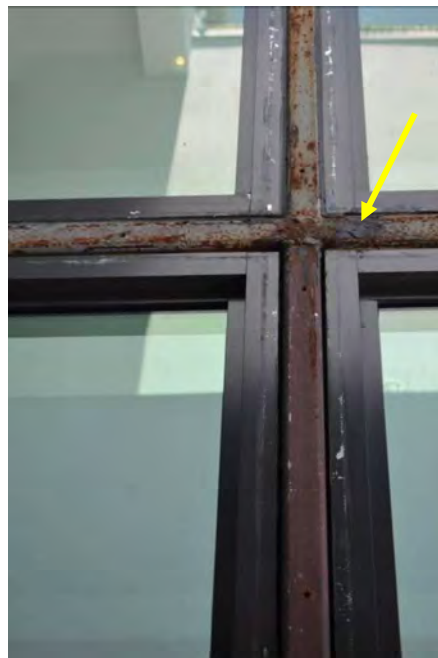
- Prior to Summit's inspection, the exterior aluminum wrapping was removed at the structural steel tubes.
- Portions of the reported water damaged interior wall finishes were removed (**Figure 3**).
- Summit observed varying degrees of corrosion to the structural steel tubes consistent with water intrusion (**Figure 4**).
- It is recommended the steel tubes be cleaned and coated per details prepared by a licensed Florida engineer.
- Summit observed water staining to the ceiling finish consistent with roof leakage.
- The cause of this observed and reported wall damage is related to improper waterproofing performed during construction, which has allowed rainwater to penetrate the wall envelope.
- The cause of the ceiling damage is related to improper roofing/flashing during construction, which has allowed rainwater to penetrate the roof envelope.

Figure 4) Exemplar view of corrosion observed to the steel tube framing at the exterior wall of the main stair.

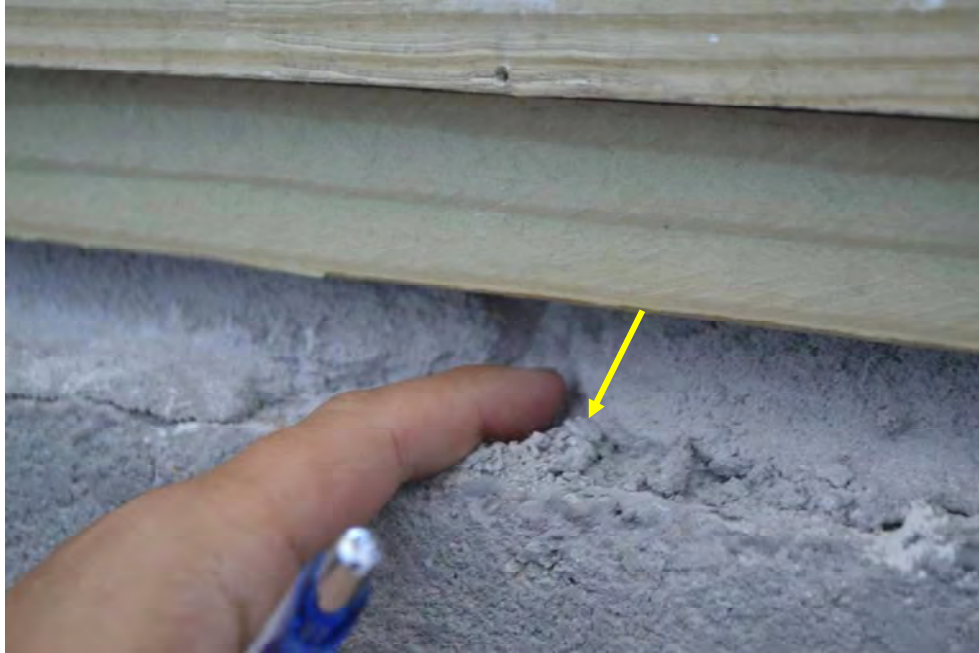
- Portions of the reported water damaged interior wall finishes were removed prior to Summit's site inspection.
- Summit observed a missing anchor at a girder truss connection (**Figure 8**).
- Summit observed water damage and apparent mold growth to the wall finish (**Figure 9**).
- Summit observed low strength grout added between the concrete beam and window buck (**Figures 10 through 12**).
- The cause of this observed and reported water damage and apparent fungal growth is related to improper roofing/waterproofing/flashing performed during construction, which has allowed rainwater to penetrate the roof and/or wall envelope.
- It is recommended the girder truss connection be evaluated by a licensed Florida engineer.

Figure 11) Close-up view of low-strength grout installed between the window buck and concrete beam at the stair to the third floor.

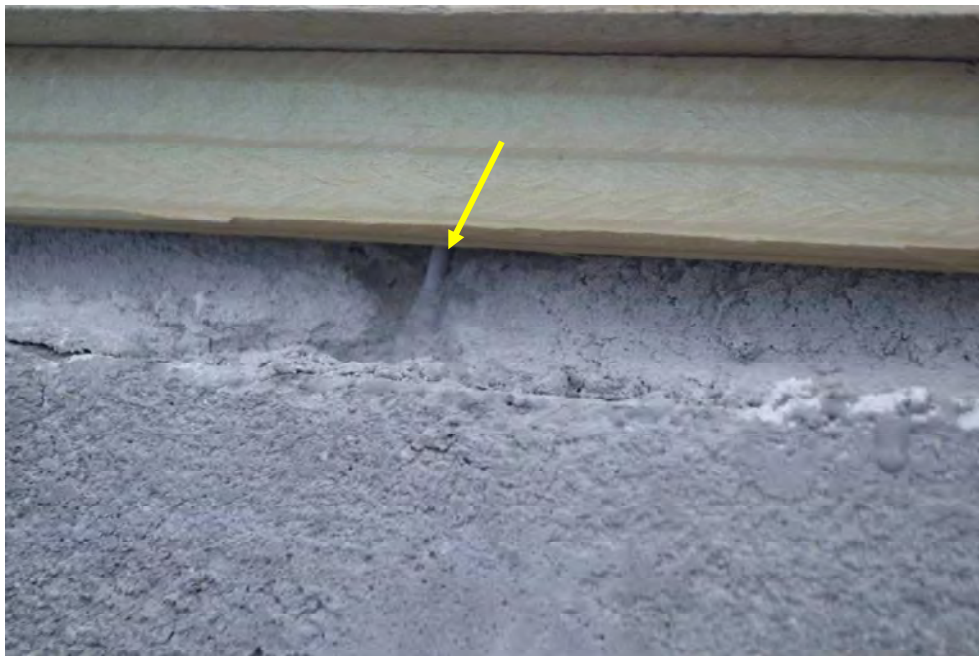
Figure 12) Close-up view of low-strength grout installed between the window buck and concrete beam at the stair to the third floor. Note window anchor.

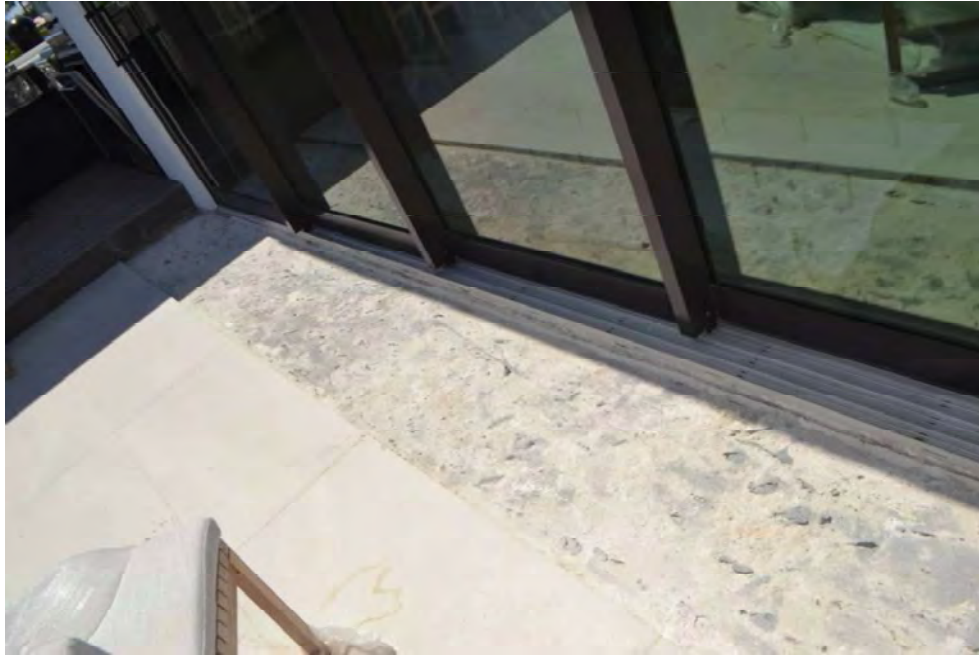
- According to Mr. Villa, there is no roof drain below the outdoor kitchen deck and a concrete curb prevents water from draining from this area (**Figure 14**) which is a defect.
- Portions of the pavers were removed along the sliders and windows prior to Summit's site inspection.
- Portions of the pavers are installed above the slider track weep holes (**Figure 15**), which does not allow rainwater in the track to properly drain and is a defect.
- Portions of the pavers are installed above the lower window frame portion causing water to pond against the window (**Figure 16**) and is a defect.
- It was reported to Summit that portions of the pavers do not adequately slope to the roof drains.

Figure 15) Exemplar view of removed pavers at the third floor rear balcony. Note pavers installed above the slider track weep holes in some locations.

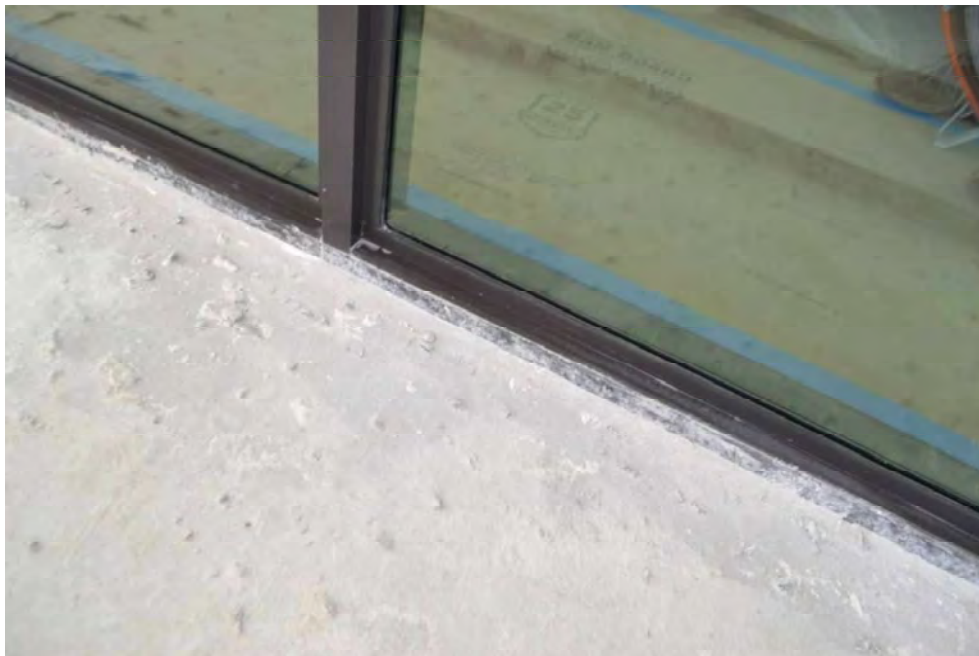
Figure 16) Exemplar view of removed pavers at the third floor rear balcony. Note pavers installed above lower window frame in some locations.

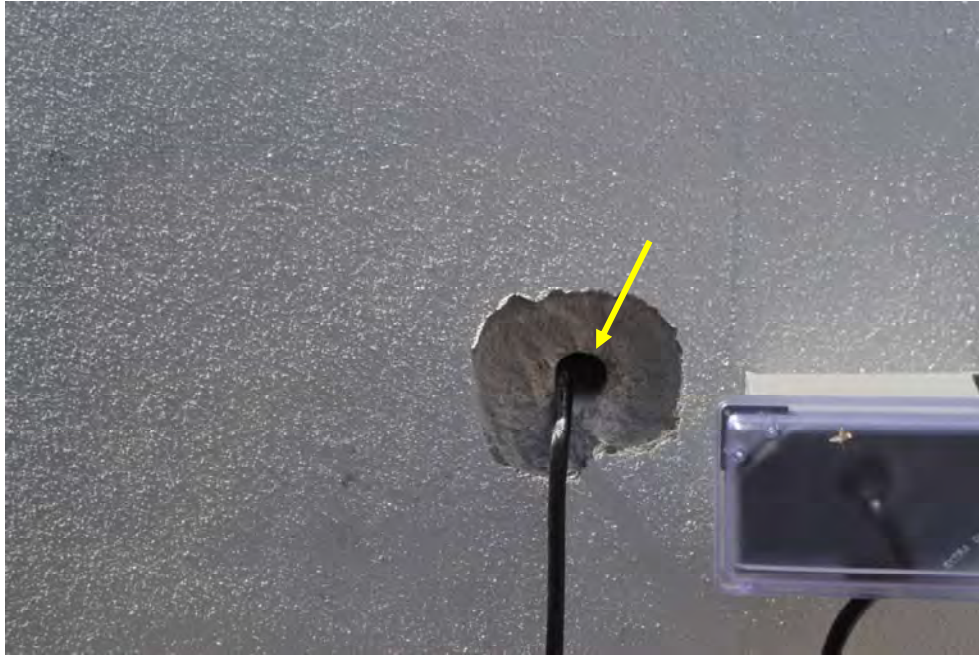
Figure 19) View of a wall opening at a wire penetration at the outdoor mechanical area.

- Summit observed an opening in the wall at a wire penetration (**Figure 19**).
- To repair this defect, it is recommended to seal this hole with a proper sealant material.

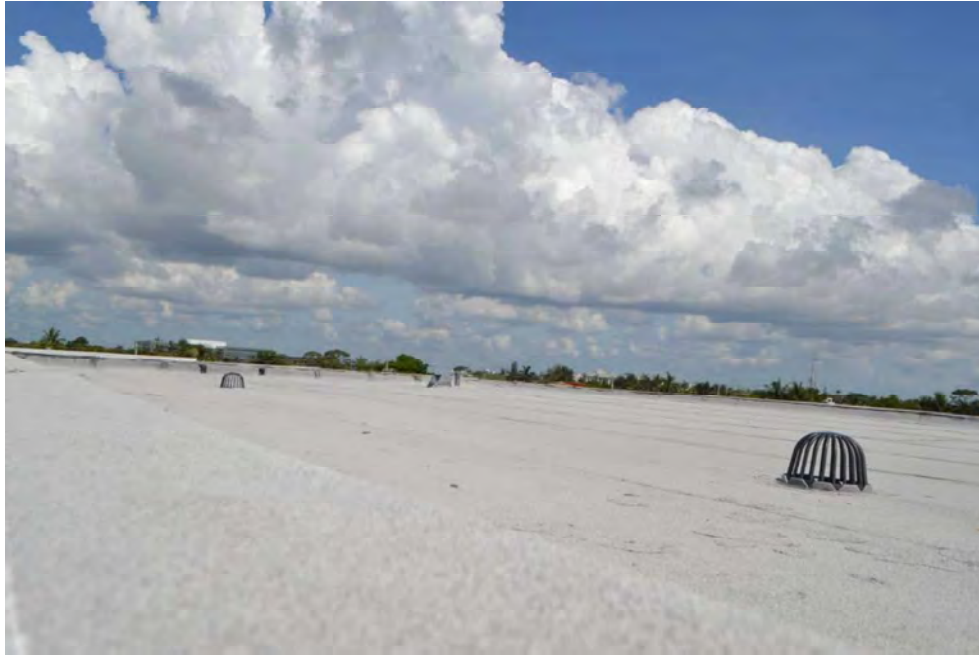
Figure 27) Overview of the upper roof covering.

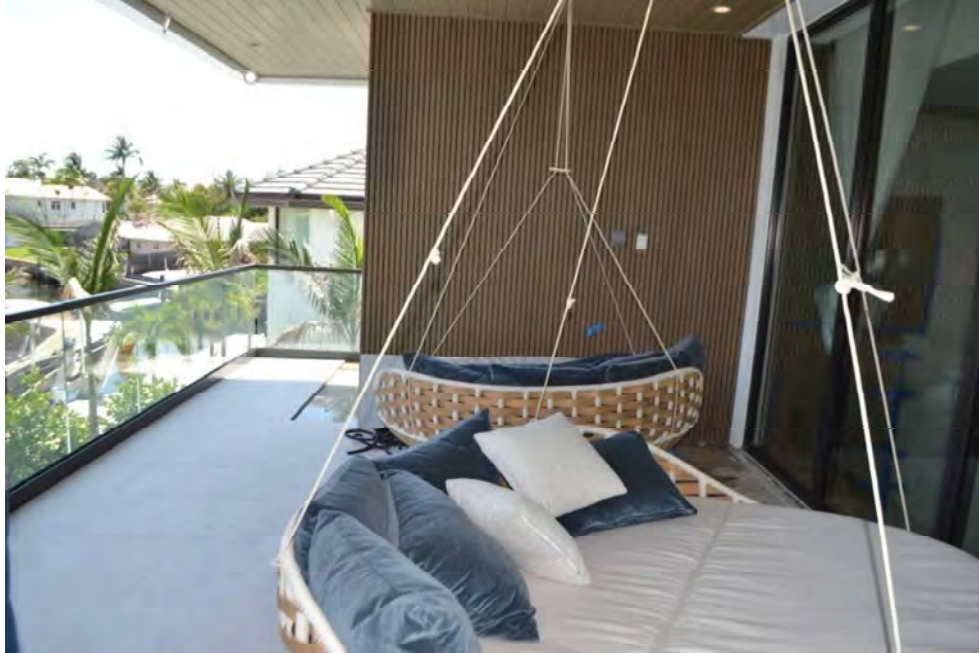
Figure 29) Overview of the second floor rear balcony.

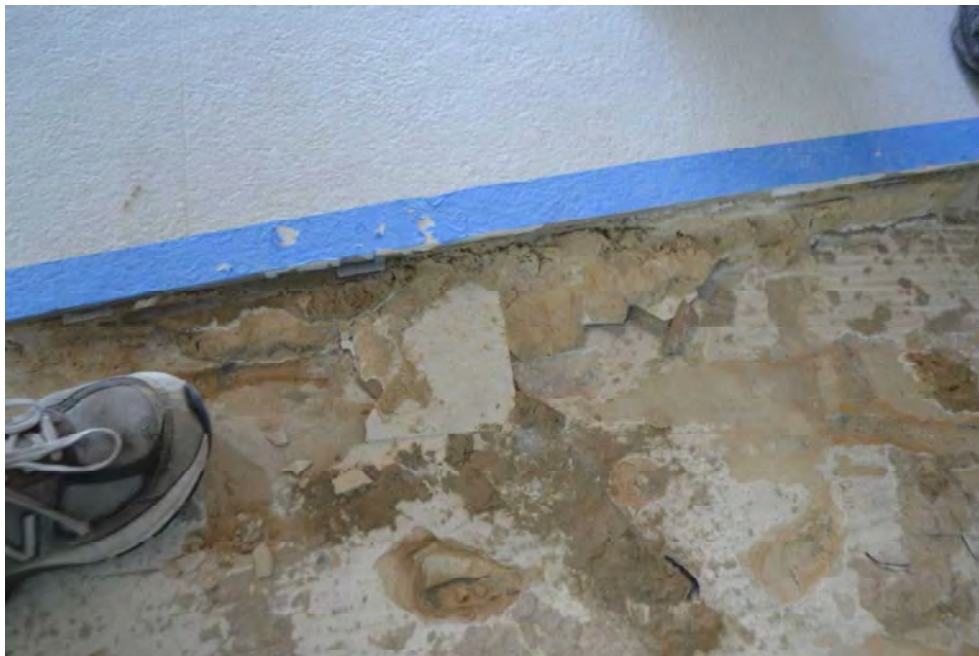
Figure 30) View showing pavers installed over a tile floor.

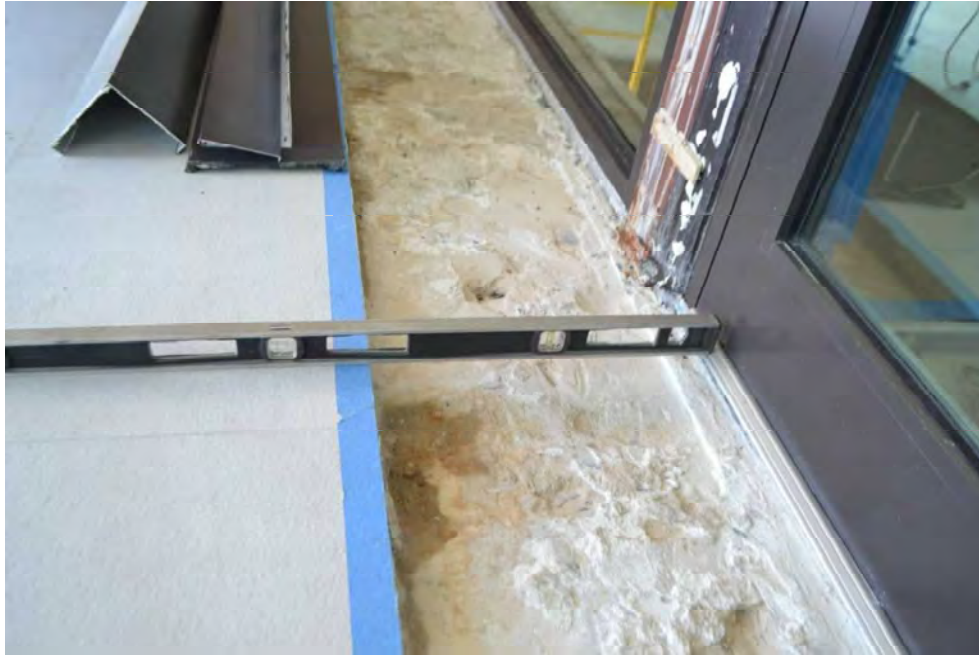
Figure 31) View showing pavers installed at or above the door threshold at the second floor rear balcony.

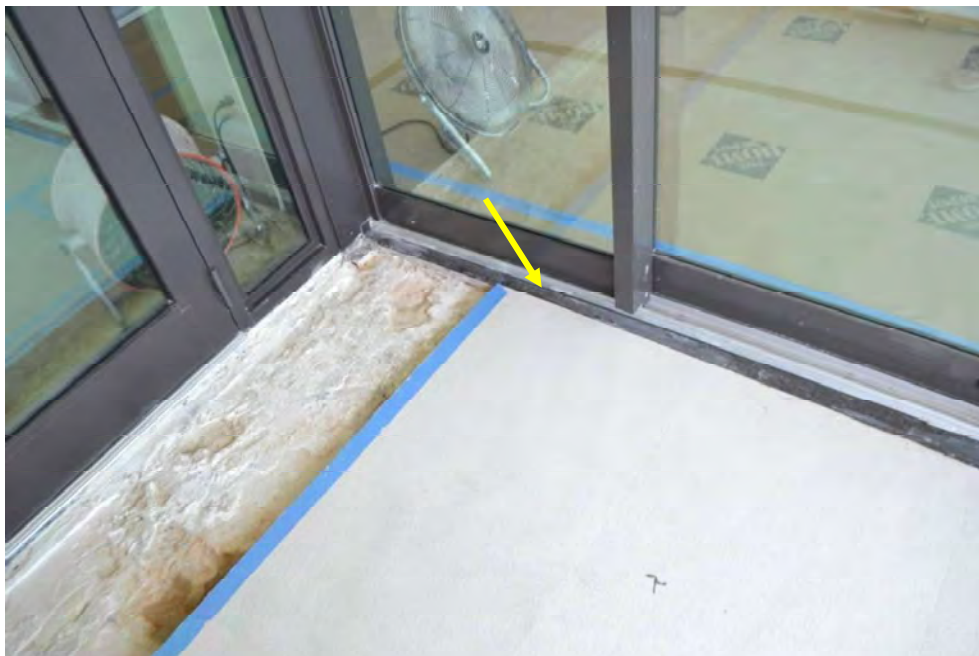
Figure 32) Exemplar view showing pavers installed above the lower window frame at the second floor rear balcony.

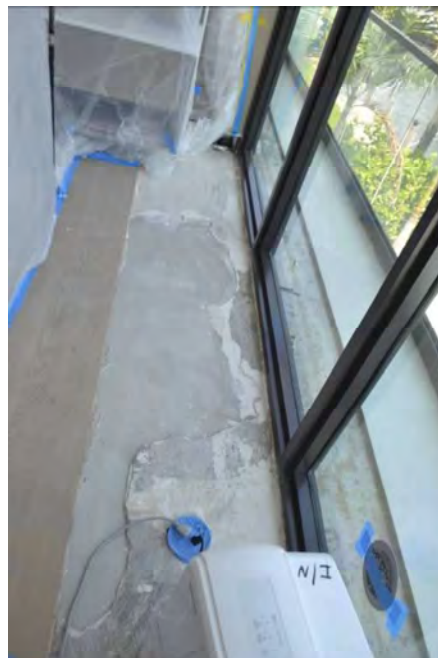
Figure 36) View showing the reportedly water damaged wood flooring removed in the master bedroom along the exterior windows.

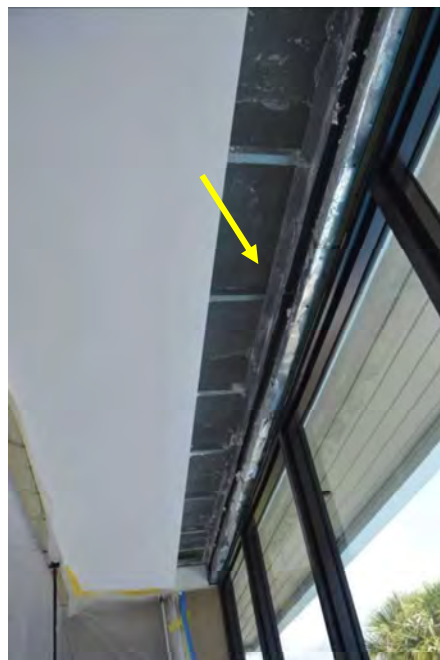
Figure 38) View showing the reportedly water damaged ceiling finish removed in the master bedroom along the exterior windows.

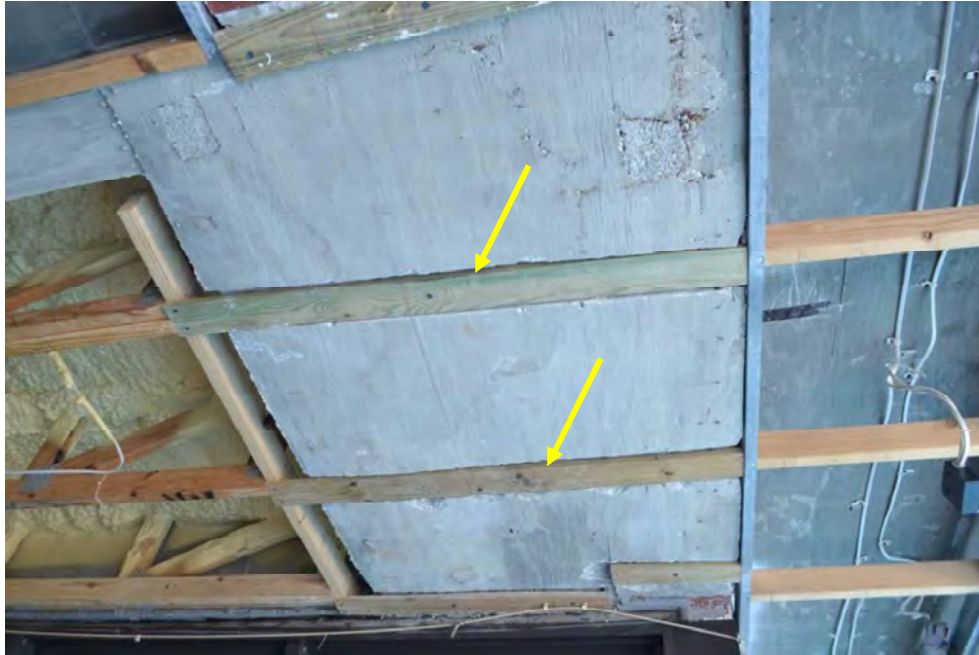
- Summit observed the ceiling finish was removed prior to Summit's site inspection. Water damage reportedly occurred to the ceiling finish.
- Summit observed removed concrete at a beam at the ceiling finish furring strips (**Figures 55 and 56**). At some locations Summit observed exposed beam reinforcing.
- Summit observed that the pavers were covering the slider track weep holes at some locations (**Figure 57**) which is a defect.
- The cause of this reported water damage is related to improper waterproofing and/or flashings performed during construction, which has allowed rainwater to penetrate the slab above.
- It is recommended the concrete beams, which were partially removed at the ceiling furring strips, be evaluated by a licensed Florida engineer to determine the proper repair.

Figure 55) View of removed concrete at a beam at the ceiling furring strips above the rear porch.

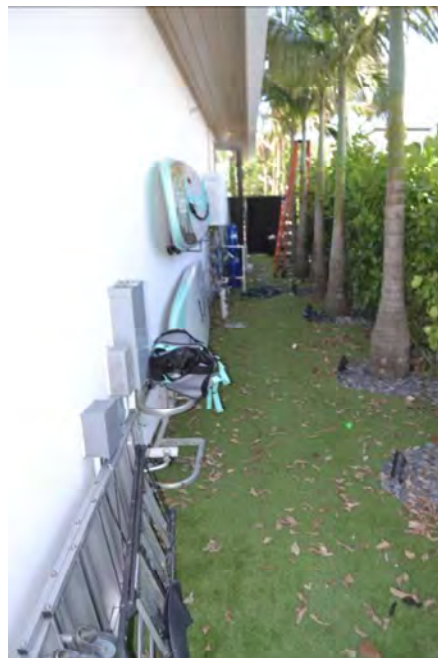
**Figure 58** is a view of the partial left elevation of the home. The following observations were made and conclusions have been derived at the left elevation of the home.

Figure 58) Partial view of the left elevation of the home.

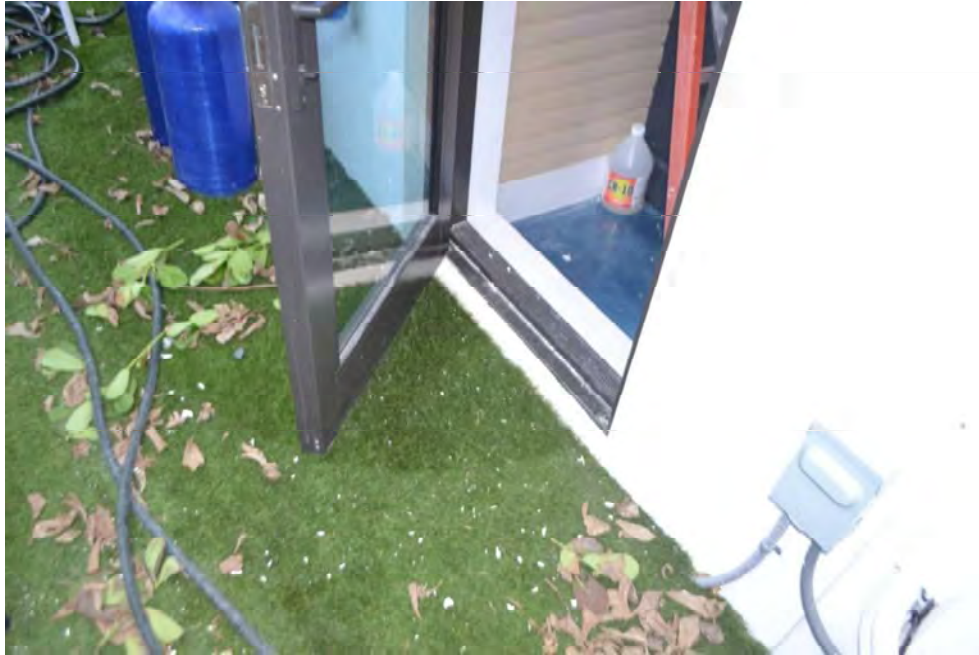
- According to Mr. Villa, water intrusion occurs at the door during heavy rain events. Summit observed that the exterior grade was near the door threshold (**Figure 59**).
- Summit observed an outlet bottom improperly installed near the finish exterior grade (**Figure 60**).
- The cause of this reported water intrusion is related to improper site grading.

Figure 59) View showing exterior grade elevation near door threshold at the left elevation of the home.

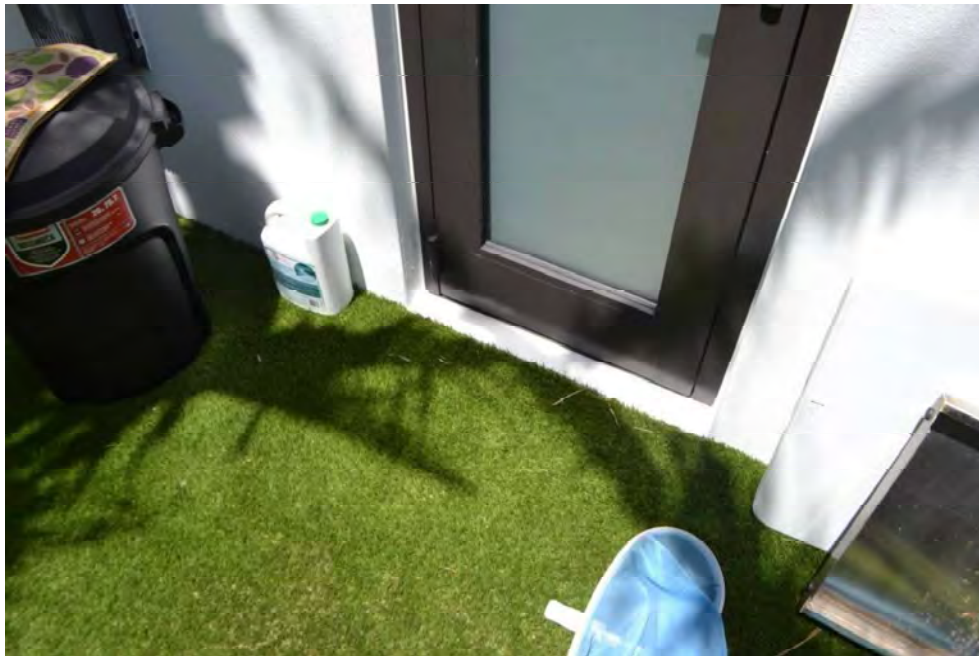
- Summit observed that the exterior grade was near the door threshold (**Figure 62**). This grading is improper.
- Summit observed a roof drain was partially covered by the exterior grade (**Figure 60**). This grading is improper.

Figure 62) View showing exterior grade elevation near door threshold at the right elevation of the home.

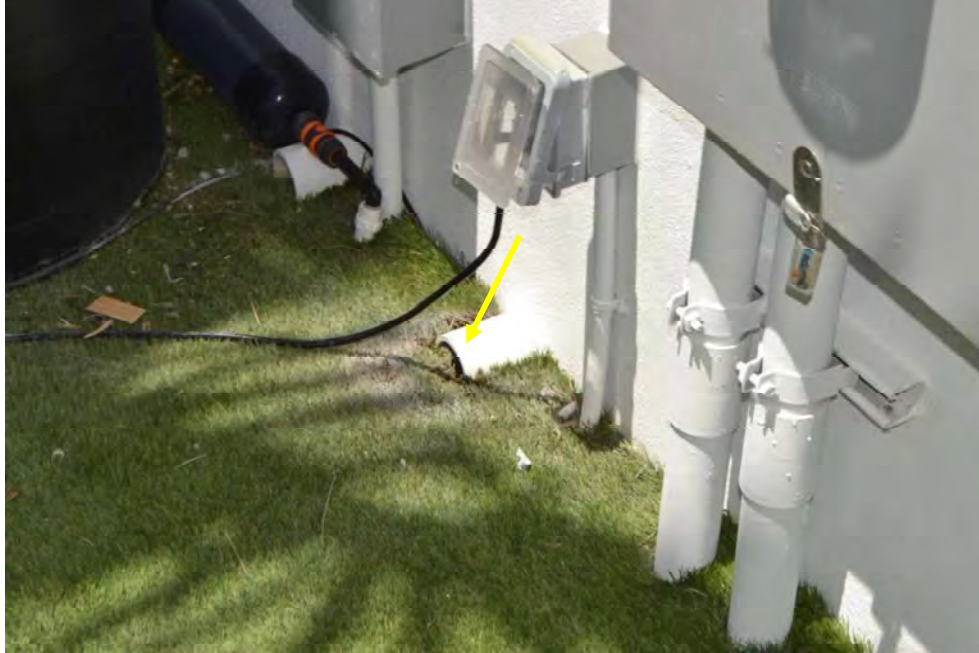
Figure 63) View showing exterior grade above a roof drain outlet at right elevation of the home.

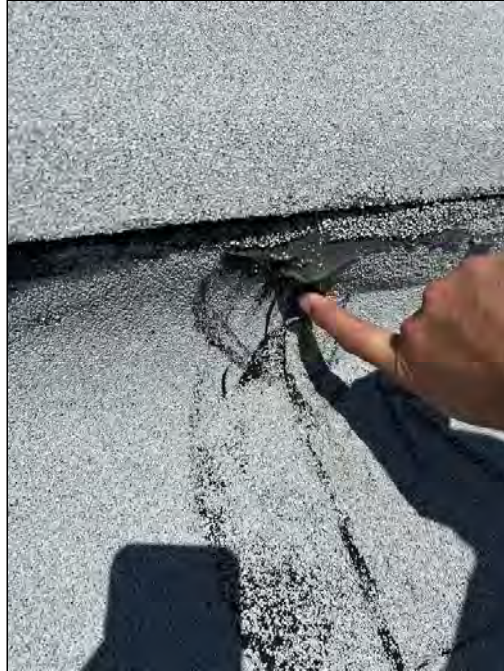
1 - Hole observed at the roof membrane to be detailed.

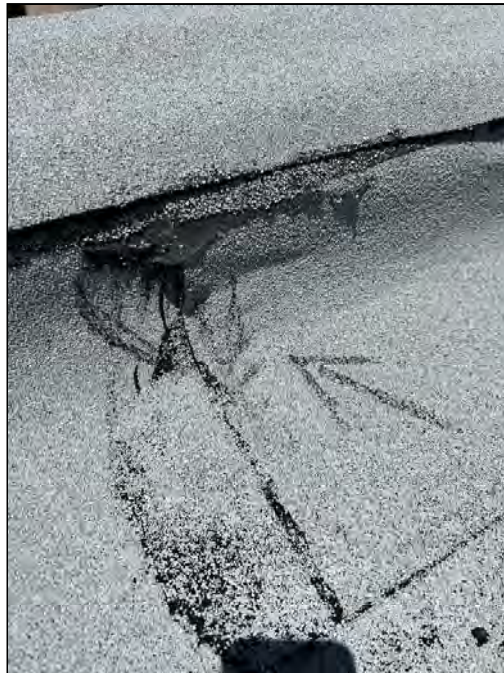
2 - Roof membrane was marked for remediation.

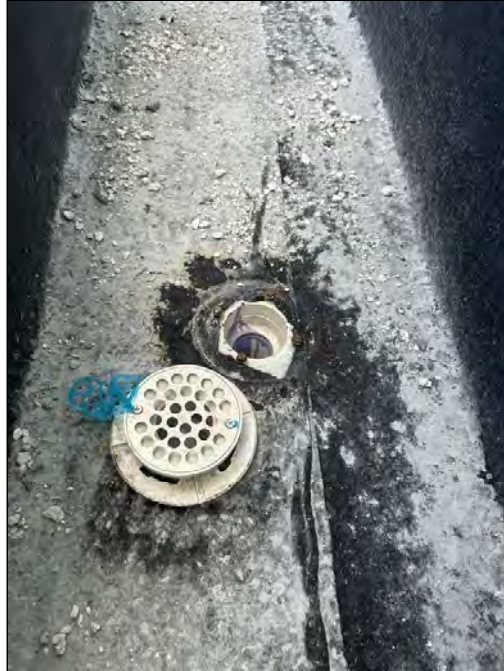
3 - Drain body without proper level.

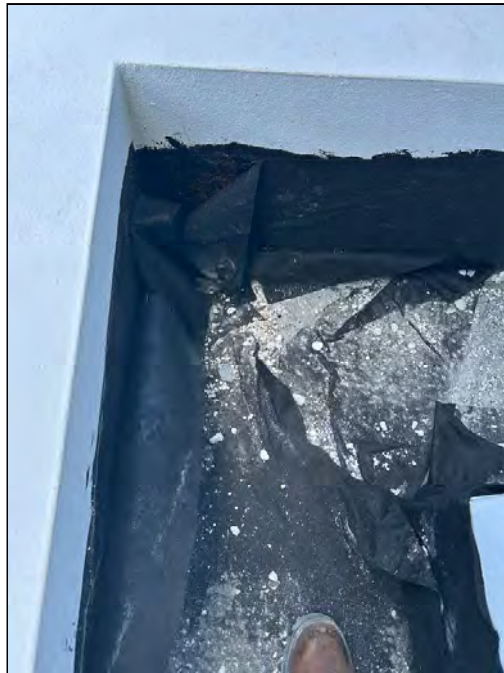
4 - No termination bar or detailing observed for the waterproofing system at planter.

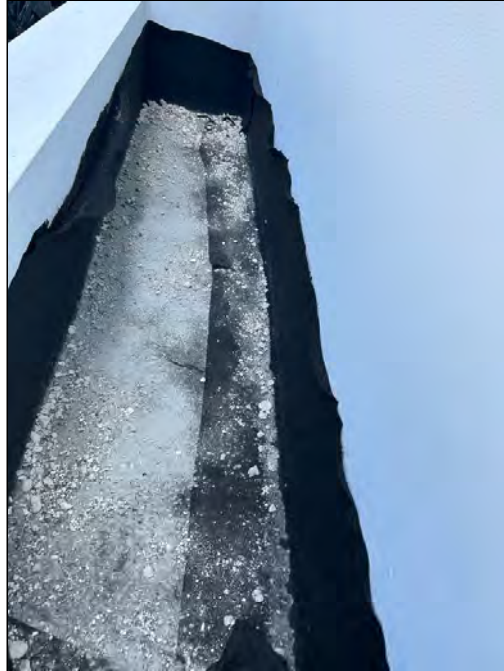
5 - Inconsistent waterproofing membrane applied.

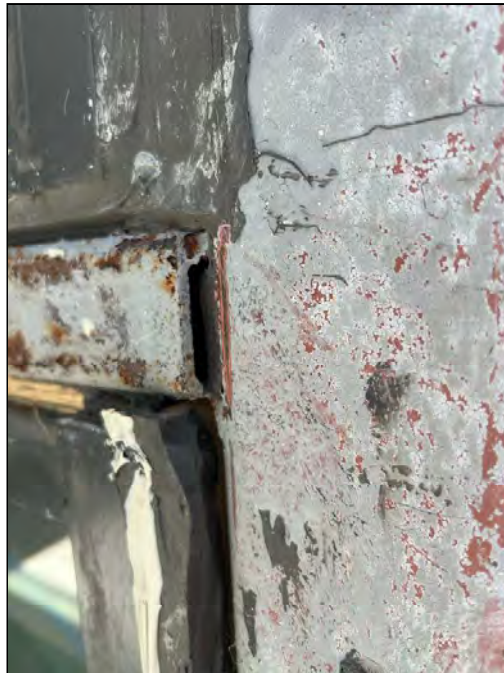
6 - Window assembly observed without proper sealant.

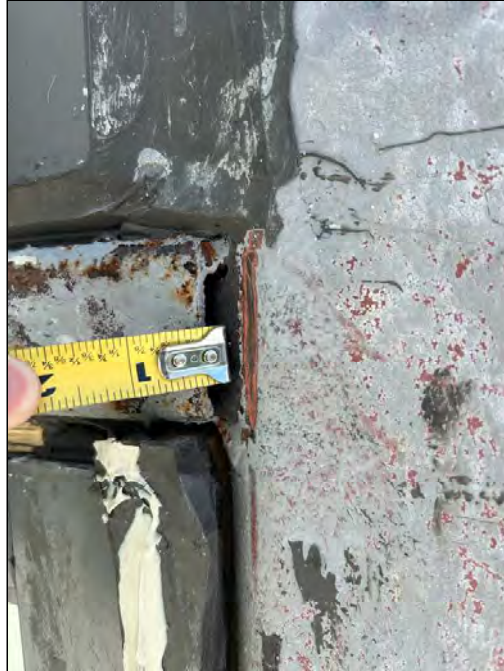
7 - Gap at windows assembly, to be properly detailed.

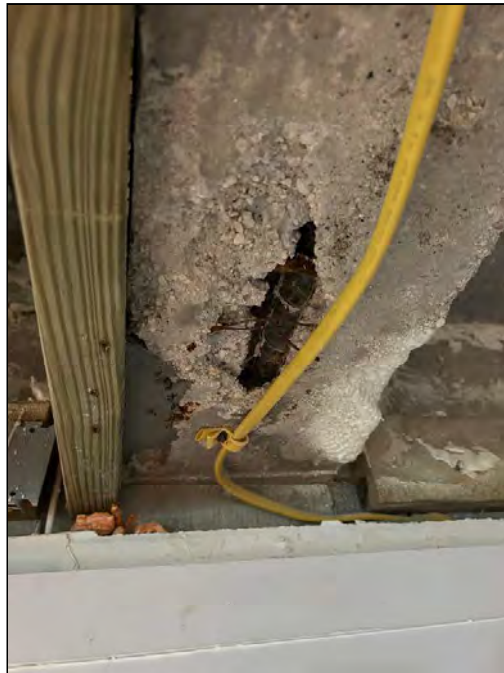
8 - Active leak observed during visit.

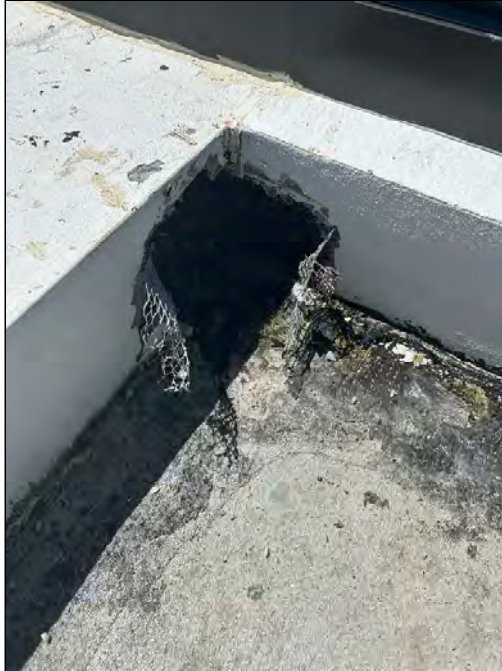
9 - Roofing membrane to be repaired.

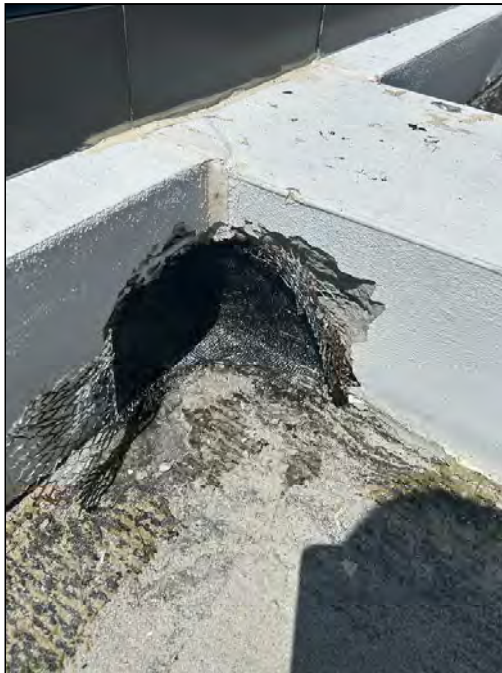
10 - Roofing level pending remediation and stucco application.

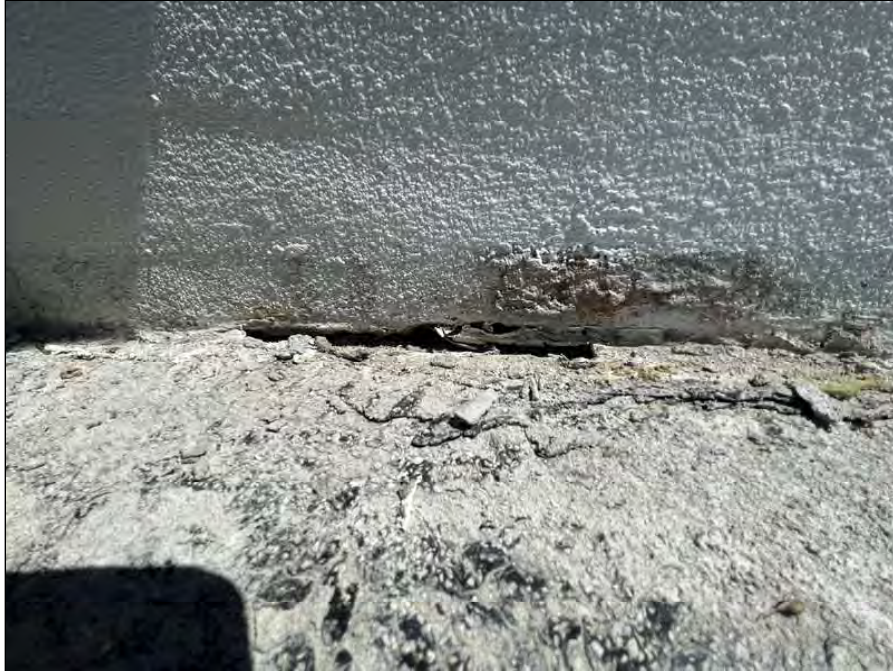
11 - Not signs of proper flashing at roofing membrane.

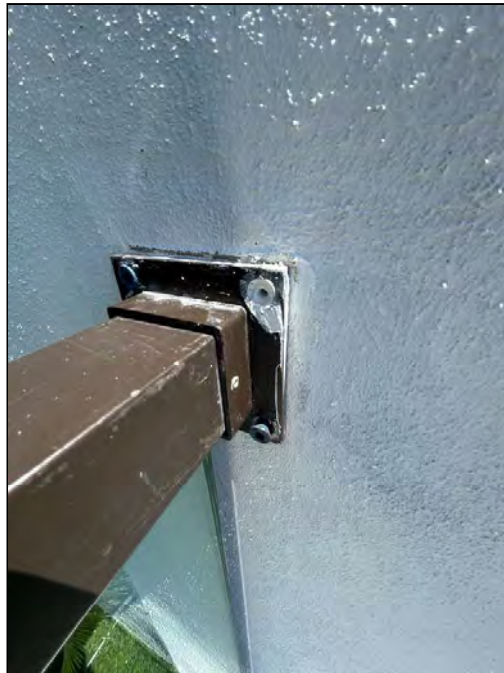
12 - Railing system observed missing screws.

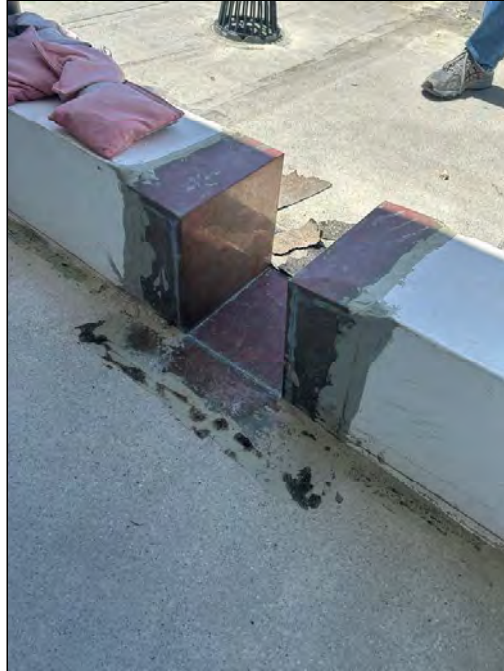
13 - Improper slope at roof. restraining the water flow.

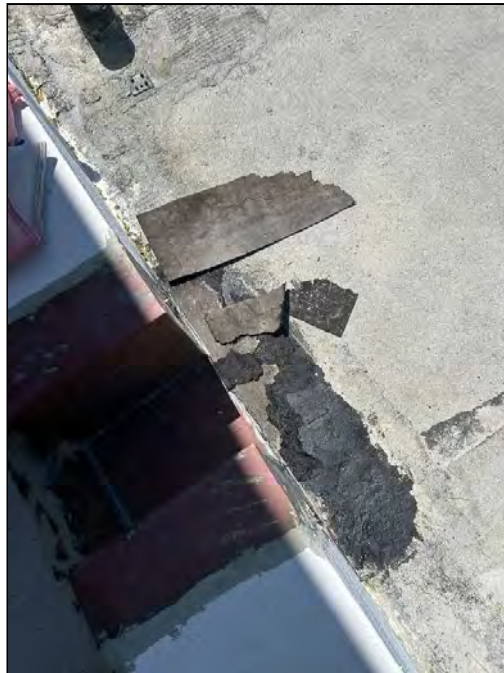
14 - Membrane repair not properly adhered to substrate.

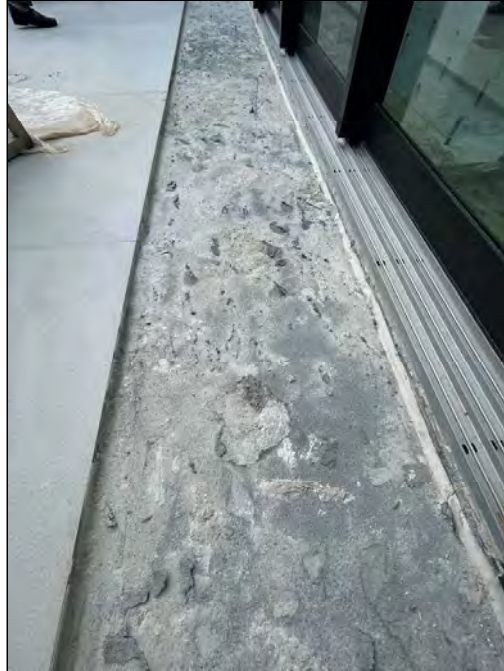
15 - Level 3 Balcony - Damaged waterproofing membrane.

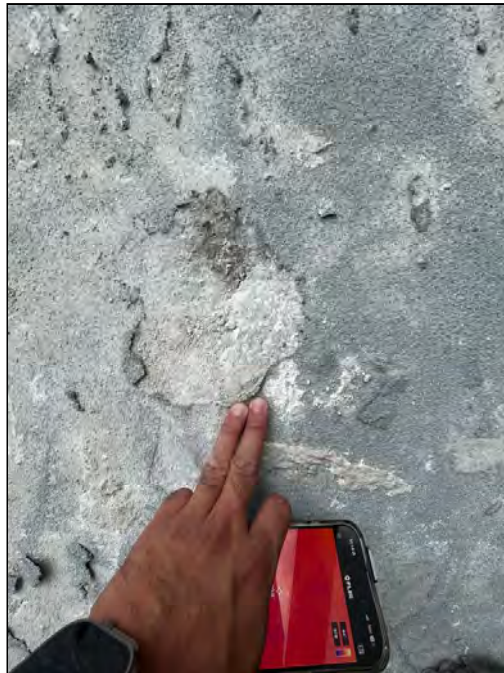
16 - Waterproofing system not properly adhered to the substrate.

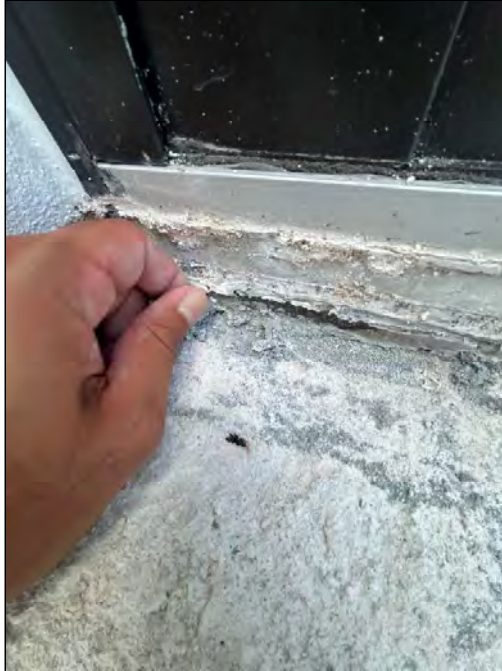
17 - Sealant gap between window frame and substrate.

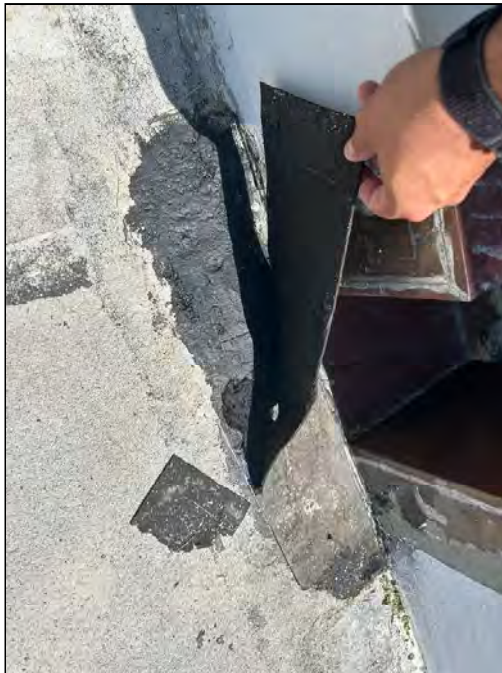
18 - Roofing membrane repair loose.

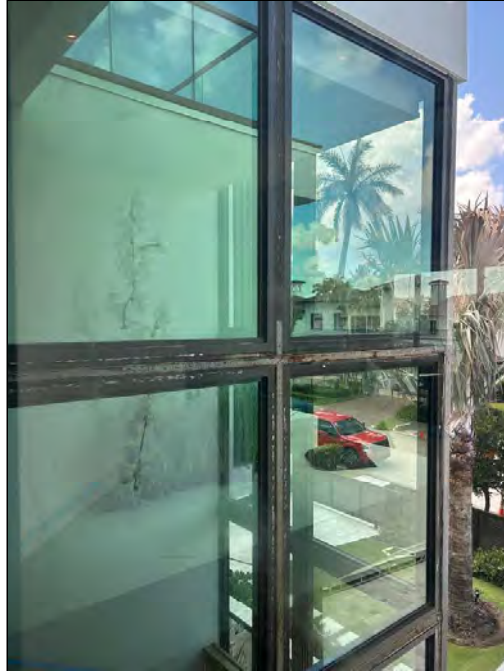
19 - Windows observed missing backer rod and sealant installation.

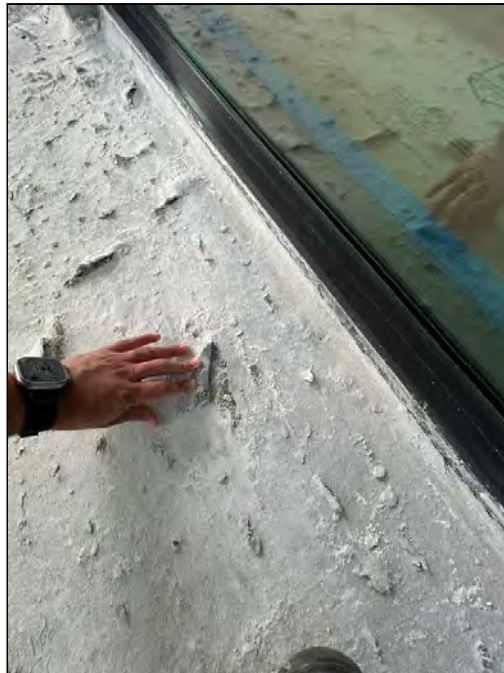
20 - Waterproofing system not adhered to substrate.
