IN THE CIRCUIT COURT OF THE 15TH JUDICIAL  
CIRCUIT IN AND FOR PALM BEACH COUNTY, FLORIDA

**COMPLAINT**

<sup>4</sup> The three independent reports include: Structural Construction Defect Evaluation – Prepared by Summit Design and Forensics, Inc. (attached hereto as **Exhibit C**); Forensic Investigation Report – Prepared by ECS Florida, LLC (attached hereto as **Exhibit D**); Property Evaluation Report – Prepared by Pistorino and Alam Consulting Engineers, Inc. (attached hereto as **Exhibit E**); J.R. Inspections Services, Inc. – Mold Inspection Report (attached as **Exhibit “F”**) (collectively, the “**Engineering Reports**”)

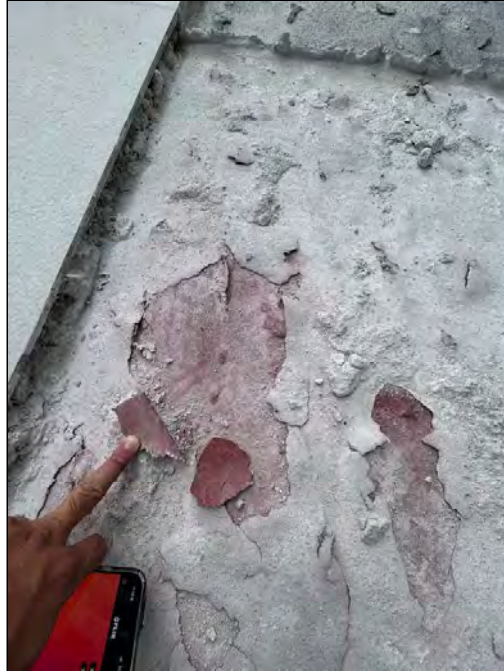
21 - Multiple layer of waterproofing material without clear indication of compatibility.

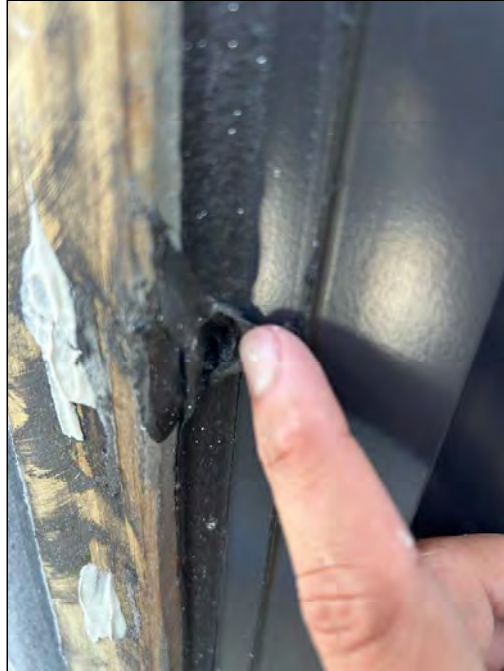
23 - Inconsistent application of sealant at window perimeters

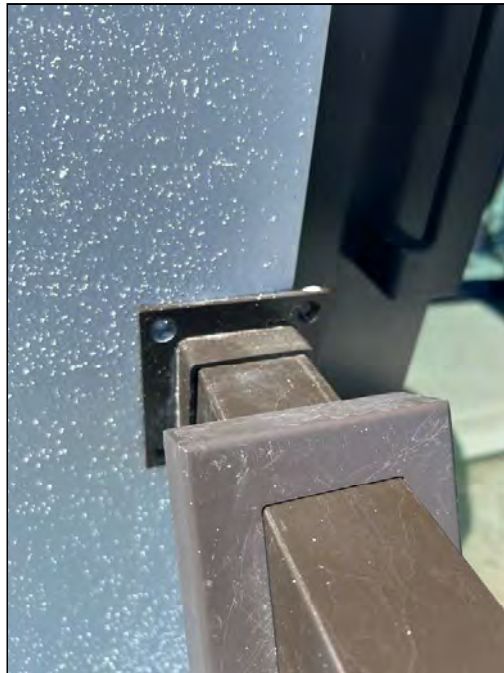
24 - Missing fastening screws, exterior wall system unsealed.

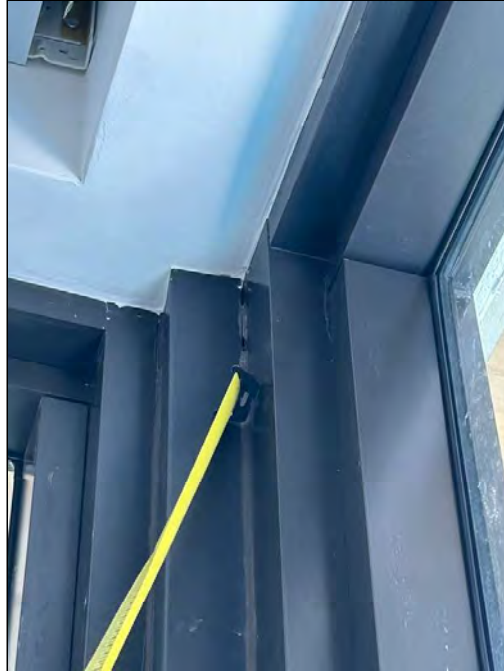
25 - Sealant bead with visible voids and holes.

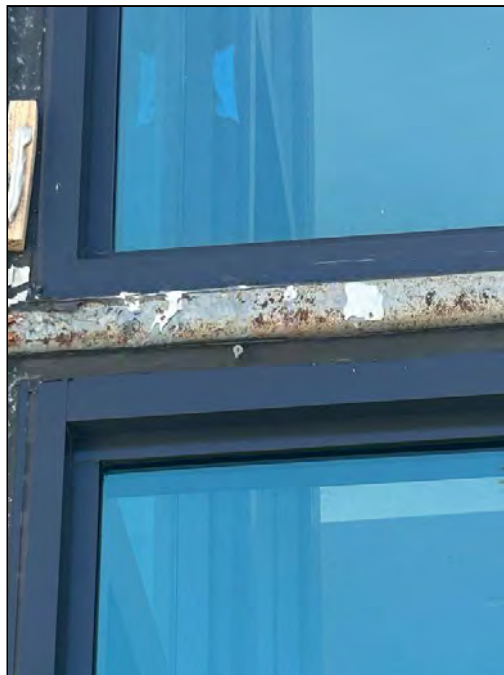
26 - Screws were installed directly through sealant joints.

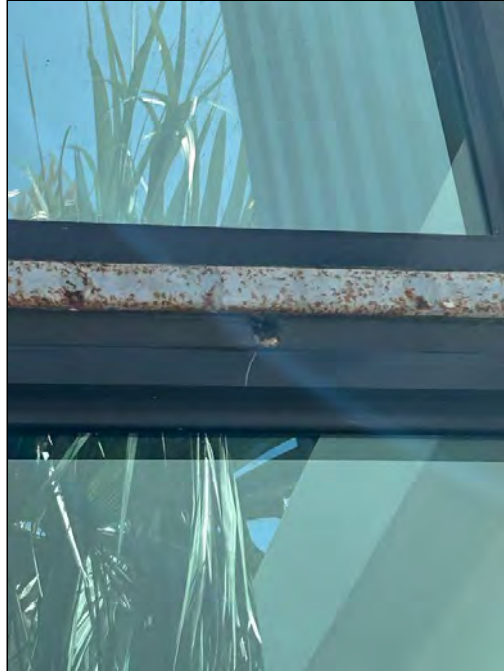
27 - Observed hole along sealant joint.

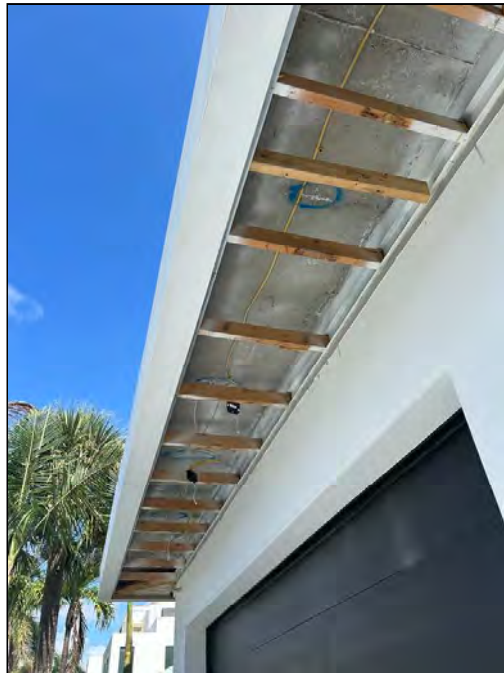
28 - Active leak location observed.

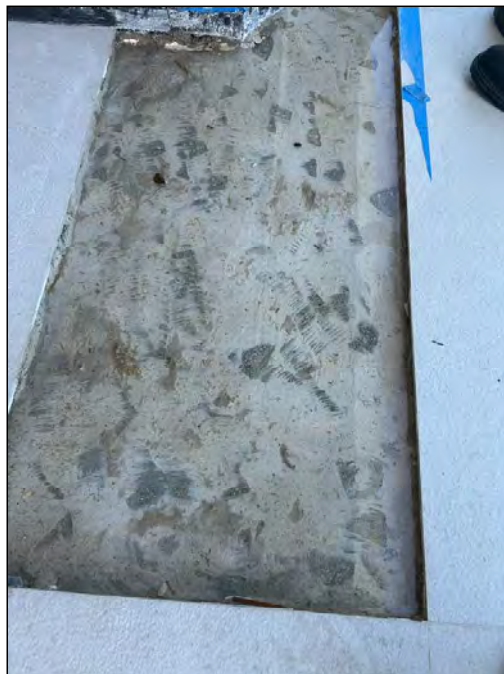
32 - Tile installed over concrete without waterproofing membrane,

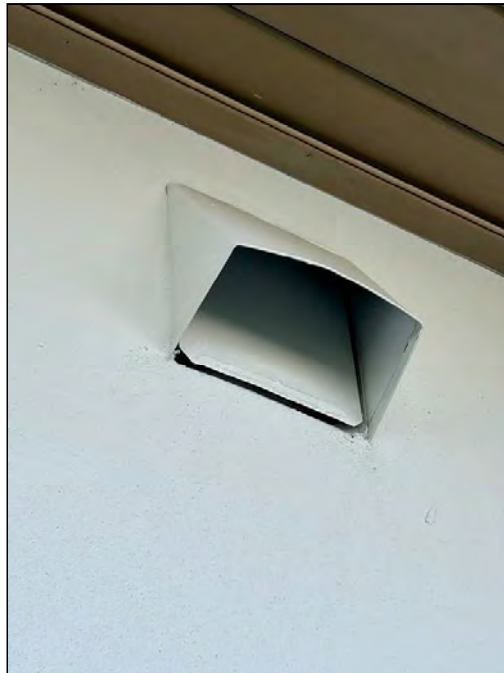
34 - Vent observed without sealant installed.

- Apply sealant around all exterior wall penetrations including vents and electrical boxes to prevent moisture entry.

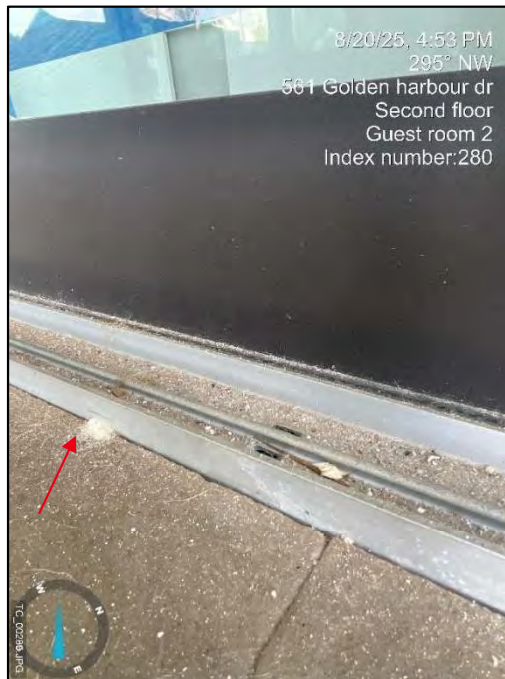
**Observation:** The aluminum framing of the glazing system were observed with significant signs of pitting and damage. The aluminum frames were observed to be prematurely pitting and deteriorating where the glazing systems are in contact with dissimilar materials like the tiles finishes/ mortar system at the exterior balconies. Additionally, at many locations the weep holes provided at the bottom track of frames were blocked by inadequately installed tile and mortar system. Also, at many locations missing sealant was observed below the sliding glass doors and windows and water intrusion was reported to be occurring below the sliding glass doors into the interior of the residence (Please refer to article 2.6 for locations of water intrusion and article-2.8 for photos of missing sealants below glazing system).

**Photo 280:** Signs of galvanic reaction and pitting at contact with tile finishes/mortar system at the ground floor outdoor living area adjacent to the dining room.

**Recommendations:** Repair or replace with new, all damaged aluminum frames for the sliding glass doors, and wall assemblies and provide appropriate protection against corrosive elements.

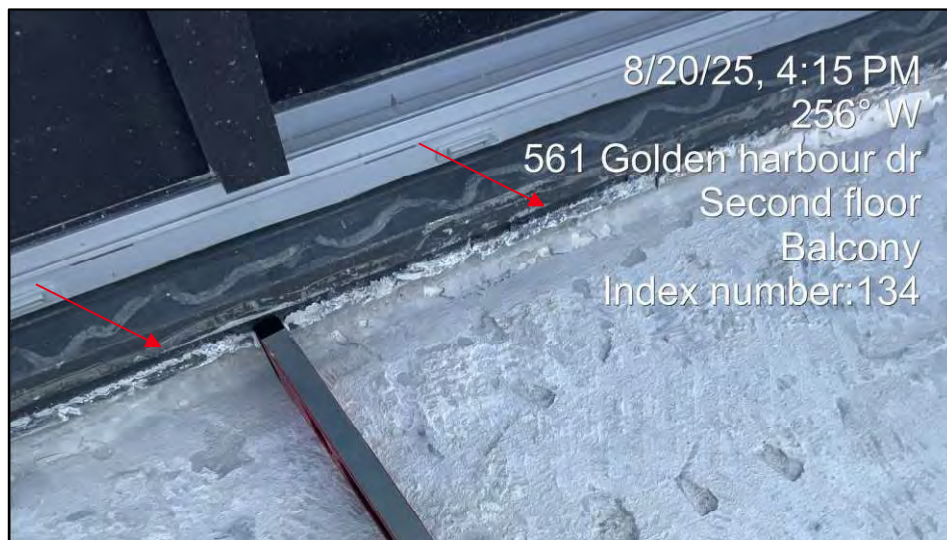
**Photo 134:** Mortar bed in contact with sliding glass door frame at the second-floor balcony area adjacent to the guest bedroom #1.

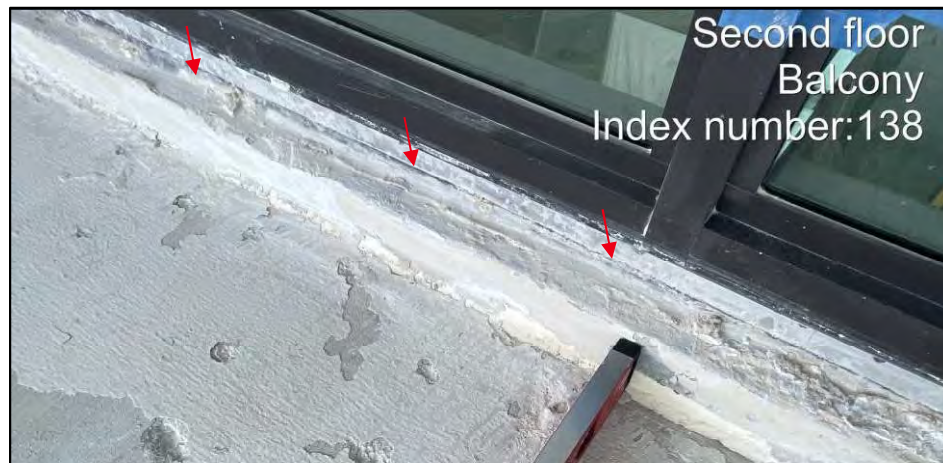
**Photo 138:** Mortar bed in contact with fixed glass door frame at the second-floor balcony area adjacent to the living room.

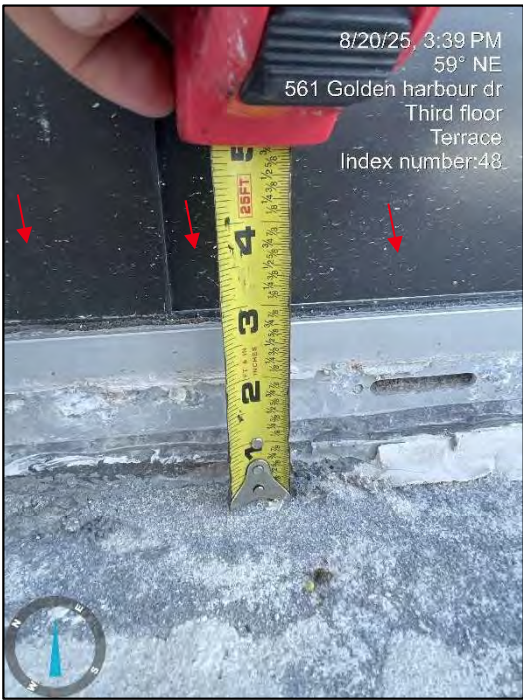
**Photo 48:** Stains on the aluminum frame show the level of tile and mortar bed prior to removal of tiles. It is evident that the weep holes were blocked by tile and mortar system at the third-floor terrace.

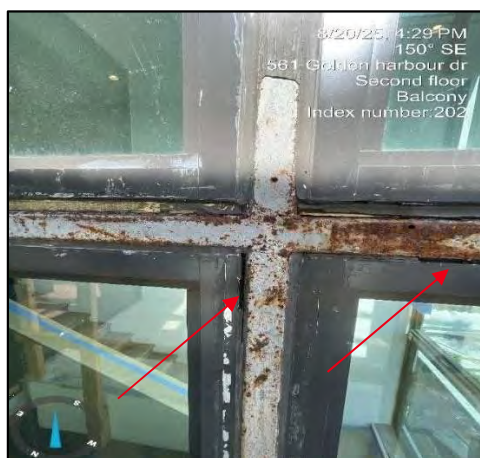
**Photo 202** –Missing Sealants at staircase landing at the second floor.

**Photo 202** – Corroded metal mullions between aluminum glazing system in staircase landing at the second floor. Also, sealant is missing.

**Recommendation:** Remove and replace with new all existing unbonded and damaged sealants with new.

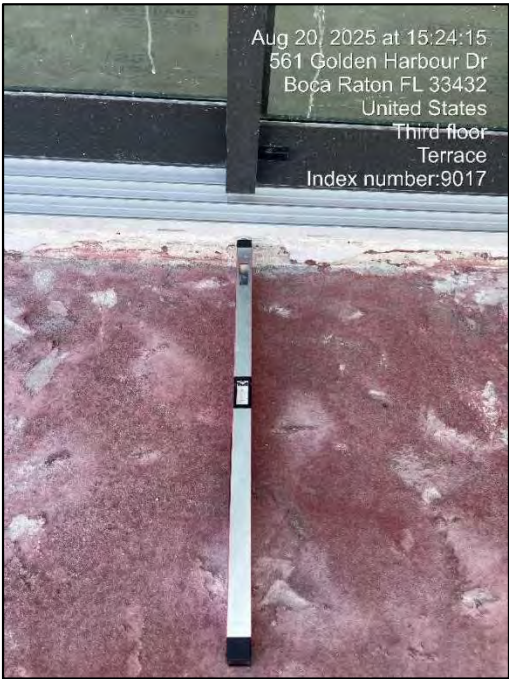
- a. **Observation:** Inadequate slope (0%) was identified at many locations with the use of a level in the balcony, walkways and terrace areas. The FBC and the permit/record set of drawings prohibit the existing conditions. The owner has also advised of water ponding and water intrusion inside the house. During the demolition of the balcony/terrace floor finishes water was observed to be

accumulated below the finishes adjacent to the glazing system. The existing conditions are a result of incorrect slope and inadequately installed or missing waterproofing system.

**Photo 9017:** Third Floor Terrace – General view of the north terrace without any slope. Client has reported water intrusion from this area damaging the interior floor finishes.

**Recommendation:** Provide slope and install waterproofing systems at floor slabs in compliance with the permit/record set of drawings and waterproofing manufacturer's recommendations. Professional of Record shall provide a protocol for remedial work.

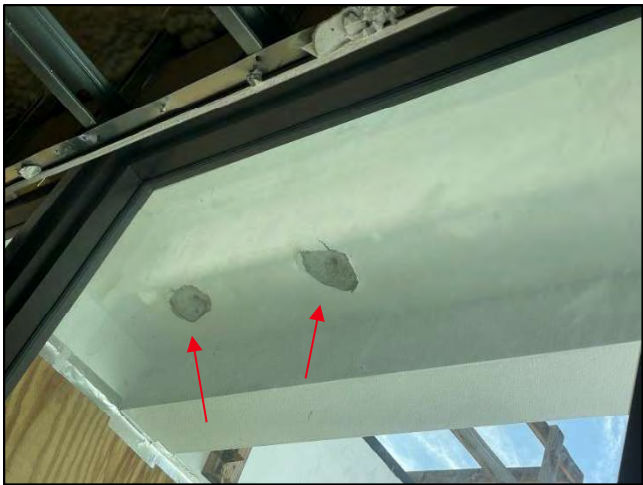
**Photo 5593** – Penetrations made in the slab at second-floor walkway (at the south side -front portion of the residence) in order to drain ponding water.

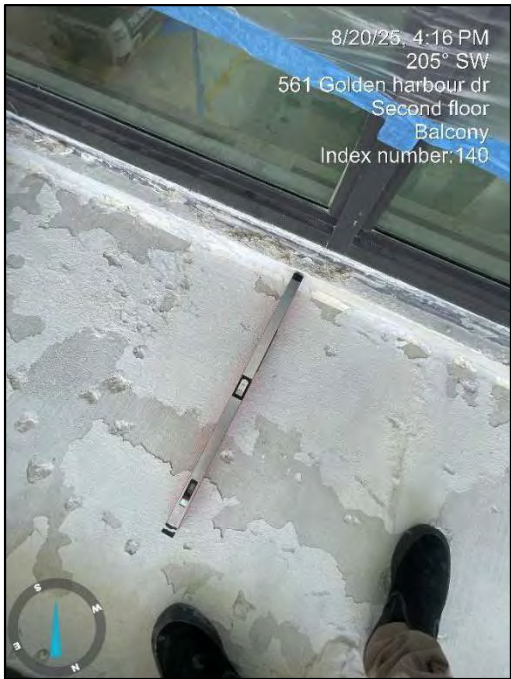
**Photo 140:** Second Floor Balcony – General view of the north balcony without any slope.

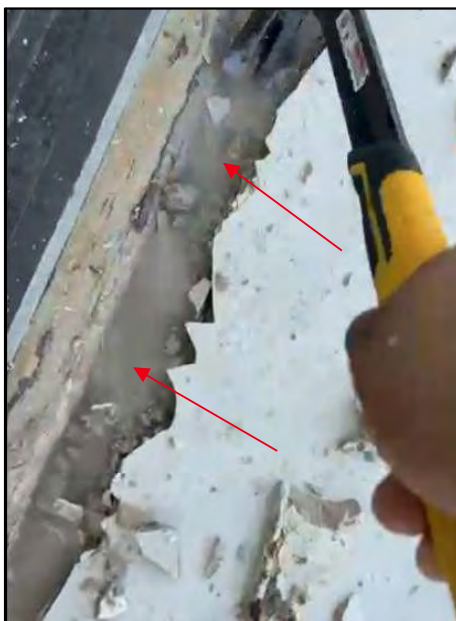
**Photo 561 – 6.9.25 – Video #1 Still:**  
*Second Floor Balcony – Showing water standing below floor finishes during demolition adjacent to window wall.*

**Criteria:** The existing conditions are not in compliance with the permit/record set of drawings, FBC Chapter 15 and accepted industry standards.

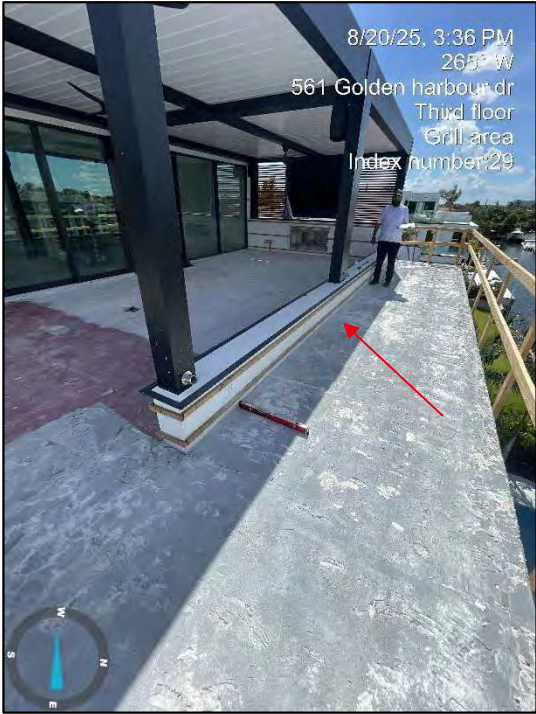
**Photo 29:** Emergency scupper not provided as per sheet P-03 at the curb on third-floor terrace.

**Recommendations:** Provide a roofing system throughout the property that complies with the requirements of FBC, particularly with proper slope to prevent ponding water, ensuring that drains and scuppers are properly located and installed to allow required drainage. Professional of Record shall provide protocol for remedial work.

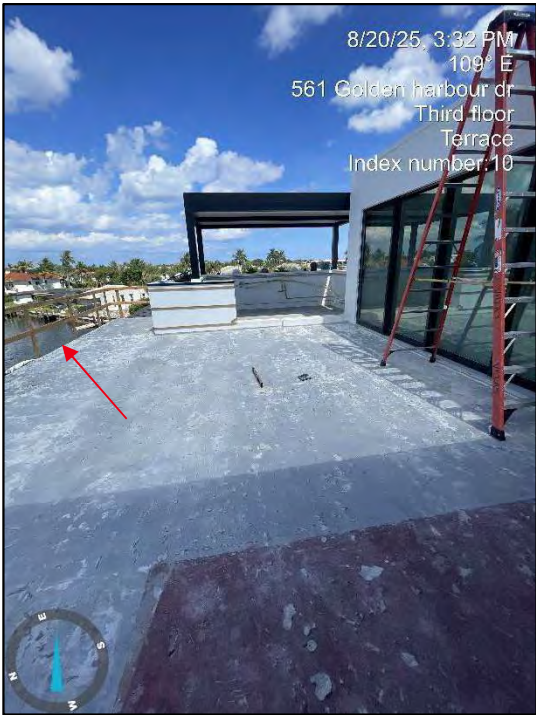
**Photo 10:** No curb was constructed at North terrace on third floor as specified on sheet P-03.

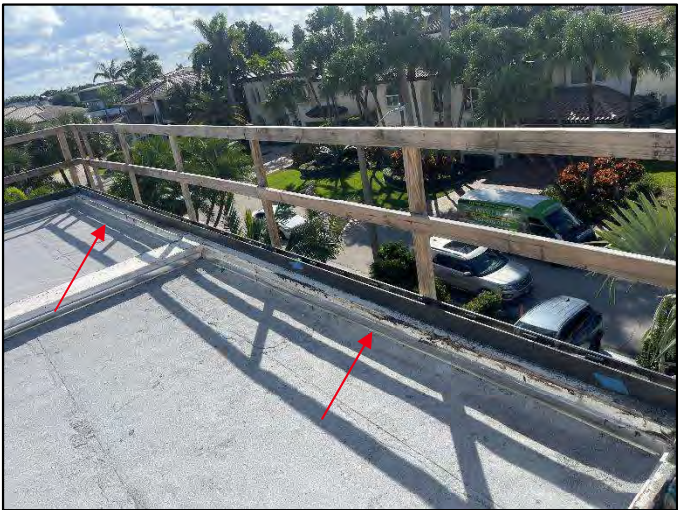
**Photo 5638:** *No scupper was provided at the curb of the South terrace at third floor.*

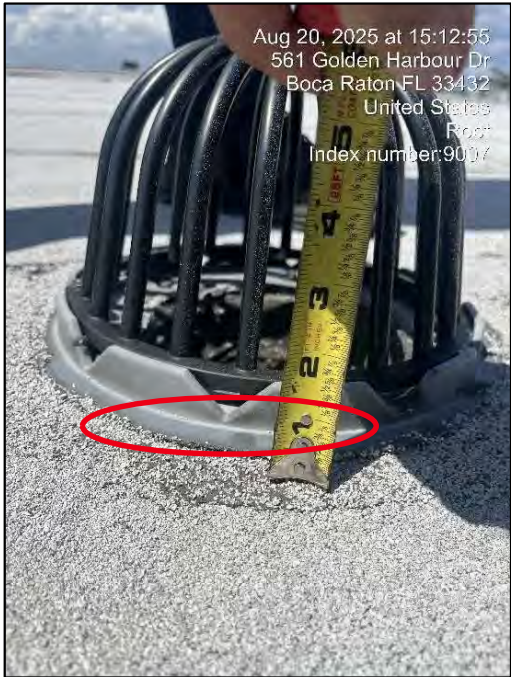
**Photo 9007:** View of roof drain at 4<sup>th</sup> Floor. Note the drain is installed above the Roofing System.

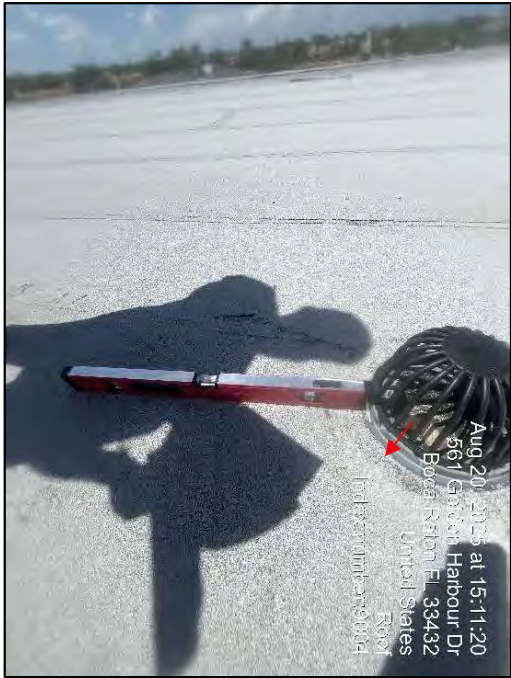
**Photo 9004:** Measurement of 0 % slope on roof at 4<sup>th</sup> Floor.

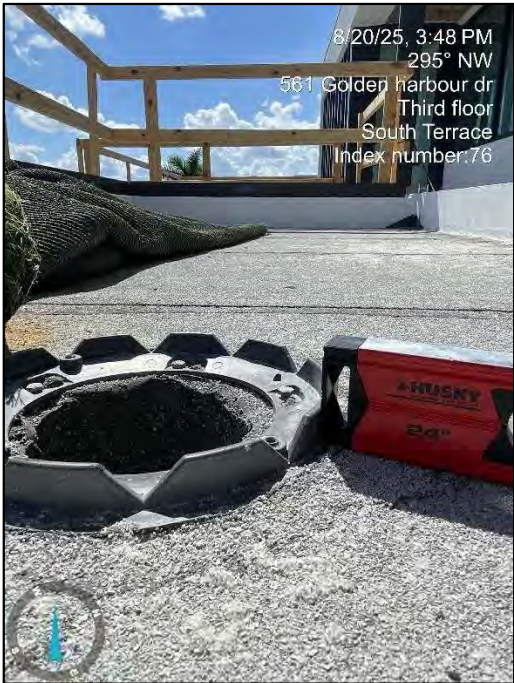
**Photo 76:** The slope of the roof is away from the drain at South-East Terrace on the 3<sup>rd</sup> Floor.

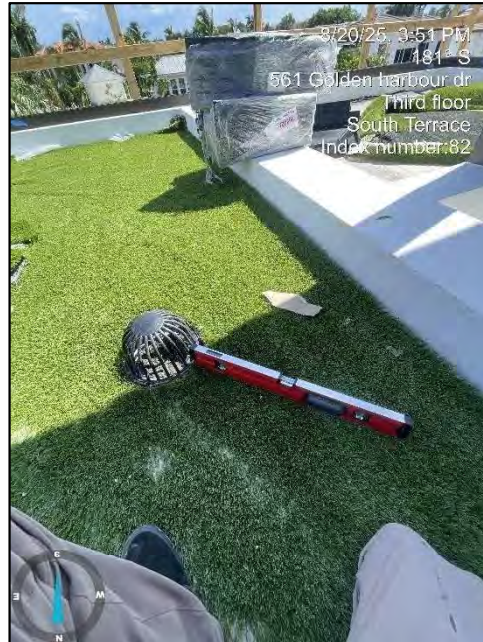
**Photo 82:** The slope of the roof is away from the drain -East Terrace at 3rd Floor.

**Criteria:** The existing conditions are not in compliance with FBC Chapter 15, Permit documents, and acceptable industry standards.

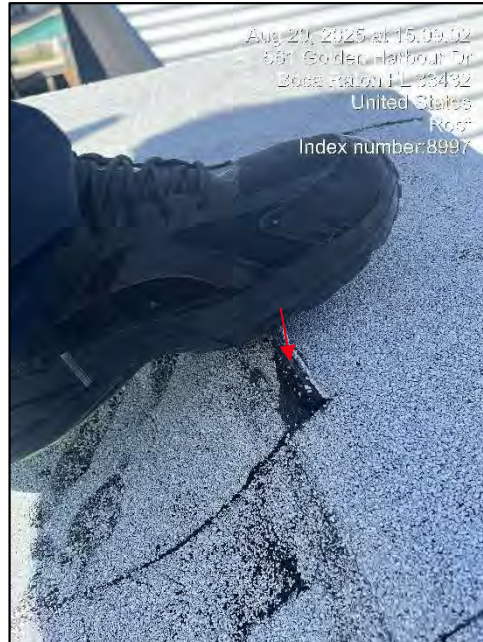
**Photo 8997:** View of loose / debonded roofing membrane. at the roof curb.

**Recommendations:** Repairs to all deficiencies identified above must be designed and performed to provide proper weather protection and flashing at roof areas that comply with the requirements of FBC and applicable NOAs and manufacturer recommendations. Professional of Record shall provide protocols for remedial work.

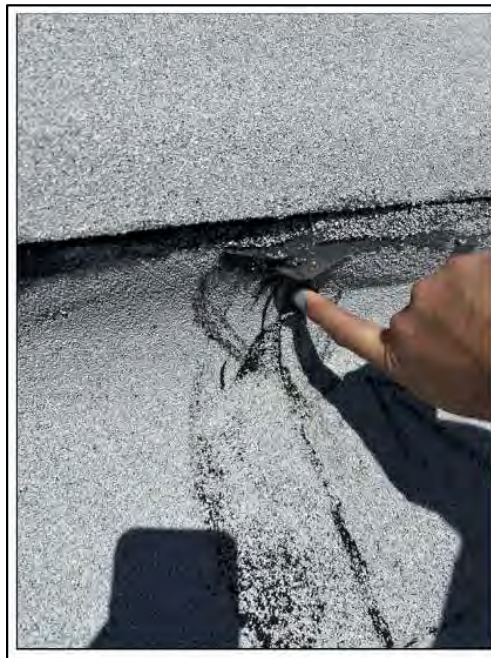
**ECS Photo 1:** View of unadhered roofing membrane.

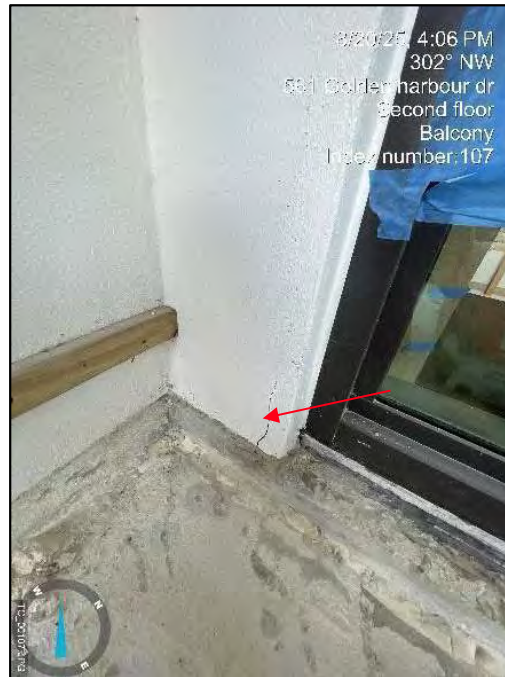
**Observation:** Accessible areas at the finished stucco surfaces were randomly selected for percussion sound testing with the aid of a steel instrument. The hollow sound, characteristically associated with delaminated surfaces, was audible at the referenced locations. The existing condition is evidence that delamination of the stucco from the substrate has occurred. Cracks in the stucco were also observed at many locations on the walls throughout the building. The cracks and voids will allow moisture penetration and cause delamination and further deterioration of the finish and substrate materials. Typical sample areas found with this defect are listed below:

**Photo 107** – Delaminated stucco at the exterior wall of the master bedroom at the second level.

All cracked and delaminated stucco areas must be removed and replaced with properly bonded stucco applied in strict conformance with FBC and stucco manufacturer’s recommendations. Top surface of the repaired areas must be finished and painted to match adjacent areas.

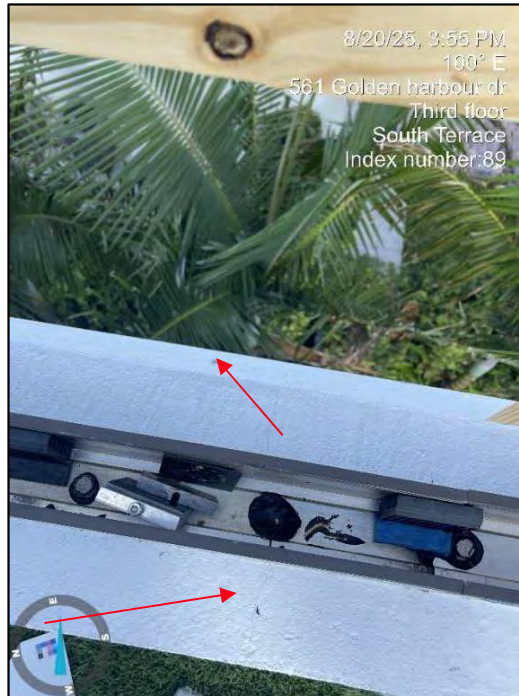
**Photo 89** – Stucco crack at parapet wall adjacent to South Terrace of glass railing at Level 3.

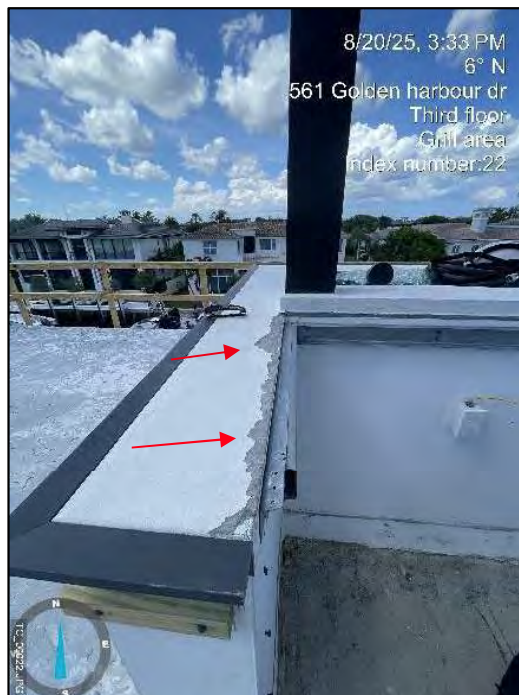
**Photo 22** – Delaminated stucco at parapet wall adjacent to Grill area at Level 3.

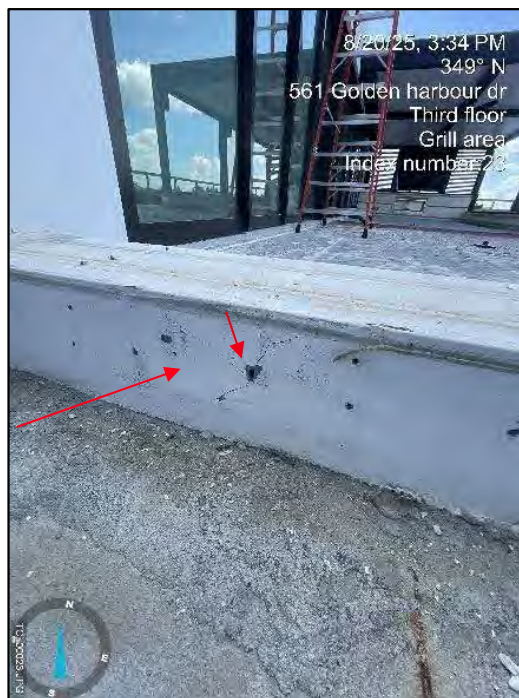
**Photo 23** – Stucco crack at parapet wall adjacent to Grill area at Level 3.

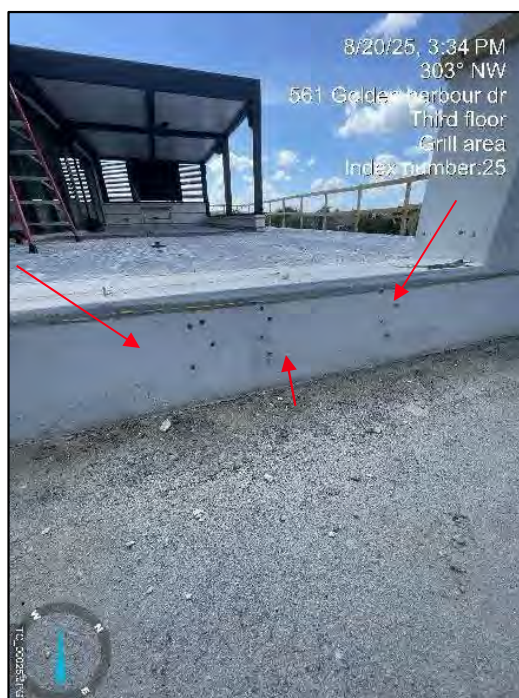
**Photo 25** – Stucco cracks at wall adjacent to Grill area at Level 3.

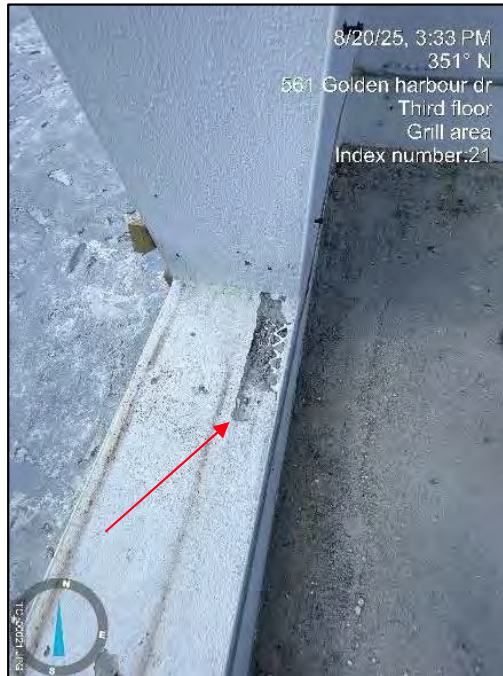
**Photo 21** – Delaminated Stucco at parapet adjacent to Grill area at Level 3.

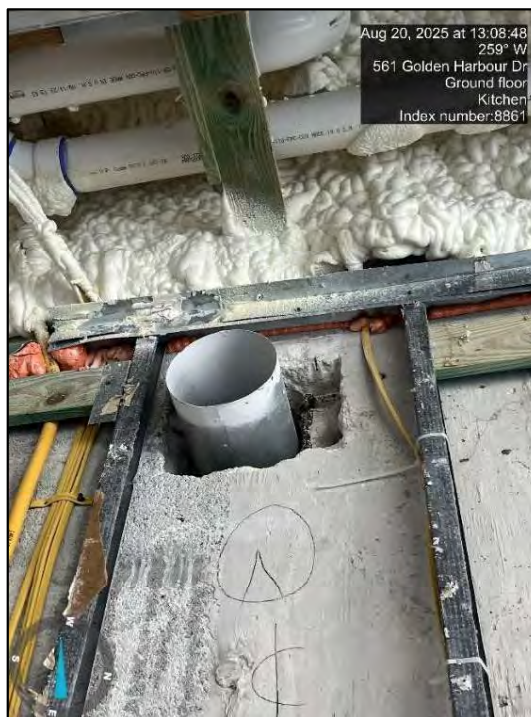
**Photo 8861** – Pipe penetration at the column at Kitchen, not shown on structural drawings.

**Recommendation:** Structural cracks in reinforced concrete structures are typically repaired by utilizing epoxy pressure injection. Minor and non-structural cracks are repaired by utilizing elastomeric polyurethane sealants to prevent moisture intrusion into the concrete. The Structural Engineer of Record must be informed about the existing conditions and requested to verify adequacy of the structural design. The request for information must be submitted to the Engineer of Record (EOR) for verification of design capacity of the existing column considering the opening and a letter must be issued to the Home Owner confirming the adequacy of structure. Repairs to areas identified in this report must be designed and performed.

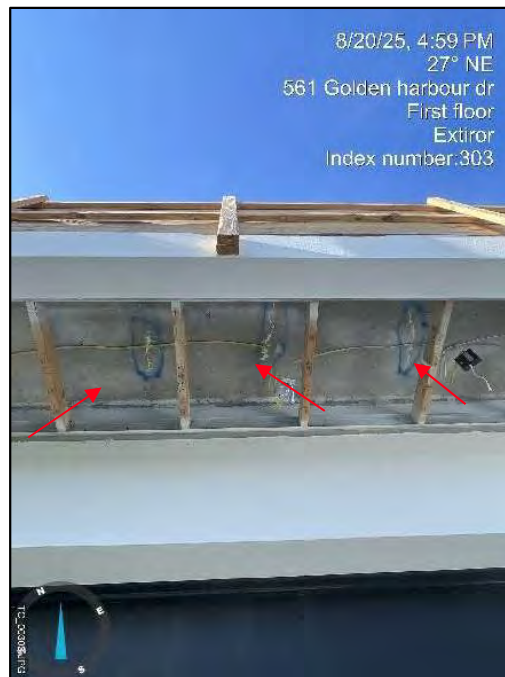
**Photo 303** – Multiple cracks at the concrete ceiling slab at the Southwest corner of the office – 2<sup>nd</sup> level.

**Photo 303** – Multiple cracks with signs of water intrusion and stalactites are visible at the concrete ceiling slab at the Southwest corner of the office – 2<sup>nd</sup> level.

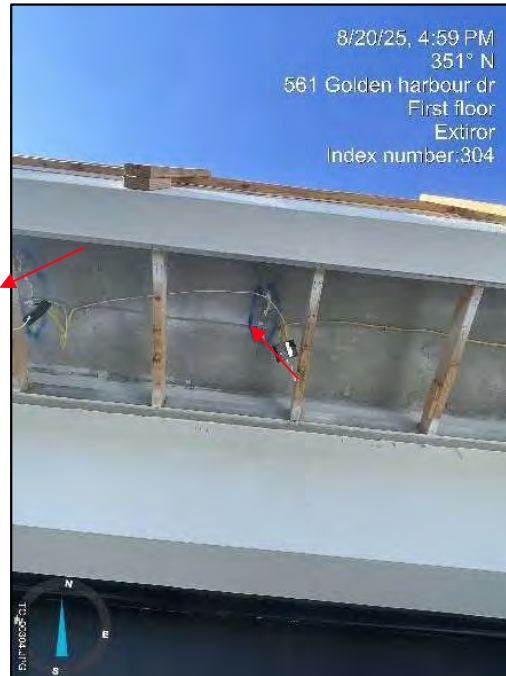
**Photo 304** – Multiple cracks at the concrete ceiling slab at the Southwest corner of the office – 2<sup>nd</sup> level.

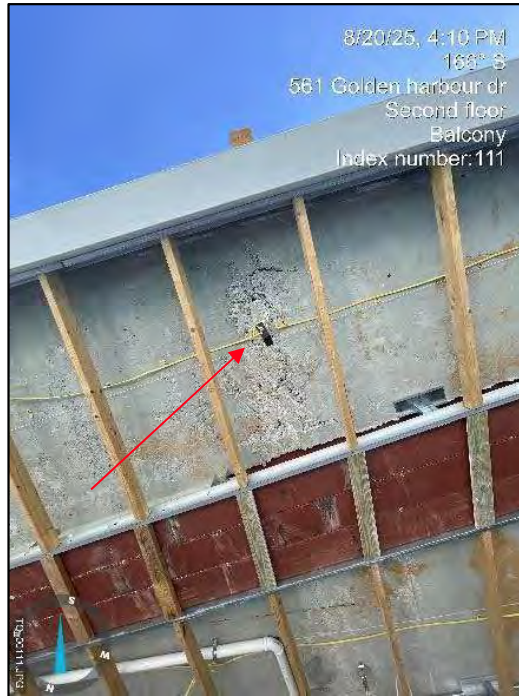
**Photo 111** – Honeycombing at the overhead ceiling slab at the outdoor living area at the first floor.

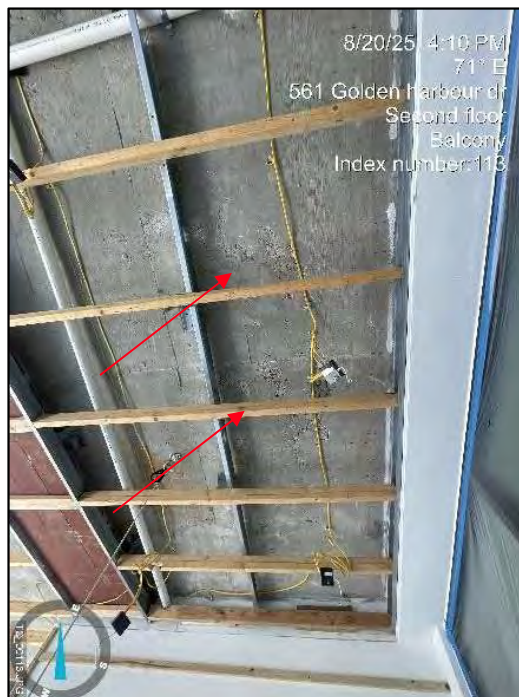
**Photo 113** – Honeycombing at the overhead ceiling slab at the outdoor living area at the first floor.

**Criteria:** The existing conditions are in violation of Florida Building Code, 2020 7<sup>th</sup> Edition, and compromise the specified concrete cover on top of the embedded reinforcement in the concrete member. Additionally, existing conditions promote

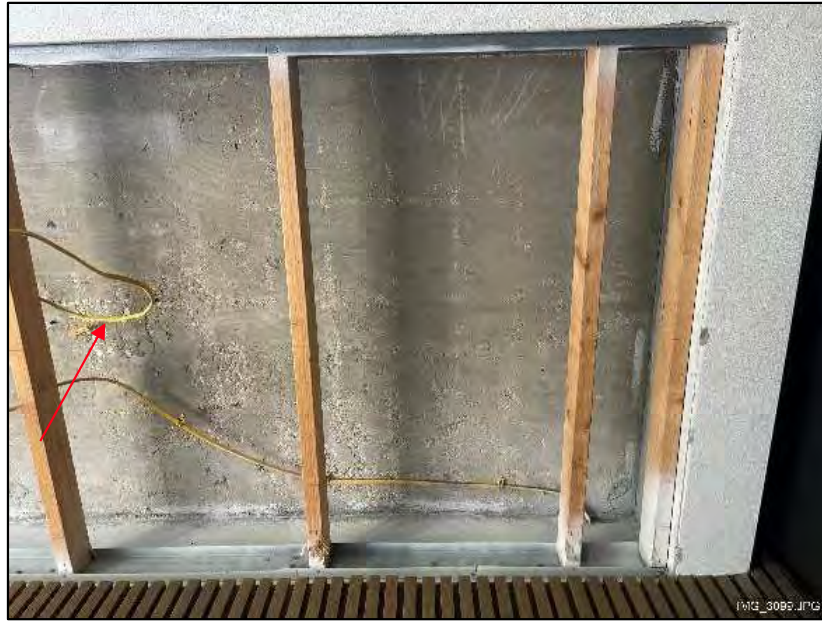
**Observation:** At many locations, exposed rebar and honeycombed concrete were observed in the building. Exposed rebars and honeycombing of concrete have also permitted moisture intrusion with signs of corrosion and cracks in concrete. Typical sample areas found with this defect are listed below:

**Photo 3099** – Honeycombing at the overhead ceiling slab at the main entrance adjacent to the garage area at the first floor.

**Recommendation:** Repairs to remediate existing conditions must be designed and performed. If existing repairs are not performed, the existing conditions will eventually result in corrosion of steel reinforcement, delamination of concrete and expensive repairs in future.

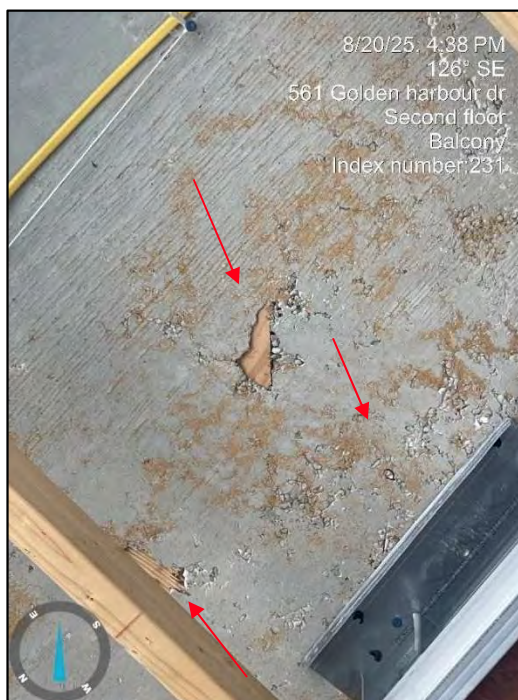
**Photo 231** – Honeycombing and wood embedded in the ceiling slab at the balcony at second floor.

premature corrosion of embedded steel reinforcement. Please refer to Item 2.2 for Florida Building Code references.

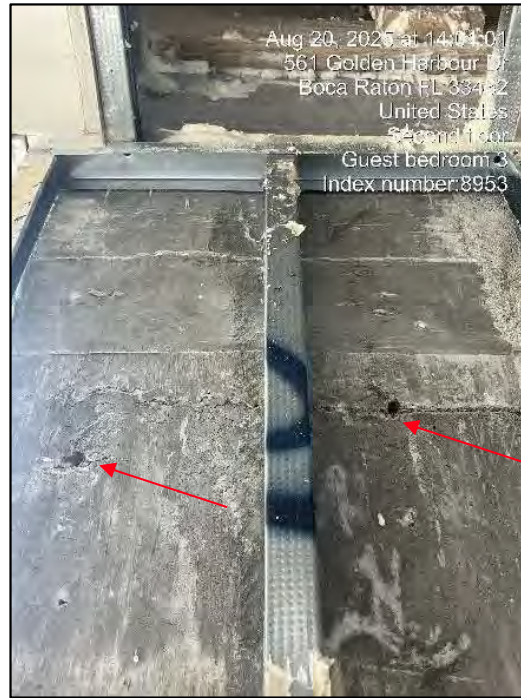
1. Multiple corrosion stains were observed at column in Guest bedroom #3 on the second level.
2. Multiple strips of corroded metal are embedded in the ceiling slab adjacent to the dining room at the first floor.
3. Corroded rebar is embedded in the beam at overhead ceiling of the guest bedroom #3 at second level.
4. Multiple corroded metal nails are embedded in the beam at overhead ceiling of the guest bedroom #1 & #3 at second level.

**Photo 8953** – Corroded metal is visible at wall in Guest bedroom #3 at the 2<sup>nd</sup> Floor.

**Recommendation:** All deleterious materials in the concrete must be removed. Repairs to remediate existing conditions must be designed and performed.

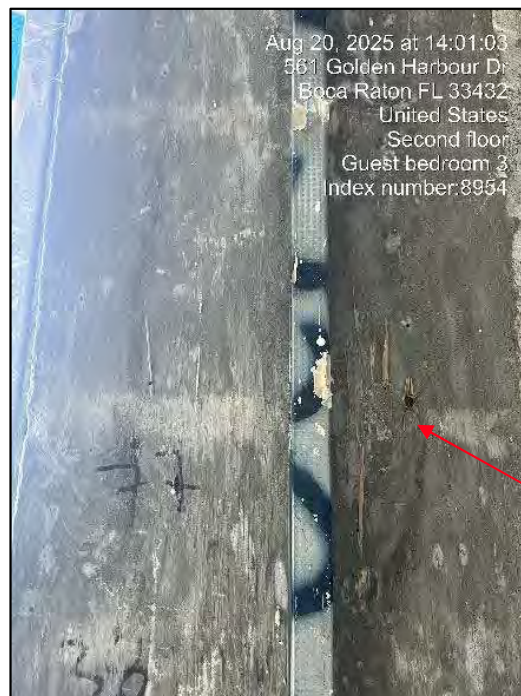
**Photo 8954** – Corrosion stain visible at wall in Guest bedroom #3 at the 2<sup>nd</sup> Floor.

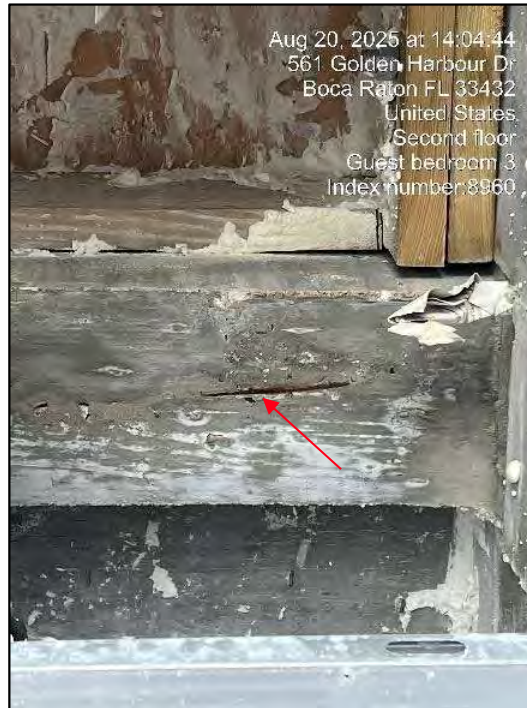
**Photo 8960** – Corroded metal embedded in the beam at overhead ceiling of the guest bedroom #3 at second level.

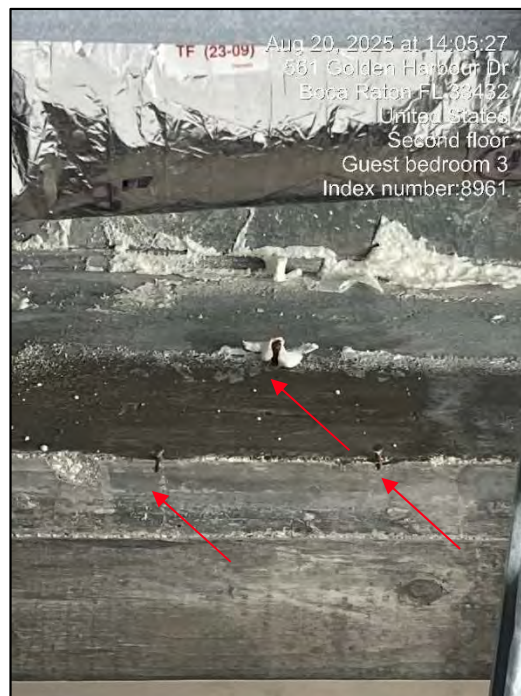
**Photo 8961** – Corroded metal nails embedded in the beam at overhead ceiling of the guest bedroom #3 at second level.

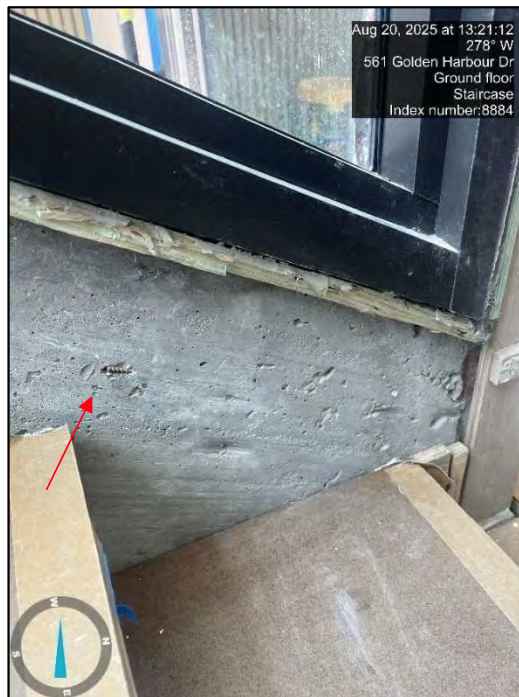
**Photo 8884** - Exposed corroded nail at the staircase landing at the first floor.

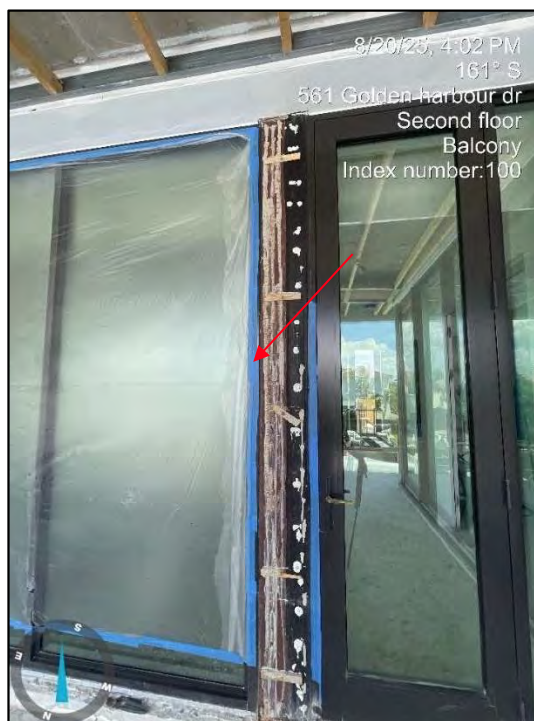
**Photo 100** – Corroded metal column at balcony at the second floor.

**Recommendation:** Elements showing corrosion are to be remediated by cleaning all corroded metal items by suitable means to bare silver metal surface and coat with oil-based primer and two coats of oil or epoxy-based paint. Excessively corroded elements must be removed and replaced with new.

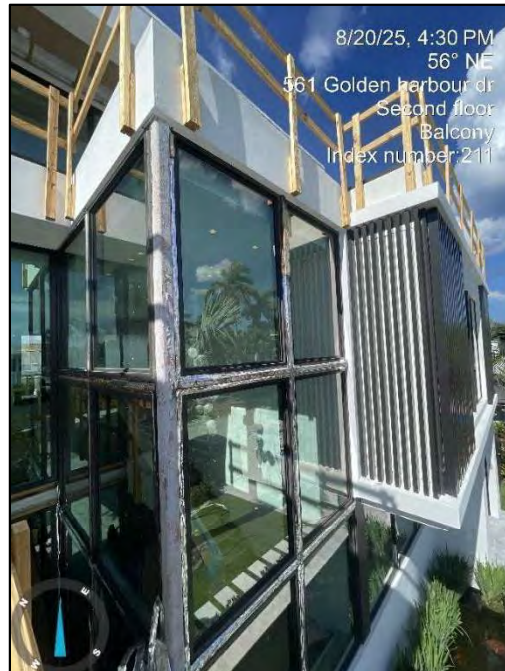
**Photo 211** – Corroded metal columns and horizontal members at staircase landing at the second floor.

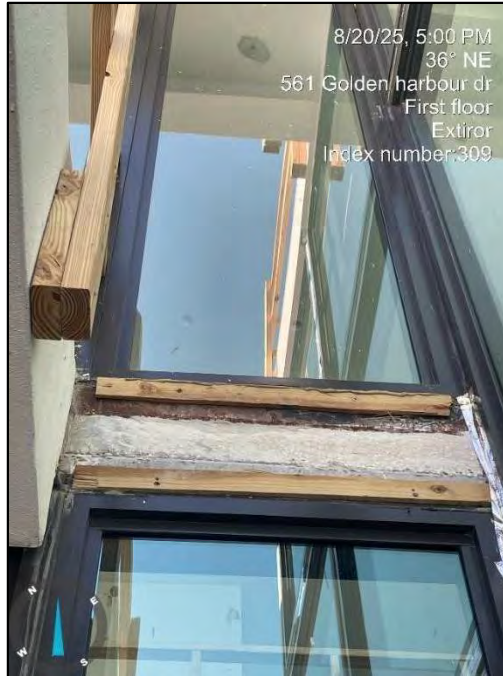
**Photo 309** – Corroded metal beam/mullion at second floor slab above the main door.

**Criteria:** The existing conditions are a violation of the FBC and not in compliance with Permitted Drawings and industry standards. If not remediated the materials will deteriorate, compromising their structural integrity and functionality.

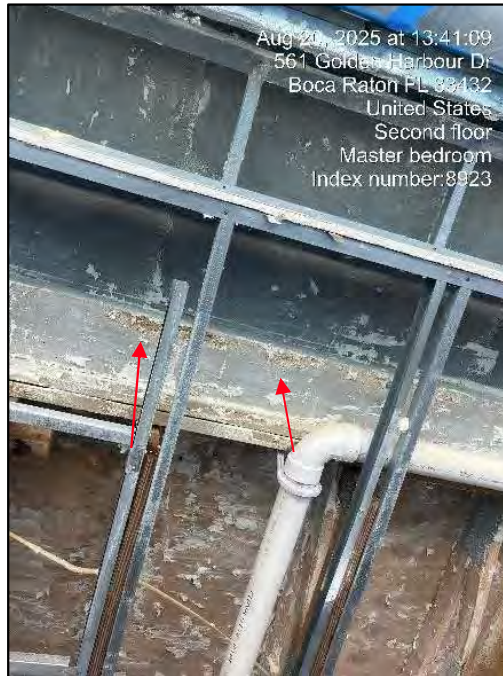
1. Water intrusion stains are visible at multiple locations at the overhead beam in master bedroom at second floor. There are also videos received from client of active water intrusion for these areas.

**Photo 8923** – Water intrusion at the overhead beam in master bedroom at second floor.

**Recommendation:** Repairs to prevent water intrusion at all areas identified in this report must be designed and performed.

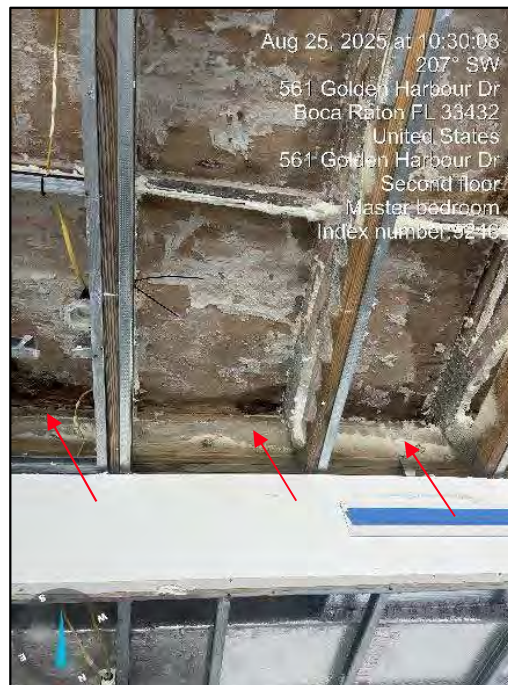
**Photo 9246** – Water intrusion at the overhead beam in master bedroom at second floor.

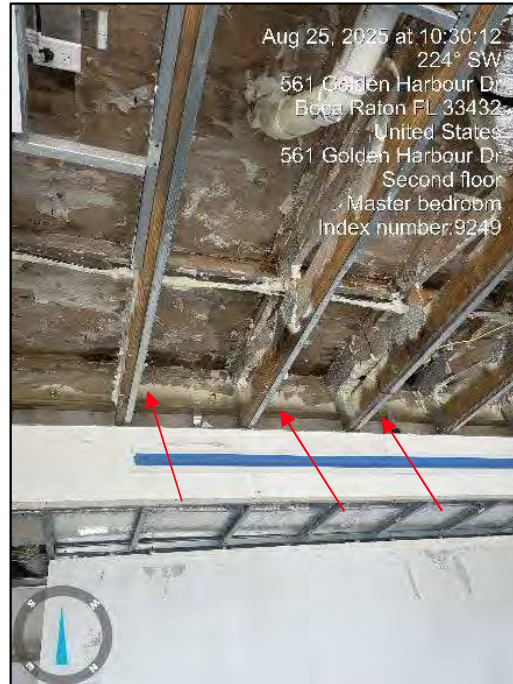
**Photo 9249** – Water intrusion at the overhead slab in master bedroom at second floor.

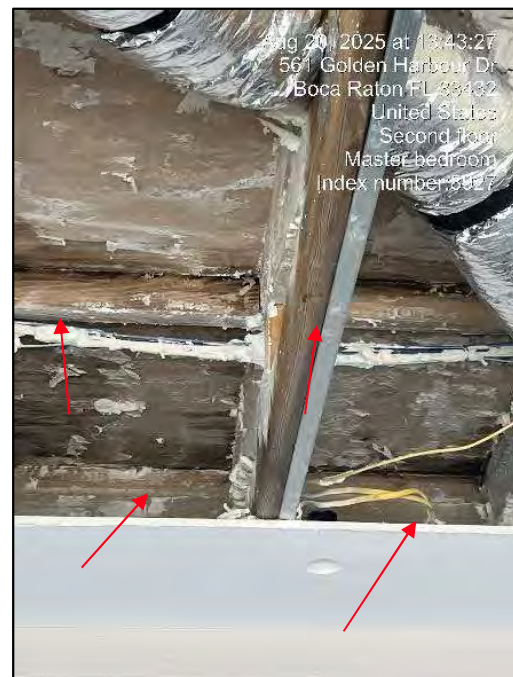
**Photo 8027** – Water intrusion from the overhead slab in master bedroom at second floor.

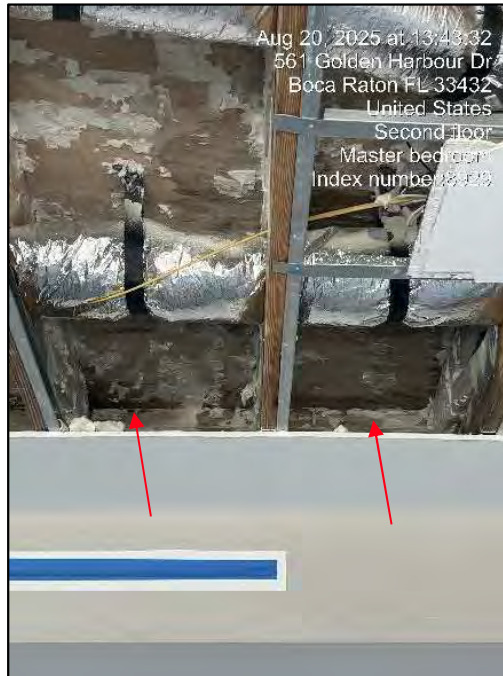
**Photo 8929** – Water intrusion from the overhead slab in master bedroom at second floor.

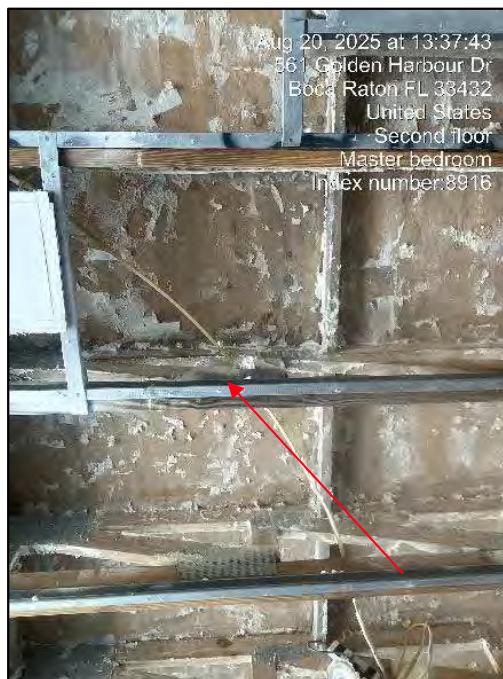
**Photo 8916** – Water intrusion from the overhead slab in master bedroom at second floor.
