IN THE CIRCUIT COURT OF THE 15TH JUDICIAL  
CIRCUIT IN AND FOR PALM BEACH COUNTY, FLORIDA

**COMPLAINT**

<sup>4</sup> The three independent reports include: Structural Construction Defect Evaluation – Prepared by Summit Design and Forensics, Inc. (attached hereto as **Exhibit C**); Forensic Investigation Report – Prepared by ECS Florida, LLC (attached hereto as **Exhibit D**); Property Evaluation Report – Prepared by Pistorino and Alam Consulting Engineers, Inc. (attached hereto as **Exhibit E**); J.R. Inspections Services, Inc. – Mold Inspection Report (attached as **Exhibit “F”**) (collectively, the “**Engineering Reports**”)

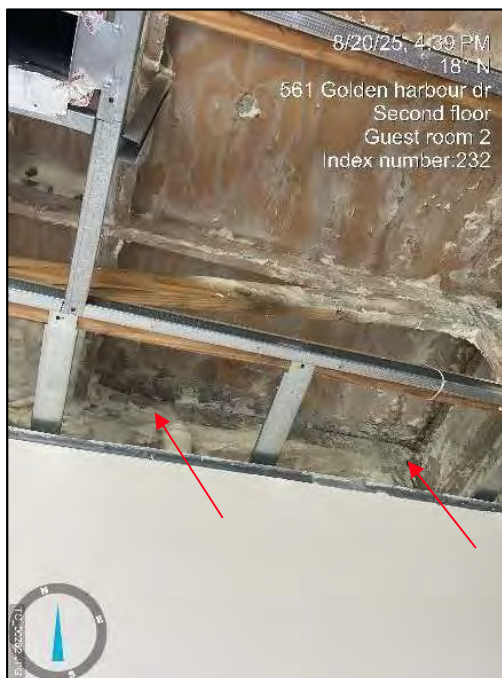
2. Water intrusion stains are visible at multiple locations at the overhead slab in guest bedroom#2 at second floor.
3. Water intrusion stains are visible at multiple locations adjacent to the pipe penetration at the overhead slab in guest bedroom #1 at second floor.

**Photo 232** – Water intrusion at the overhead slab in guest bedroom#2 at second floor.

**Recommendation:** Repairs to prevent water intrusion at all areas identified in this report must be designed and performed.

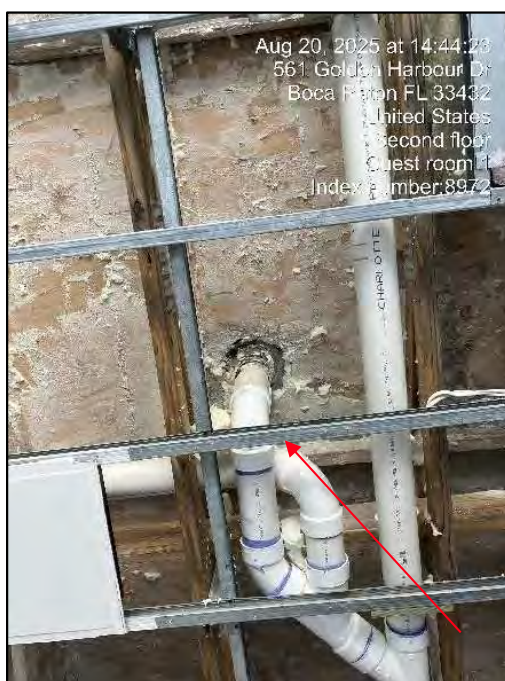
**Photo 8972** – Signs of water intrusion adjacent to the pipe penetration at the overhead slab in guest bedroom #1 at second floor.

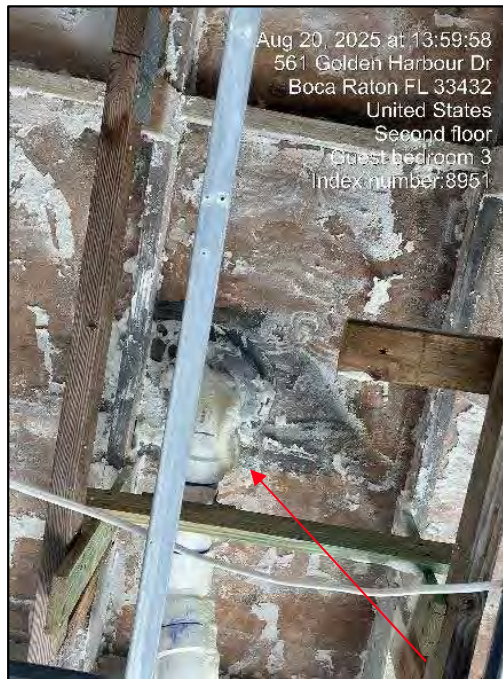
**Photo 8951** – Signs of water intrusion adjacent to the pipe penetration at the overhead slab in guest bedroom #1 at second floor.

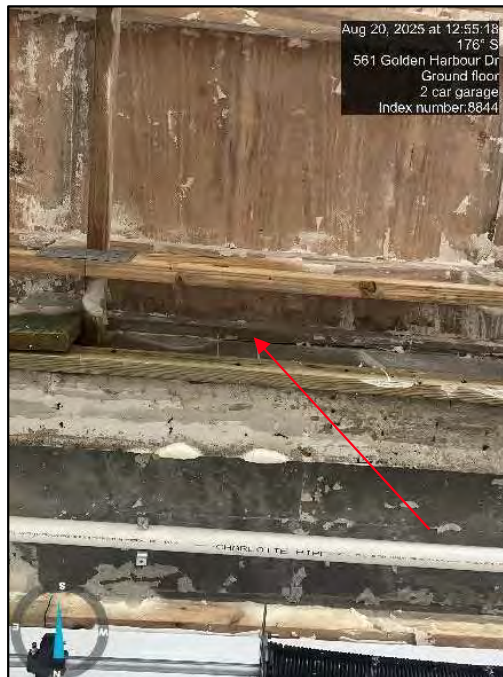
4. Water intrusion stains are visible at multiple locations at overhead slab in east car garage at first floor.
5. Water intrusion stains are visible at overhead slab in pantry at first floor.

**Photo 8844** – Signs of water intrusion from the overhead slab in east garage at first floor.

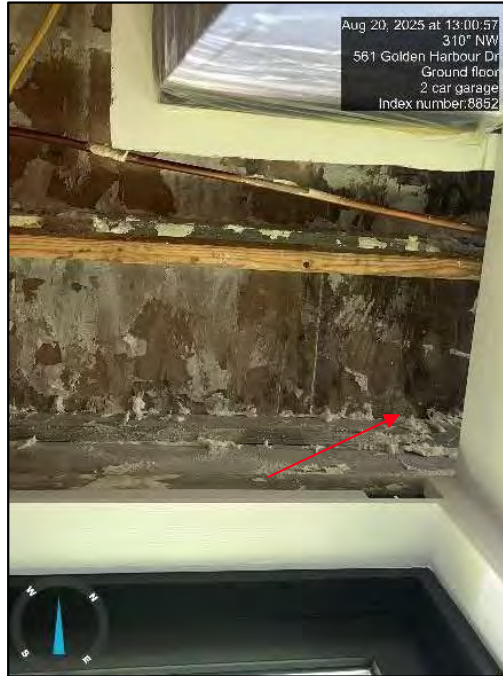
**Photo 8852** – Signs of water intrusion from the ceiling in east garage at first floor.

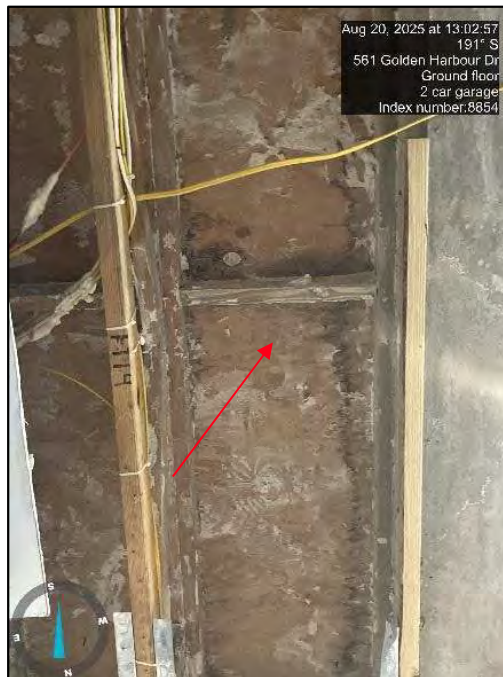
**Photo 8854** – Signs of water intrusion from the ceiling in east garage at first floor.

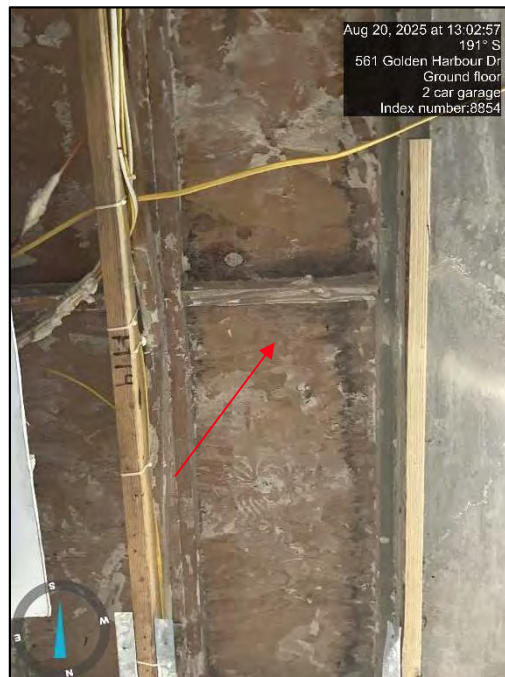
**Photo 8854** – Signs of water intrusion from the ceiling in west garage at first floor.

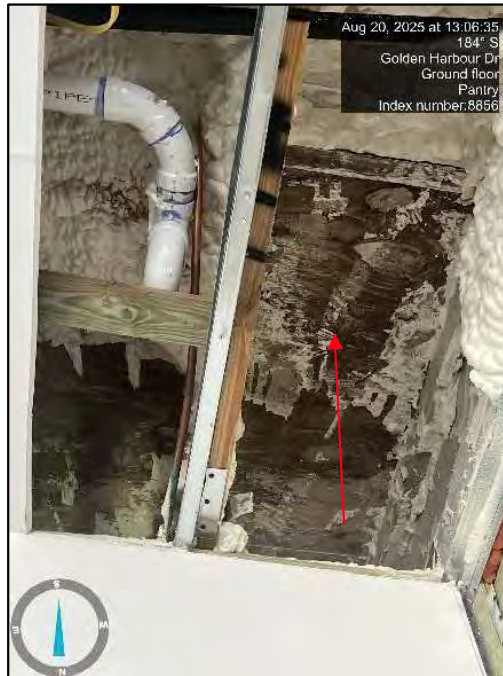
**Photo 8856** – Water intrusion from the ceiling in pantry at first floor.

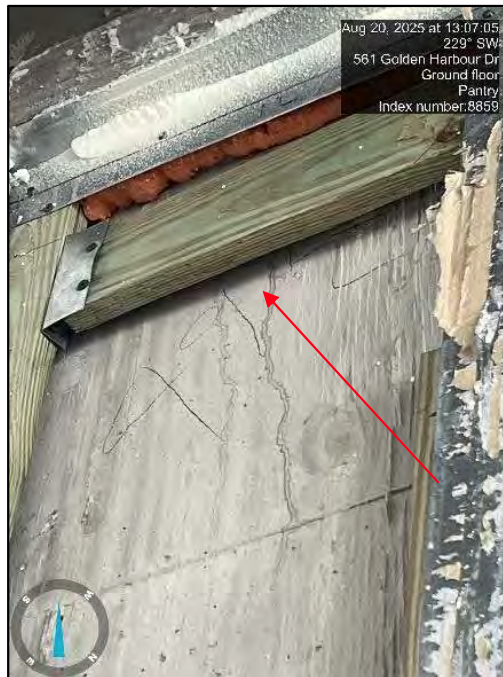
6. Water intrusion is visible from the exterior at the column in the kitchen pantry at ground/first floor.
7. Water intrusion stains are visible in east and west car garages.

**Photo 8859** - Water intrusion coming from the exterior at the column in the kitchen pantry at ground/first floor.

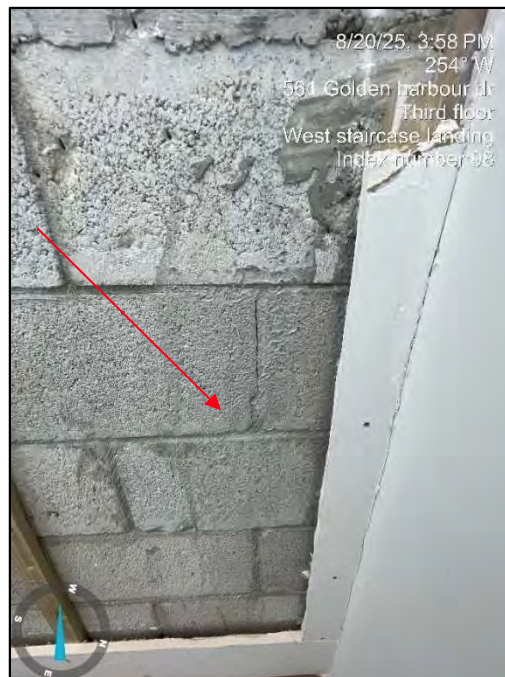
**Photo 98** – Crack in masonry wall at the west staircase landing at the third floor.

**Criteria:** Cracks in the masonry compromise the structural integrity of the walls and are not in compliance with the Record Set drawings.

**Recommendation:** Repairs to cracks in masonry walls must be designed and performed.

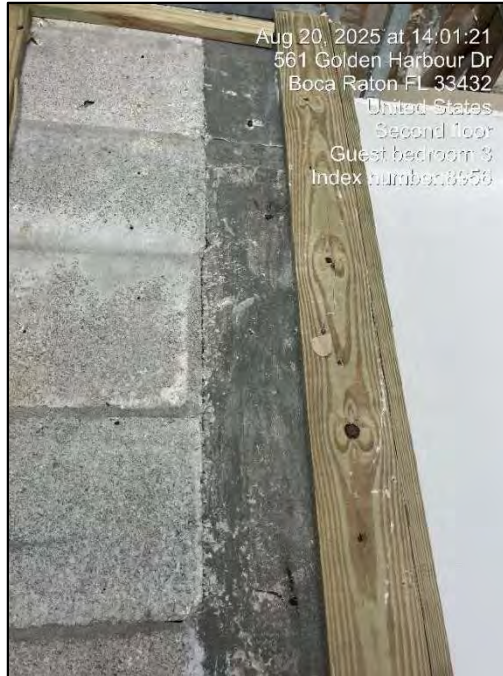
**Photo 8956** – Crack in joint between masonry wall and column at the guest bedroom #3 on second level.

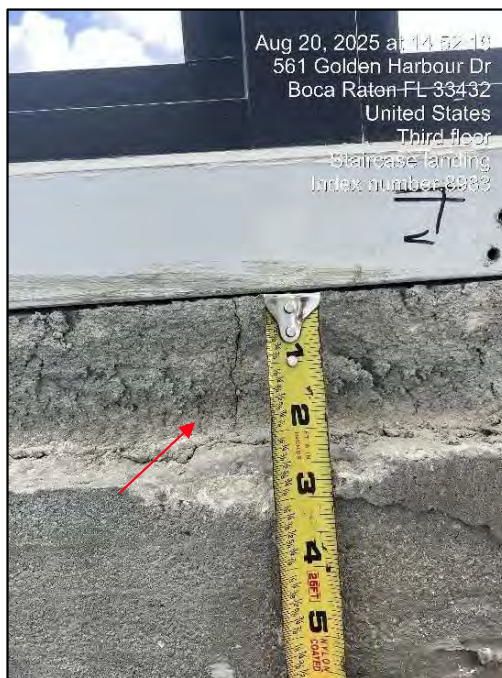
**Photo 8983** – Fixed glass window with excessive gap between framing and structural substrate at sill at third level southwest staircase. The arrow shows mortar between substrate and framing of glazing system.

4. In accordance with the approved NOAs the maximum shim space allowed is  $\frac{1}{4}$ " , whereas the existing gaps are more than specified on the permitted documents. Excessive gaps reduce the unbraced length of the fastener securing the aluminum frame to the concrete structural members. The existing condition reduces the structural capacity of the fasteners therefore compromising the lateral load resisting capacity of the glazing systems.

**Recommendation:** Considering that excessive gaps, more than specified in the permitted document, are present at many locations between the aluminum framing and structural substrate, a comprehensive remediation program must be implemented and repairs to existing sliding glass doors, windows and storefronts must be designed and performed.

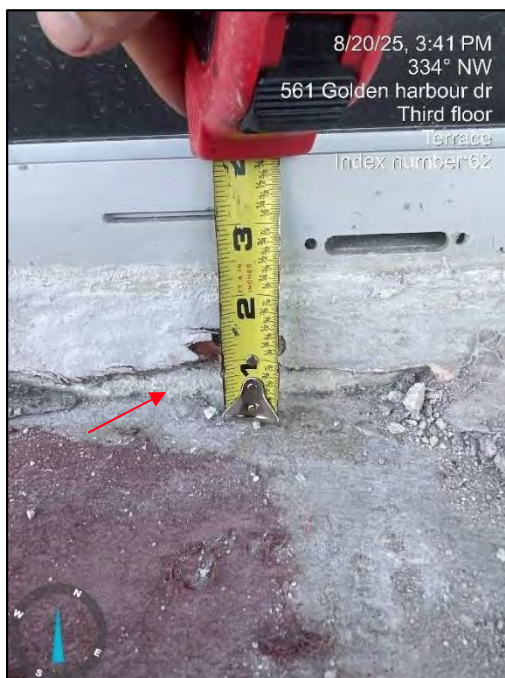
**Photo 62** – Sliding glass door with excessive gap between framing and structural substrate at sill at third level terrace.

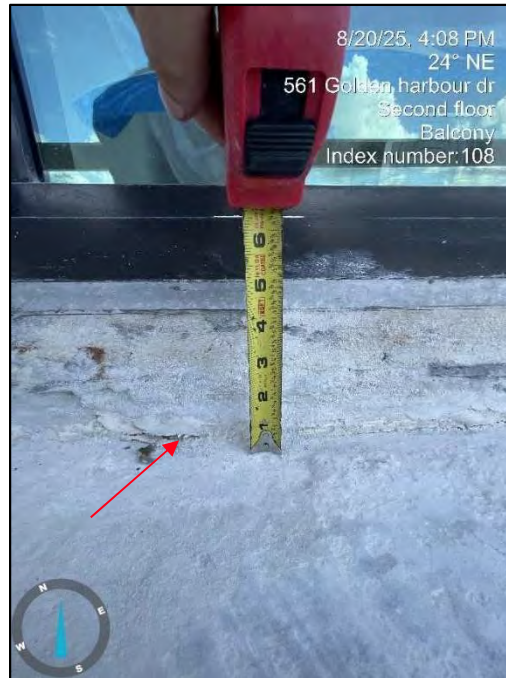
**Photo 108** – Sliding glass door with excessive gap between framing and structural substrate at sill at second level balcony.

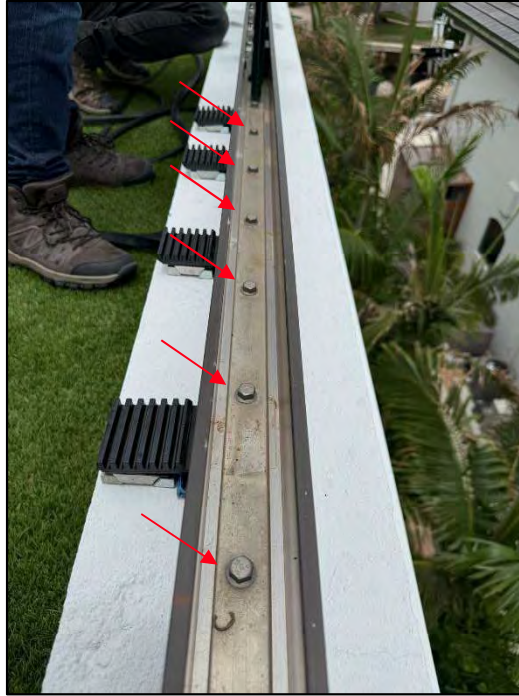
**561-6.5.25-Pic #13** – Fasteners at the base of railing system were not provided with sealant.

Missing and or inadequately installed fasteners and improper support of the railing components reduce the load resisting capacity of the railing system. The unsealed penetrations have created conditions allowing for water intrusion into the structure and behind stucco thereby causing stucco cracking and delamination. Refer to article-2.1 for details regarding stucco deficiencies.

**Recommendation:** Missing post fasteners must be provided and inadequately installed components of railing system must be remediated to ensure that the installation of railing system is in compliance with the permitted documents.

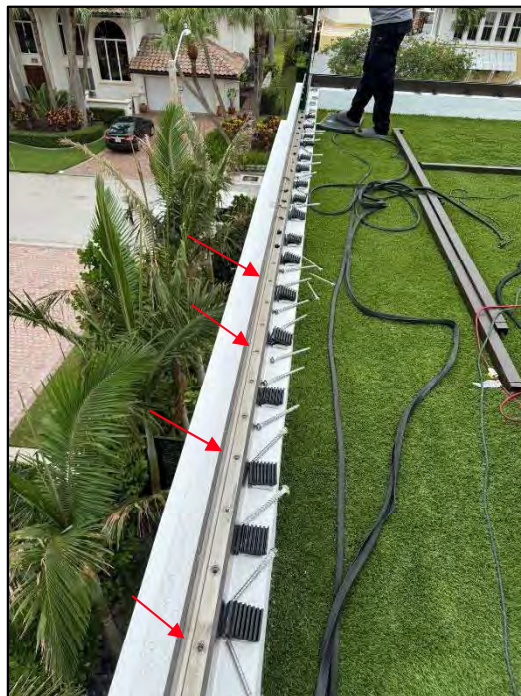
**561-6.5.25-Pic #14** – Fasteners at the base of railing system were not provided with sealant.

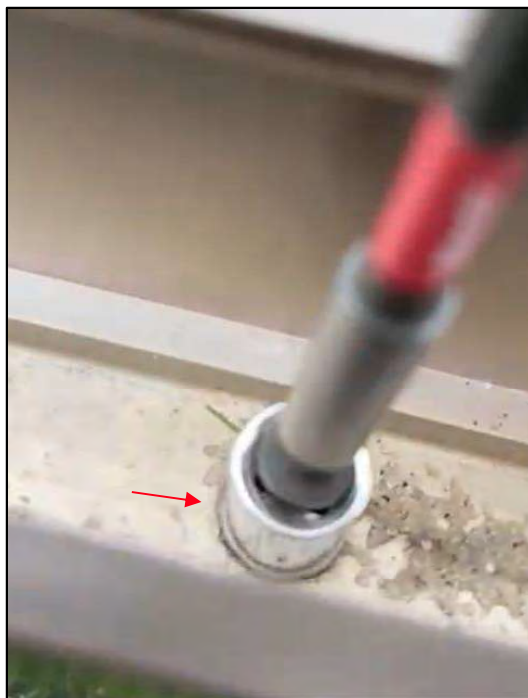
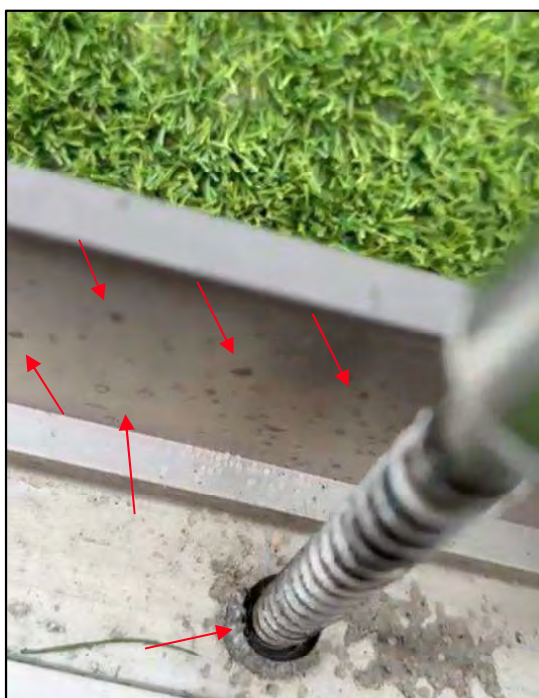
*561-6.5.25- Video#1 Still 1 – Showing general view before removal of unsealed fastener from railing system base channel.*

*561-6.5.25- Video#1 Still 2 – Showing water droplets expelled during removal of unsealed fastener from railing system base channel.*

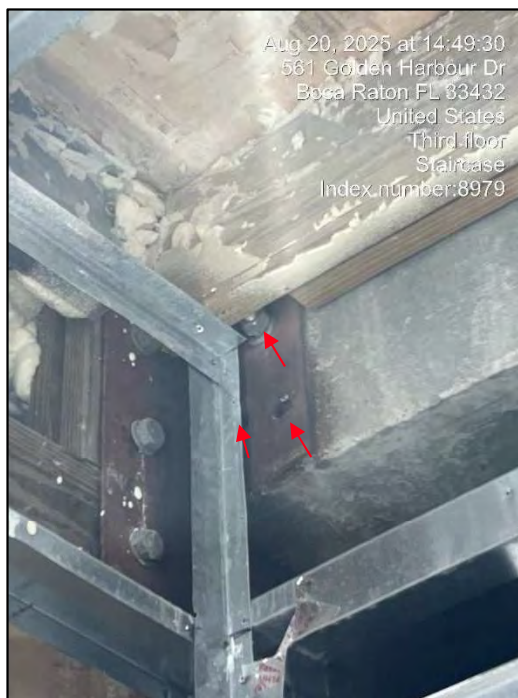
**Photo 8979** – Missing bolts and a inclined installation of one bolt.

Missing and or inadequately installed bolts reduce the load resisting capacity of the connections and therefore consequently reducing the structural capacity of the framing system and compromising integrity of the structure.

**Recommendation:** Missing and inadequately installed bolts must be provided to ensure that as-built installation is in compliance with the permitted documents.

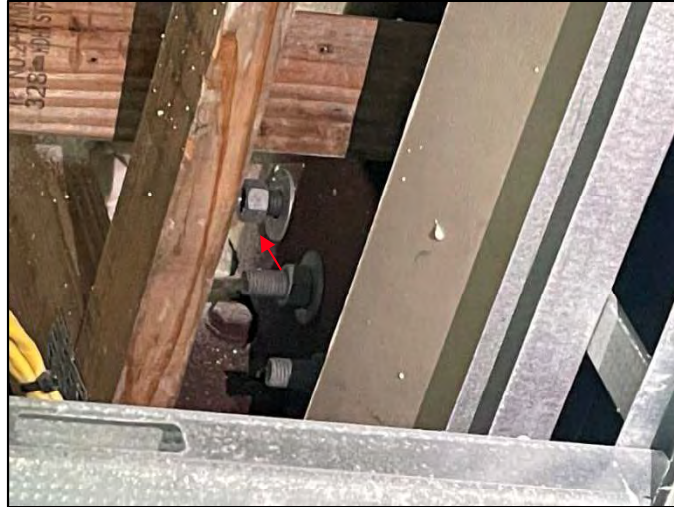
**Photo 5560** – Loose bolts at his bathroom at level 2 (west).

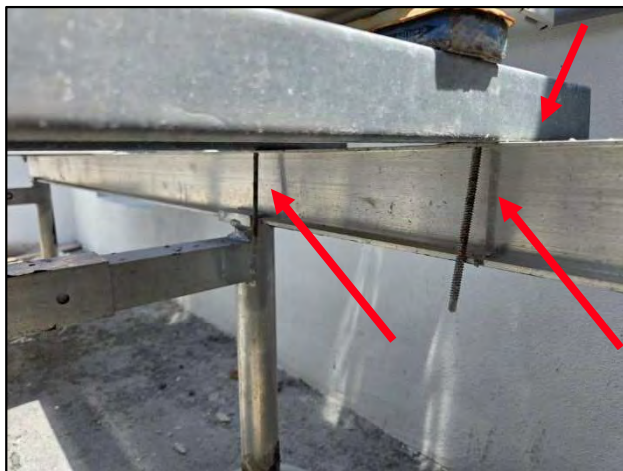
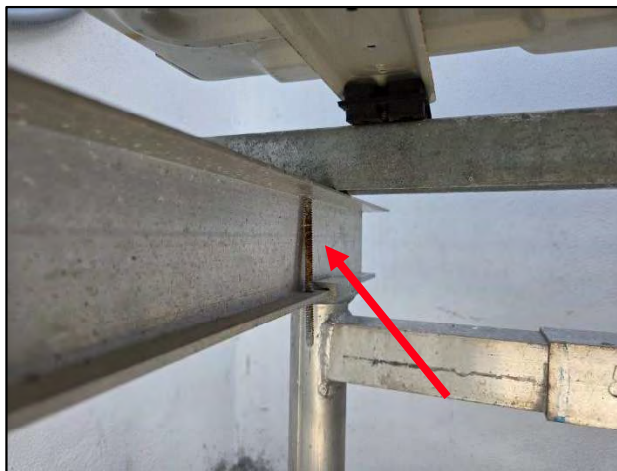
**Observation:** The outdoor condenser equipment for the wine room cooling systems are installed on aluminum equipment stands. The equipment are secured to the stands with galvanized steel Unistrut c-channels and galvanized steel anchors. This creates dissimilar metal contact which will cause premature corrosion due to galvanic action. The anchors were observed to have signs of corrosion.

*Galvanized steel Unistrut and anchors in contact with aluminum stand, typical dissimilar metals in contact*

*Corroded galvanized steel anchor in contact with aluminum equipment stand*

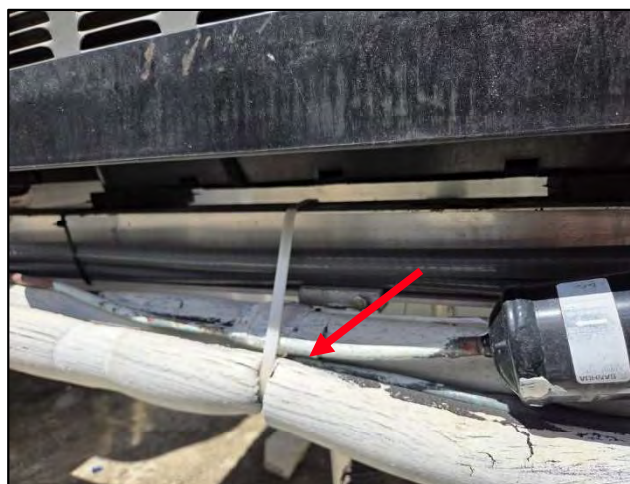
**Observation:** There are installed refrigerant piping and gas supply piping observed to be incorrectly supported. Gas steel piping servicing the appliances at the 3<sup>rd</sup> Floor Outdoor Terrace was reported completely unsupported. Tie wire and clamp were added to temporarily support the pipe by the renovating contractor. Refrigerant piping was observed to be supported with zip ties to the stand framing. The zip ties are compressing the insulation and are not suitable for outdoor installation.

*Typical conditions of zip ties supporting refrigerant piping and compressing insulation*

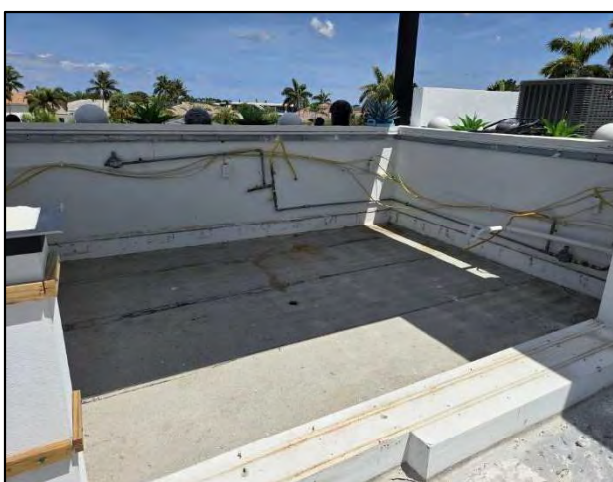
*Unsupported gas piping.*

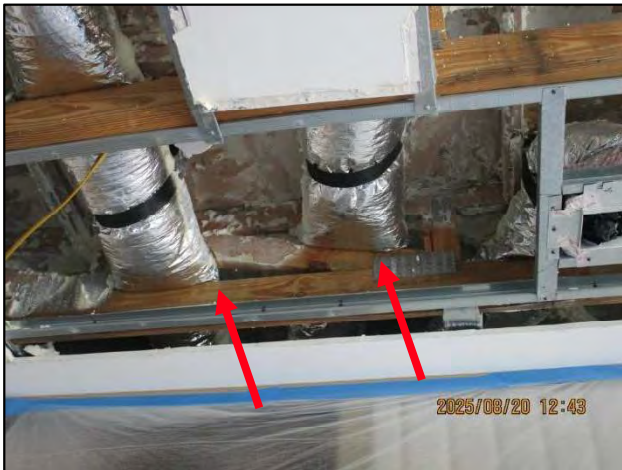
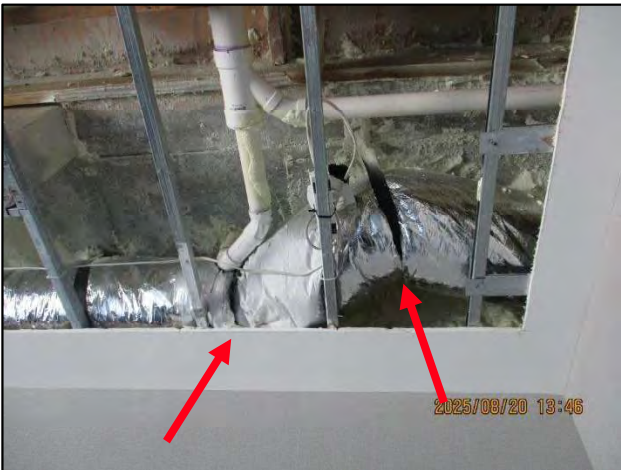
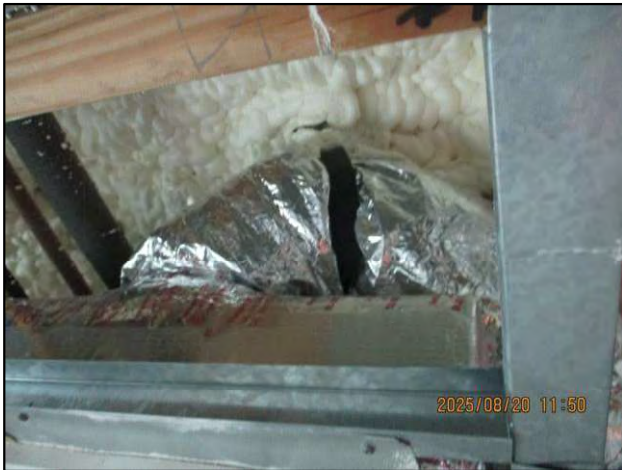
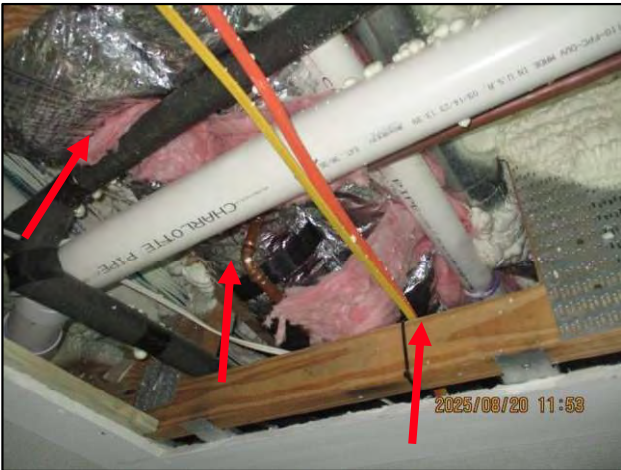
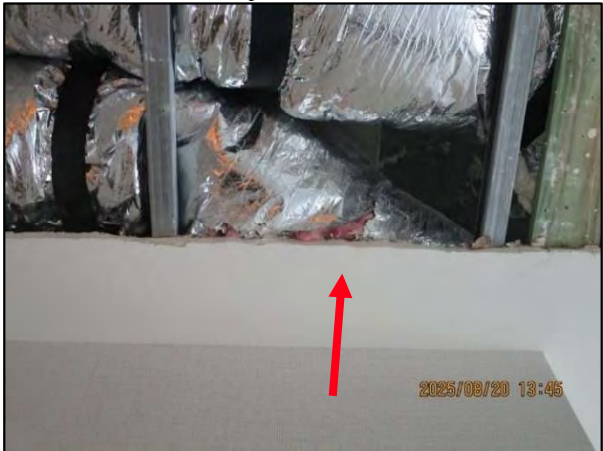
**Observation:** Remediation efforts were already in progress during P&A inspection. Sections of the finished ceiling drywall were removed throughout the entire premise allowing for observation of the installed ductwork. Some sections of the flexible duct installations above the finished ceilings were observed to be installed incorrectly. There are duct lengths that have sharp bends, compressed insulation and excessive duct lengths. Sections of the flexible duct are routed through tight spaces where they are squeezed between the floor beams, joists, or other building systems. Lacerations in the insulation were observed in some duct sections. These conditions can restrict airflow through the duct, increase static pressure in the systems, compress duct insulation, cause condensation to form and reduce energy efficiency.

*Typical condition of flexible ducts squeezed between floor beams and joists, Master Bedroom.*

*Typical condition of flexible duct with sharp bend and compressed insulation, Bedroom 1.*

*Typical condition of flexible ducts with sharp bends and compressed insulation at vent box connection, Laundry Room.*

*Typical condition of flexible ducts squeezed between floor beams, joists, and building systems, Laundry Room.*

*Typical condition laceration observed in duct insulation, Bedroom 3.*

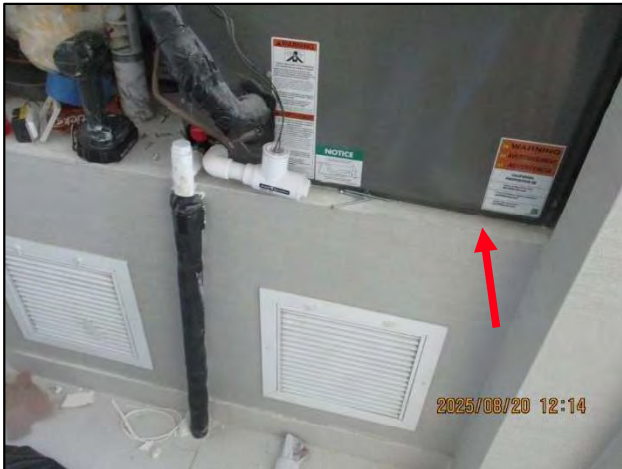
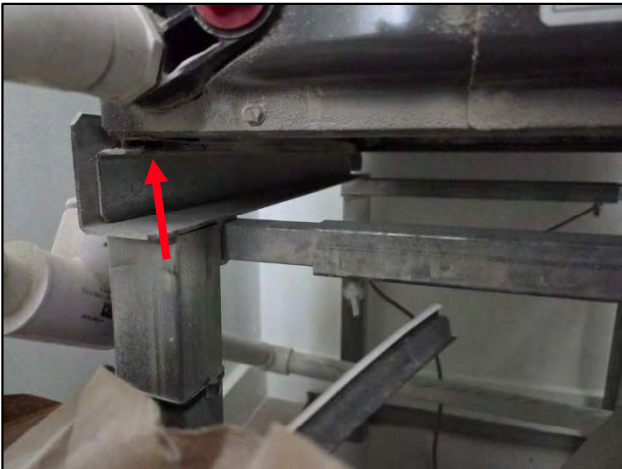
**Observation:** Rubber neoprene vibration isolator pads were not installed at any of the air handler (AHU) equipment. Rubber neoprene vibration pads are specified on the Mechanical Drawings to be installed.

*AHU #2 missing specified vibration isolator pads*

*AHU #3 missing specified vibration isolator pads*

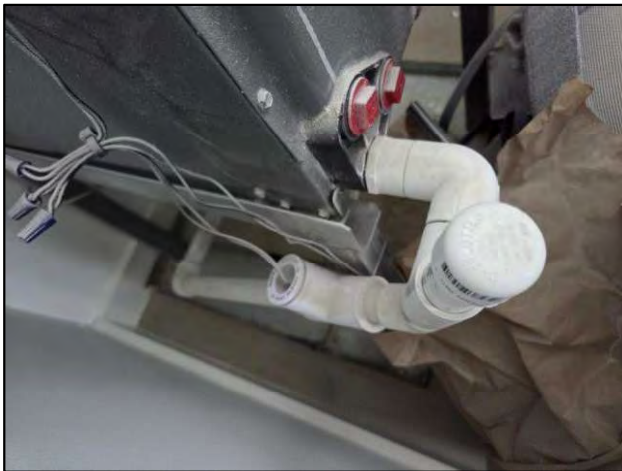
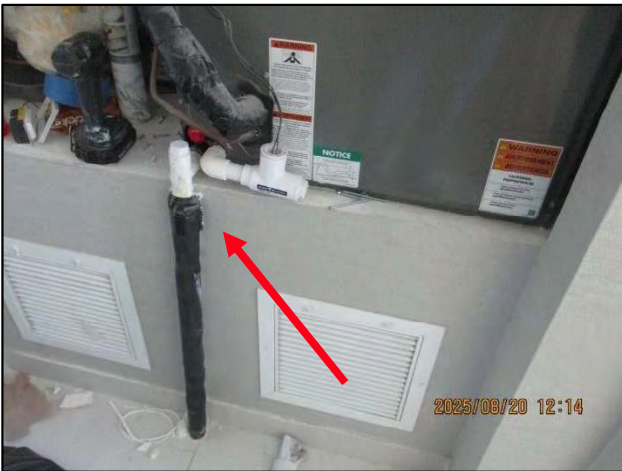
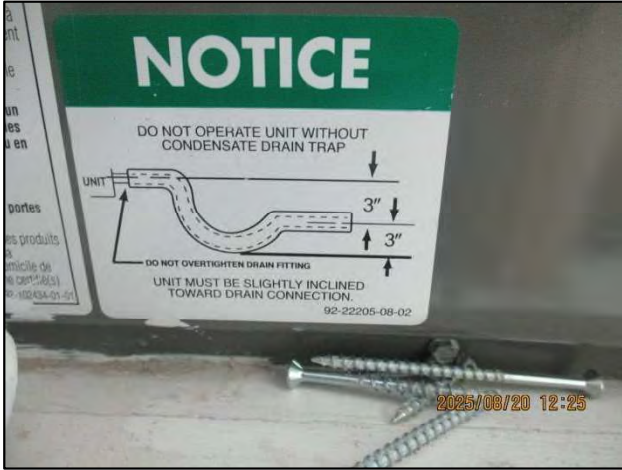
**Observation:** None of the air handling equipment (AHU) are provided with the required traps on the condensate drain lines. Traps are a necessary component to ensure proper drainage of the condensate, avoid overflows and backups, and prevent air and odors from being drain into the AHU from the condensate drainage line. The installed condition deviates from the manufacturer’s requirements and the Mechanical and Plumbing Drawings.

AHU #3 condensate drainage line missing trap

AHU #2 condensate drainage line missing trap

Label on AHU equipment indicates required trap.

**Recommendation:** P-traps must be installed at the AHU equipment condensate drainage line as required by the manufacturer’s installation instructions and as specified on the Mechanical and Plumbing Drawings.

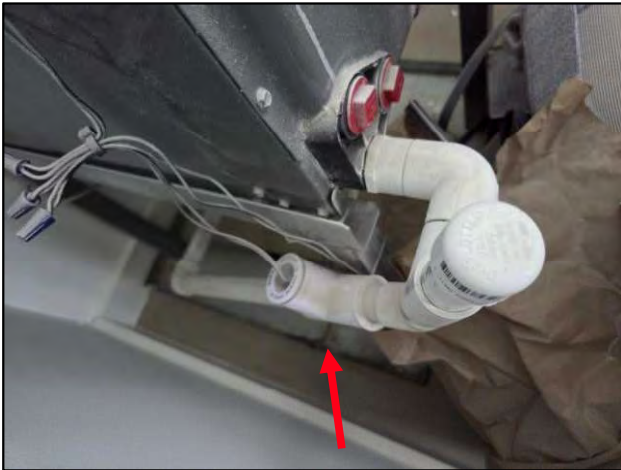
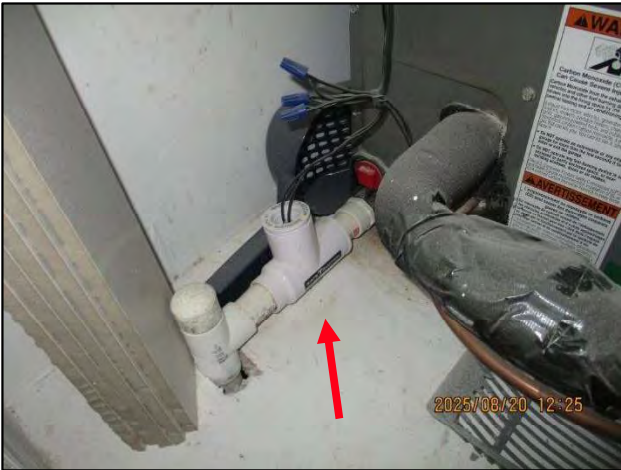
**Observation:** The float switch devices installed at air handling equipment (AHU) #1, 3, and 4 are installed on the incorrect locations. These are installed in-line and downstream of the primary condensate drain line connection. This installation deviates from the Mechanical Drawing M4 which specifies for the float switches to be attached to the secondary drain outlet.

*AHU #3 float switch in incorrect location*

*AHU #1 float switch in incorrect location*

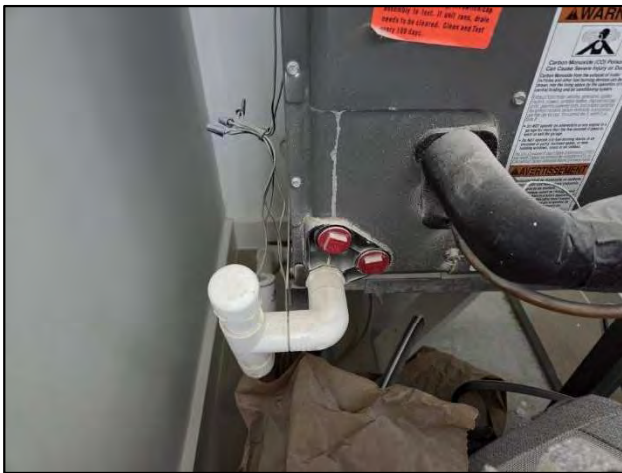
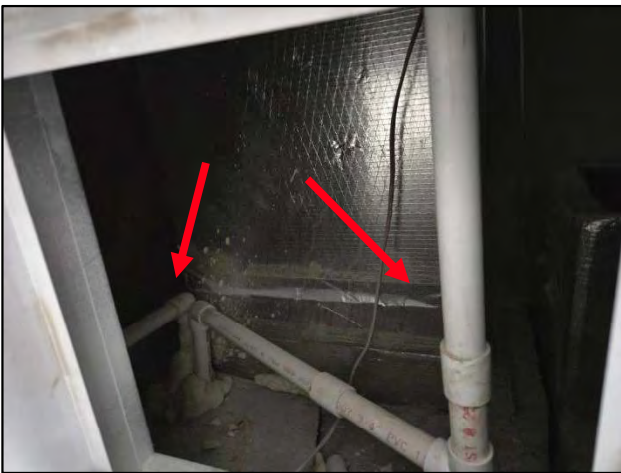
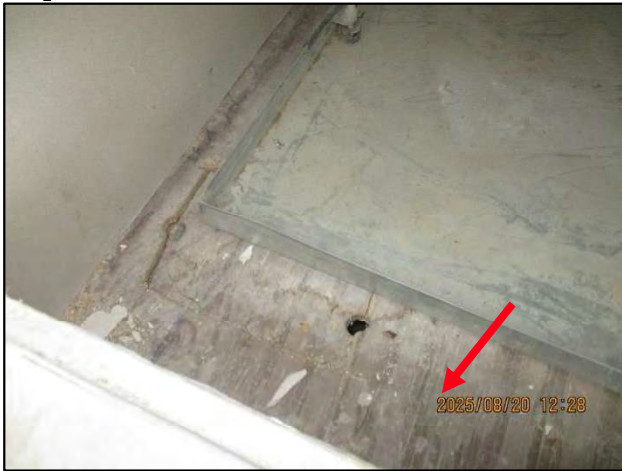
**Observation:** There are combustible materials observed within the return air plenums servicing the AHUs. The condensate drainage piping is PVC plastic which is a combustible material. Additionally, there are plywood sheets installed to cover openings in the slab. The Plumbing Drawings specify that combustible materials shall not be installed within return air plenum spaces.

*AHU #3 PVC condensate drain within return air plenum.*

*AHU #4 PVC condensate drain within return air plenum.*

*AHU #1 plywood sheet installed within return air plenum.*

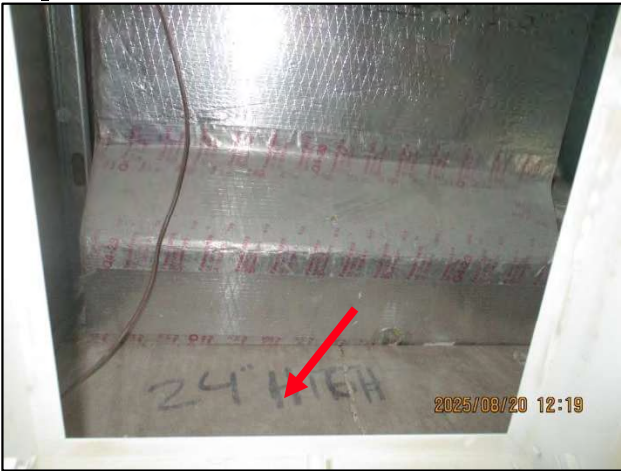
*AHU #2 plywood sheet installed within return air plenum.*

**Criteria:** The existing condition deviates from the Plumbing Drawing P-08 Plumbing Note 20 and Mechanical Drawing M4.

**Recommendation:** Combustible materials must be removed from the return air plenum and replaced with non-combustible materials. Alternatively, the materials can be provided with plenum rated wrapping (on piping) or coated with intumescent fire rated paint (wood sheets) to isolate the combustible materials from the return plenum entirely.

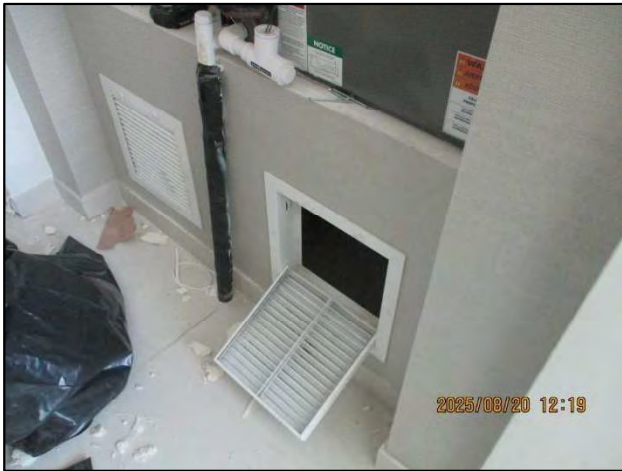
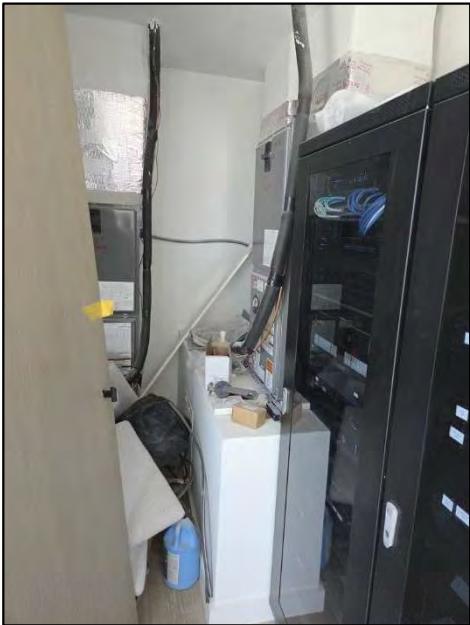
**Observation:** The air handling equipment (AHU) #1, 2 and 4 are installed on top of return air plenum boxes constructed out of metal stud wall framing and drywall panels. This installation completely deviates from the support system specified on the Mechanical Drawings. Drawing M4 specifies that the equipment are to be supported by 5/8” thick plywood sheets with 2x4 wood studs and iron angle supports welded to metal plates. The existing installation is relying on very thin gauge metal studs to support the equipment.

*Return air plenum box for AHU #1 and #2*

**Criteria:** The existing condition deviates from the Mechanical Drawings and is a Code violation.

**Recommendation:** The plenum boxes supporting the AHU #1, 2, and 4 must be reconstructed and installed as specified on the Mechanical Drawing M4 to properly support the equipment and installation.

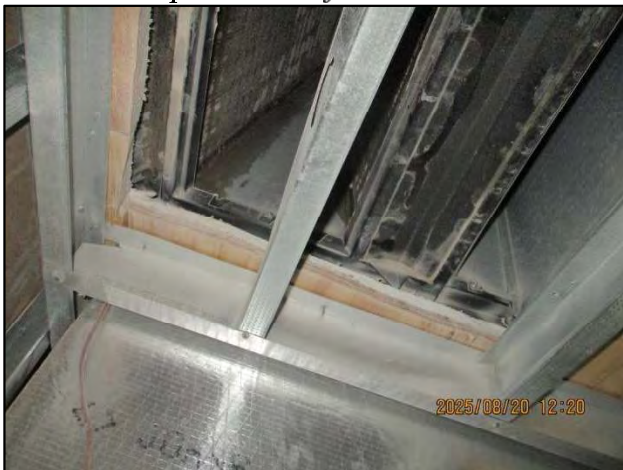
*Typical construction of the return air plenum box support with drywall and metal wall studs.*

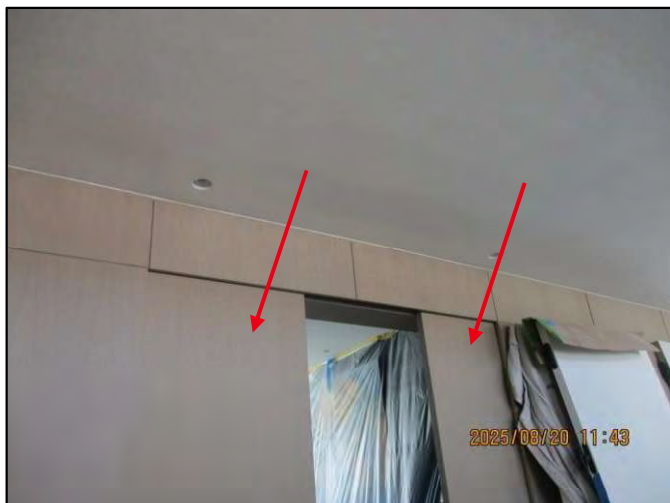
**Observation:** The Fitness Center room is not provided with means for return air transfer from the room. The Mechanical Drawing M1 specifies that the doors to the room are to be fully louvered doors. Solid doors were installed instead. Additionally, the 2<sup>nd</sup> Floor Laundry room is missing a transfer grille above the door. A transfer grill is specified on Mechanical Drawing M2. Lack of return air transfer from the rooms will affect the operation and efficiency of the air conditioning system and affect its ability to properly cool the space.

*Solid doors installed for Fitness Center and no return air provisions.*

**Criteria:** The existing condition is a deviation from the Mechanical Drawings M1 and M2 which is a Code violation.

**Recommendation:** The doors to the Fitness Center must be replaced with fully louvered doors or a transfer grille must be installed above the door to allow for return air from the space. A transfer grille must be installed at the 2<sup>nd</sup> Floor Laundry Room as specified on the Mechanical Drawings.

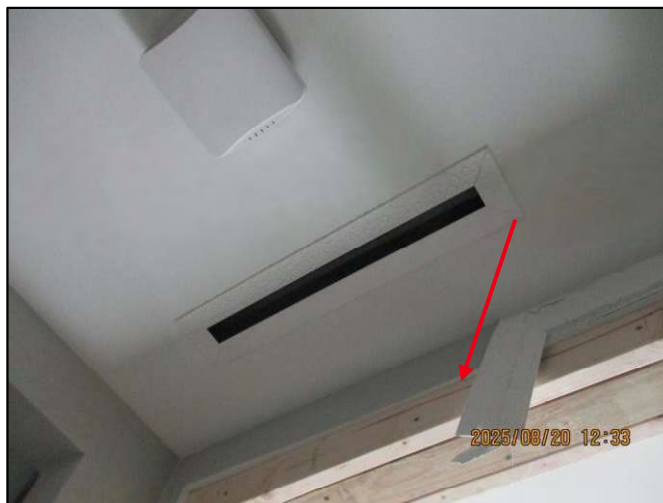
*No transfer grille at wall above door.*

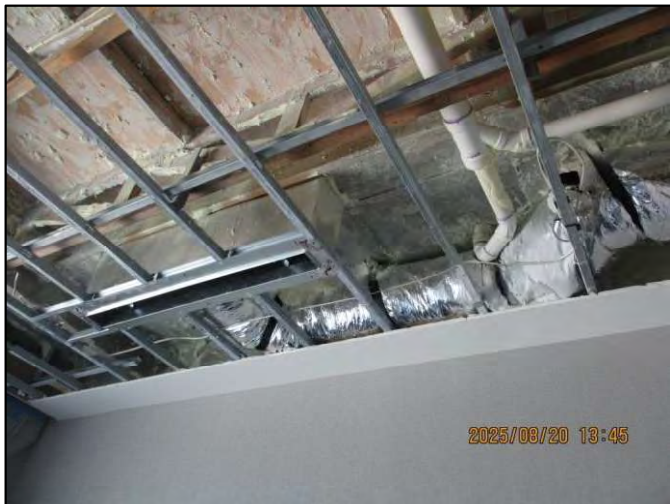
**Observation:** There are several locations where the installed duct sizes and number of duct connections deviate from the Mechanical Drawings. For example, in the 3<sup>rd</sup> guest Bedroom the return air duct is specified to be 10-inch diameter, but instead an 8-inch duct was installed. The register is also in the incorrect location. Similarly in the 1<sup>st</sup> Guest Bedroom the supply air register is specified with two 6-inch ducts and the return air register is specified with a 10-inch duct. Instead a single 10-inch duct is installed for the supply air and 8-inch duct installed for the return air. These deviations in the specified duct sizes may affect the amount of airflow reaching the spaces and affect the cooling of those spaces.

*1<sup>st</sup> Guest Bedroom with single SA duct where two are specified.*

**Recommendation:** Ductwork configurations and sizes must be installed as specified to ensure that the proper CFM airflow rates are being realized in the services spaces and to ensure proper cooling of spaces and operation of the air conditioning system.

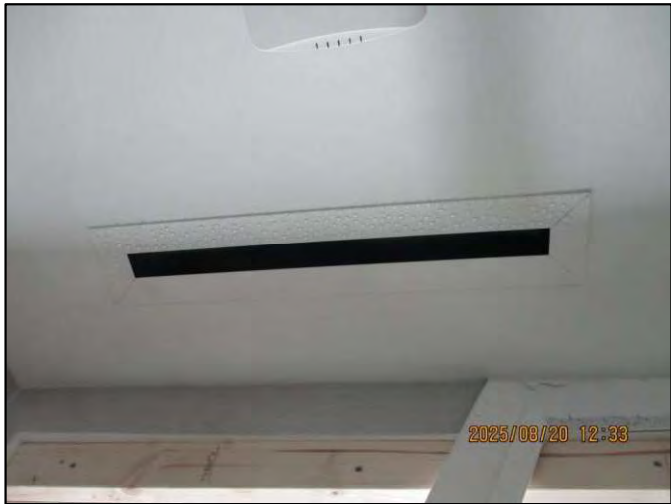
**Observation:** There are several air supply diffusers that were observed with condensation forming on the surface of the diffusers. This condition can be a result of unsealed installation of the diffuser at the drywall surface or excessive moisture/humidity in the space due to moisture intrusion.

*Condensation at diffuser in Laundry Room*

**Criteria:** The existing condition represents an incomplete building installation that is not operating as the design intended and a Code violation.

**Recommendation:** All air diffusers where condensation is occurring must be sealed to be airtight. All moisture/water intrusion contributing to elevated humidity in the building must be corrected.

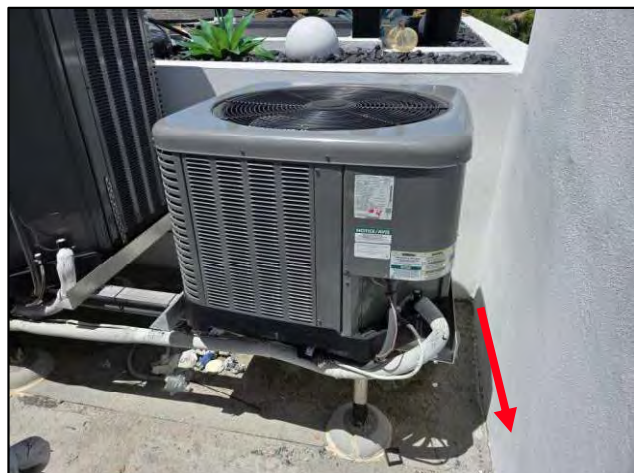
**Observation:** The mechanical roof area is missing the specified emergency overflow scupper at the parapet wall. The mechanical area is enclosed on all four sides and has no provisions for overflow drainage. An overflow scupper is specified on the Plumbing Drawings and is required by Code.

Emergency overflow drain missing at the Mechanical Roof Area

**Criteria:** The existing condition is a deviation from the Plumbing Drawing P-03 and a Code violation.

**Recommendation:** The emergency overflow scupper must be installed at the parapet wall in the Mechanical Roof area as specified on the Plumbing Drawings and required by Code.

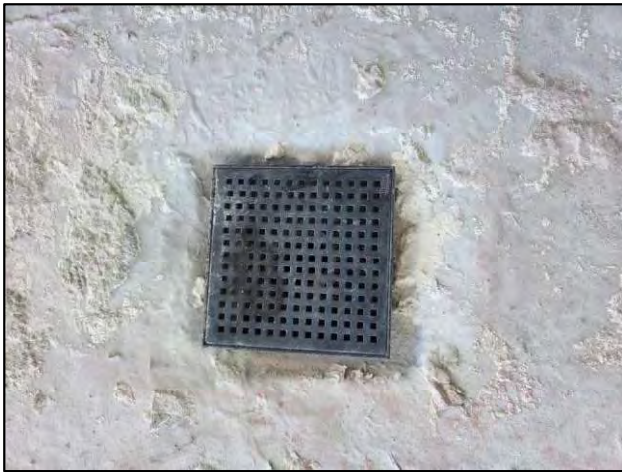
**Observation:** The drains installed at the outdoor Terrace on the 3<sup>rd</sup> Floor are not installed properly. Two drains are completely missing drain body and clamping collar assemblies. Instead, strainers were just installed within the mortar bed and the drainage piping stubbed up from below. These drain outlets were measured to be 2-

*Typical grate/strainer installed at the outdoor Terrace.*

**Recommendation:** The drains at the outdoor Terrace at the 3<sup>rd</sup> Floor and connected piping must be replaced with the appropriate two-stage drain body and clamping collar assembly matching the size specified. The Terrace is a walking surface and thus the grate/strainer must be flush with the Terrace finishes and heel-proof. The roofing/waterproofing system must not obstruct the drains or restrict waterflow.

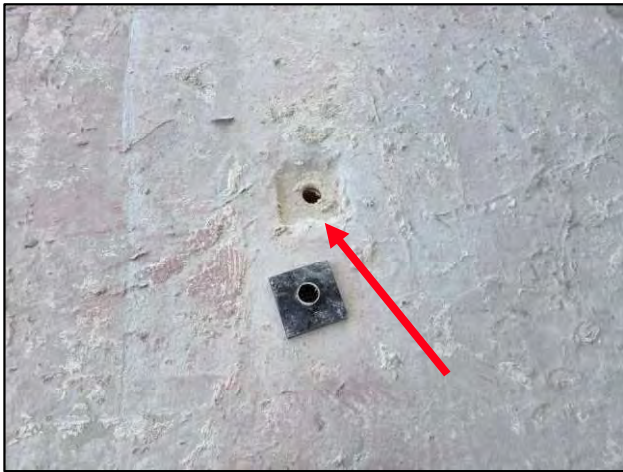
*No drain body or clamping collar assembly installed for the Terrace drains.*

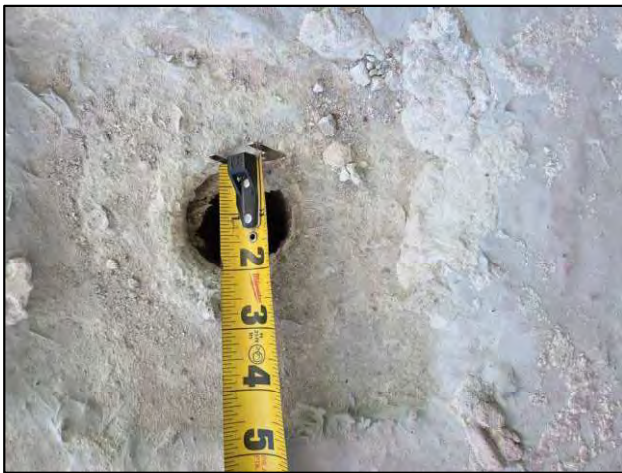
inches, while 3-inch sized drains are specified on the Plumbing Drawings. The drain in the BBQ area on the Terrace appears to be provided with a drain body assembly, however, the grate/strainer assembly with clamping collar is missing. The opening in the roofing system is too small and obstructs the flow of water for the 3-inch drain.

*Drain outlet of 2-inches*

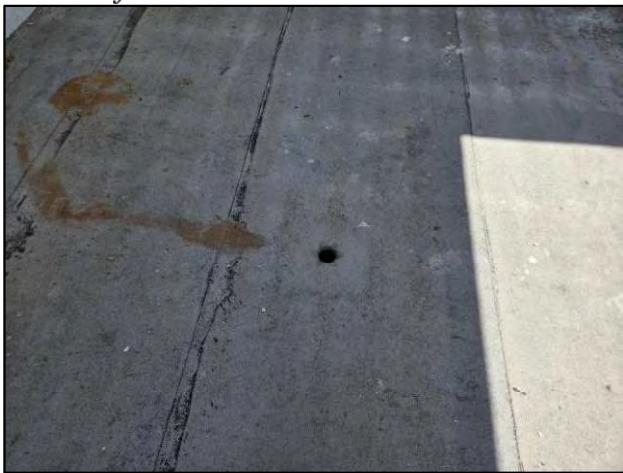
*BBQ Area drain missing grate/strainer assembly*

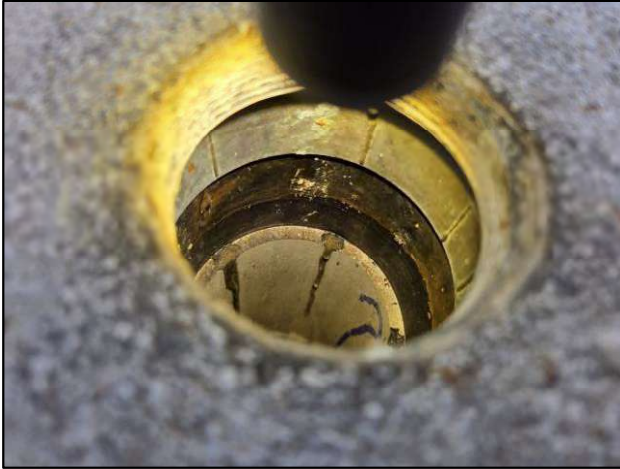
*Opening at roofing system smaller than drain outlet and obstructing water flow.*

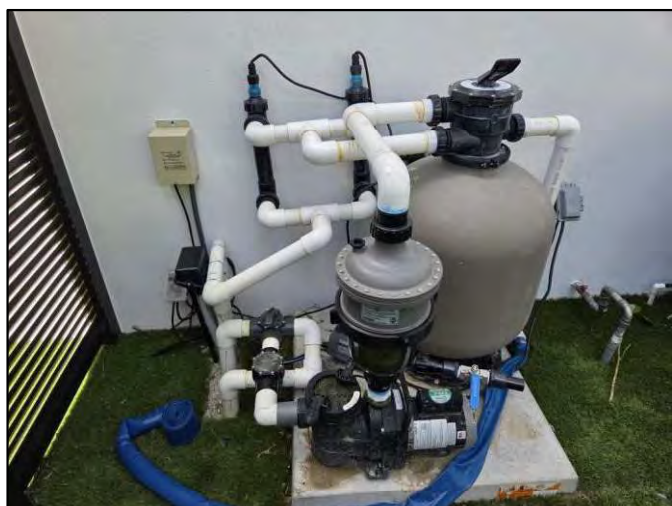
**Observation:** The plastic PVC piping for the pool/spa and koi pond systems are not painted and are exposed to UV sunlight. Constant exposure to sunlight causes deterioration of PVC plastic.

*Exposed plastic PVC piping at the Koi Pond equipment*

**Criteria:** The existing condition is a deviation from the PVC plastic piping manufacturer installation instruction, deviates from the Pool Drawing 5 and is Code violation.

**Recommendation:** All exposed PVC plastic piping at the 1<sup>st</sup> Floor must be provided with one coat primer and minimum of two coats of water-based paint to eliminate exposure to UV sunlight per manufacturer and Code requirements.

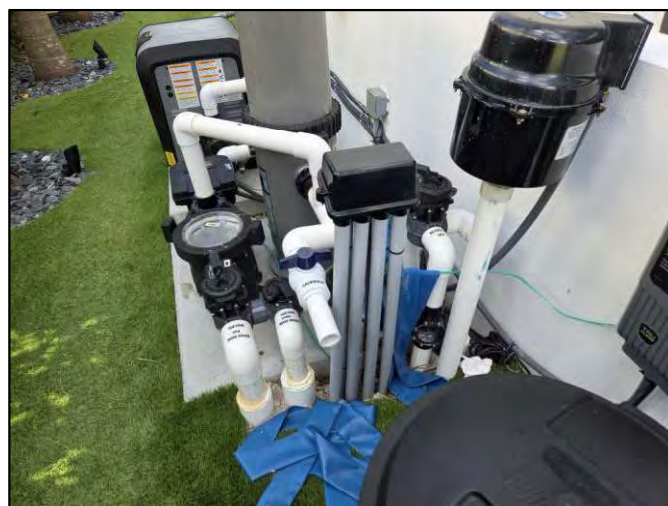
*Exposed plastic PVC piping at the Pool/Spa equipment*

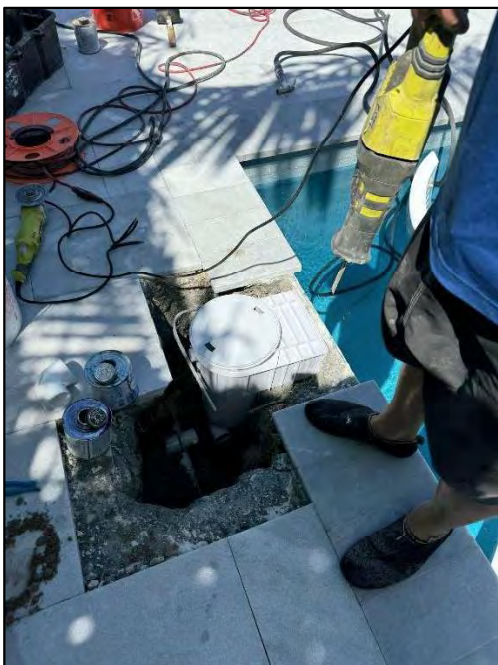
**Observation:** It was reported that there was an active leak at the pool skimmer. Photographs were provided showing the excavation of the skimmer at the cracks at the connected pipe and the skimmer body, itself. These cracks were the cause of the pool leak. The photographs were provided by the renovating contractor.

*Excavation of the installed skimmer at the pool*

**Recommendation:** The damaged piping and pool skimmer must be replaced to eliminate the leak from the pool system.
