IN THE CIRCUIT COURT OF THE 15TH JUDICIAL  
CIRCUIT IN AND FOR PALM BEACH COUNTY, FLORIDA

**COMPLAINT**

<sup>4</sup> The three independent reports include: Structural Construction Defect Evaluation – Prepared by Summit Design and Forensics, Inc. (attached hereto as **Exhibit C**); Forensic Investigation Report – Prepared by ECS Florida, LLC (attached hereto as **Exhibit D**); Property Evaluation Report – Prepared by Pistorino and Alam Consulting Engineers, Inc. (attached hereto as **Exhibit E**); J.R. Inspections Services, Inc. – Mold Inspection Report (attached as **Exhibit “F”**) (collectively, the “**Engineering Reports**”)

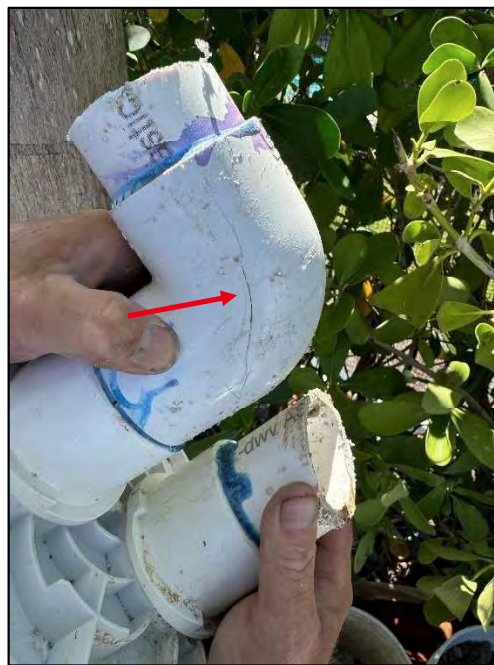
**Observation:** It was reported that there was an active leak at the pool skimmer. Photographs were provided showing the excavation of the skimmer at the cracks at the connected pipe and the skimmer body, itself. These cracks were the cause of the pool leak. The photographs were provided by the renovating contractor.

*Cracked found in the connected pipe fitting*

**Recommendation:** The damaged piping and pool skimmer must be replaced to eliminate the leak from the pool system.

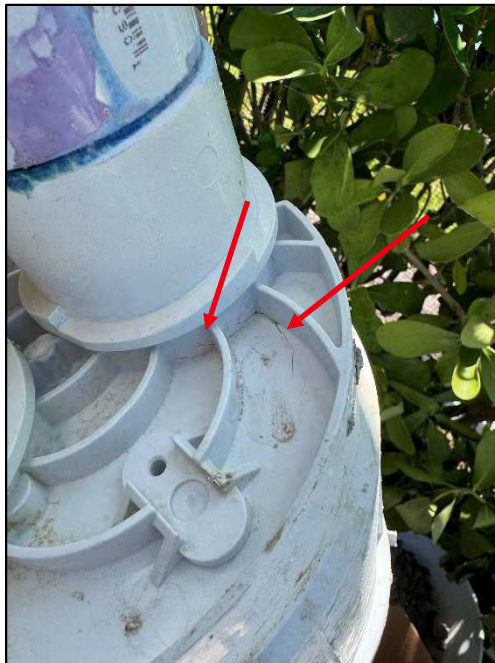
*Crack found in the pool skimmer body*

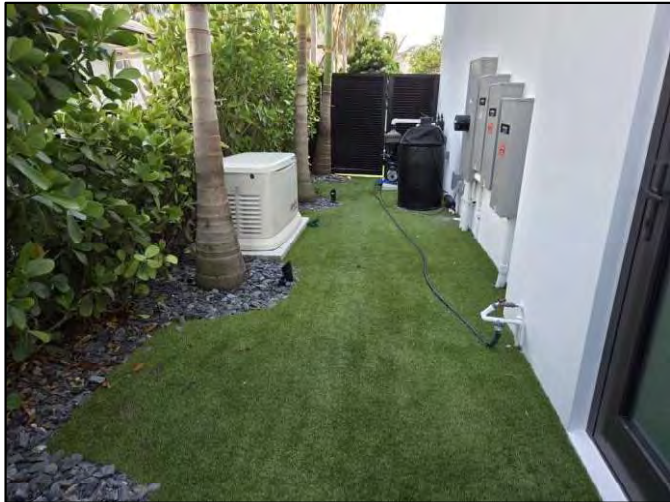
**Observation:** The gas-fired emergency generator is installed near building opening (Laundry Room exterior door). Additionally, the generator is installed within 3 feet of adjacent landscaping and property line fencing. The equipment manufacturer requires minimum 3 feet clearance at the front and sides of the unit. The equipment must also not be concealed by shrubs.

*Emergency generator within near building opening*

**Criteria:** The existing conditions deviate from the manufacturer's installation requirements and constitute as a Code violation.

**Recommendation:** The emergency generator must be relocated to meet the spacing and clearance requirements of the manufacturer and Code.

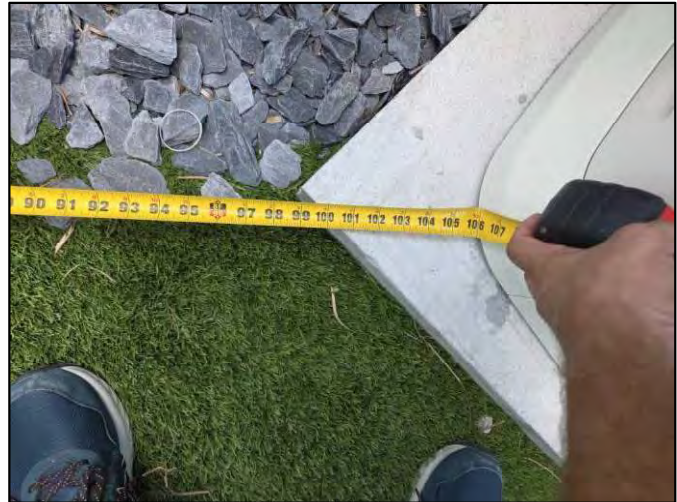
*Equipment within 10 feet of building opening*

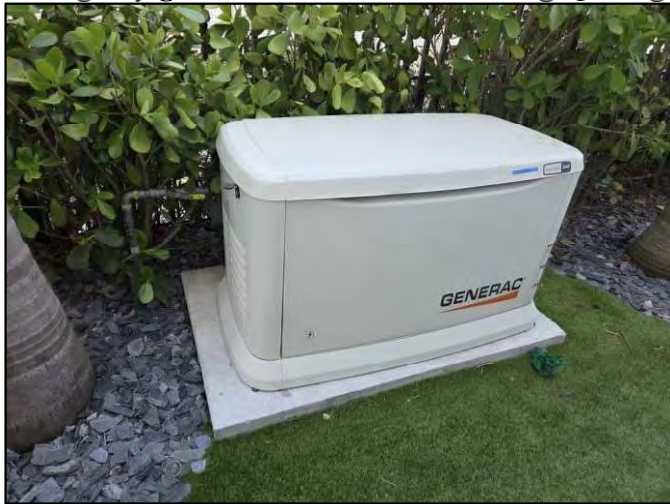
*Trees installed within 3 feet of generator*

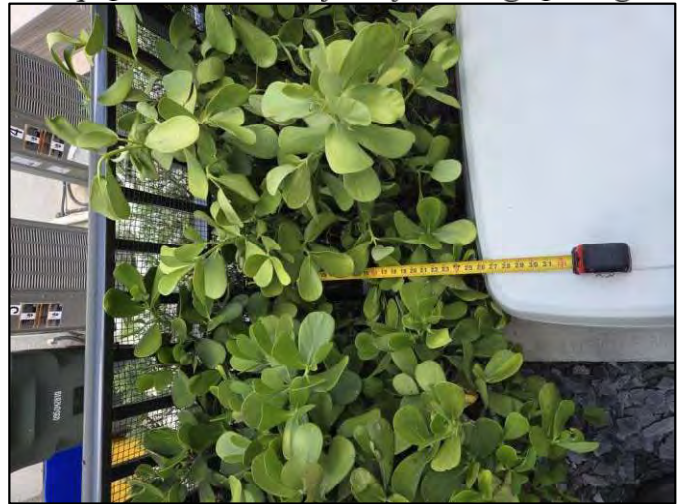
*Fence installed within 3 feet of generator and bushes installed up against generator*

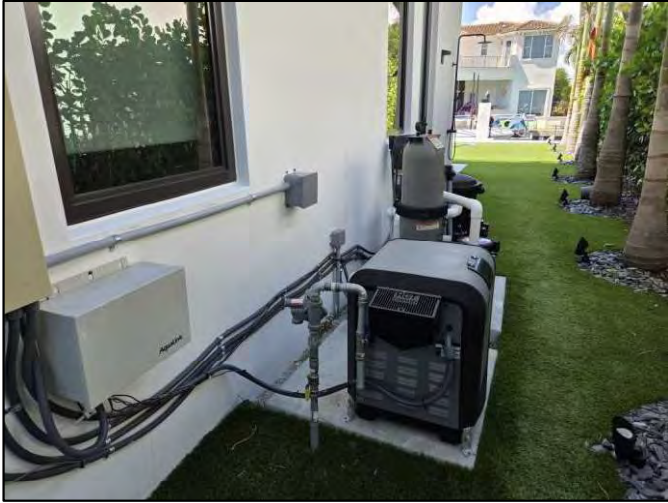
**Observation:** The gas-fired pool/spa heater equipment is located within 4 feet of an operable window. This is a life safety issue as it can allow gas fumes to enter the living space.

*Pool/Spa gas-fired heater equipment located near operable window.*

**Criteria:** The existing condition is a deviation from the manufacturer's installation instructions, the approved Pool Drawing Sheet 1, and is a Code Violation.

**Recommendation:** The pool/spa pool heater equipment must be relocated a minimum 4 feet away from any operable opening as required by the manufacturer's installation instructions and the Code.

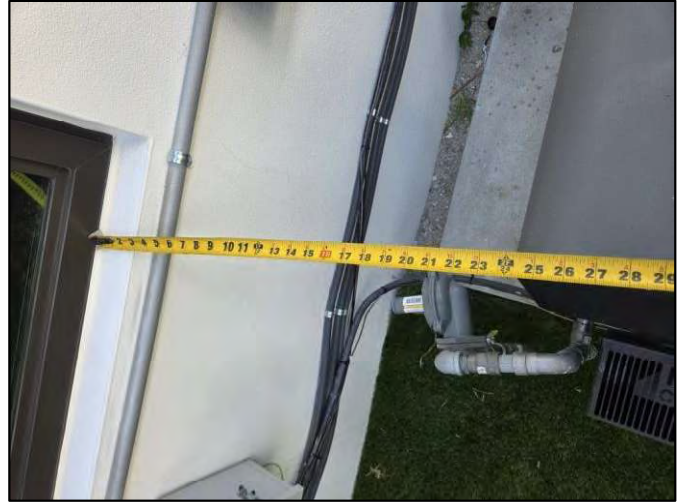
*Gas-fired heater installed within 4 feet of the operable window.*

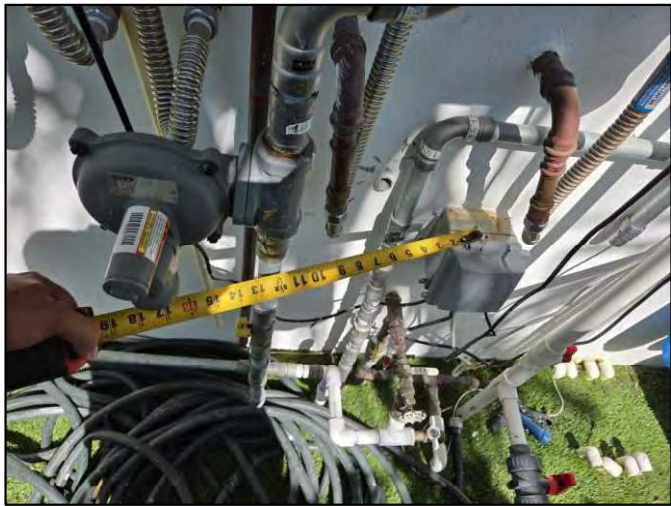
**Observation:** The vented gas pressure regulators installed for the pool heater and the hot water heaters were found to be installed within 3 feet of ignition sources (switches, outlets and panels). This is a life safety issue as ignition sources can potentially ignite gas vapors that are vented from the regulators.

*Water heater regulator within 3 feet of ignition source*

**Criteria:** The existing condition is a Code violation.

**Recommendations:** The vented gas pressure regulators must be relocated so that they are a minimum of 3 feet away from ignition sources, as required by Code.

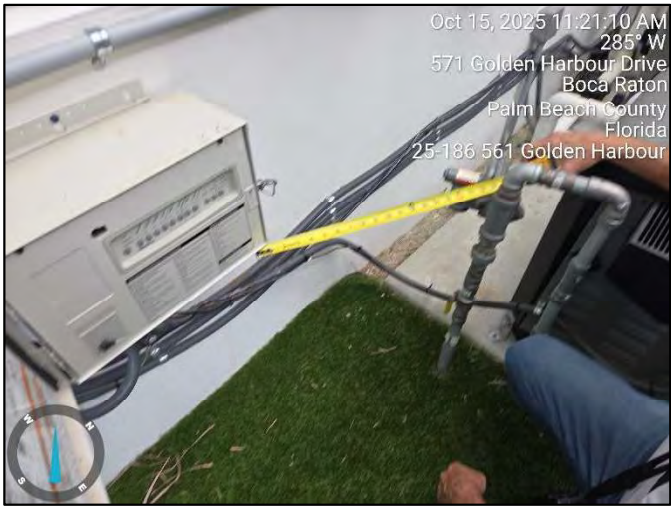
*Pool heater regulator within 3 feet of control panel*

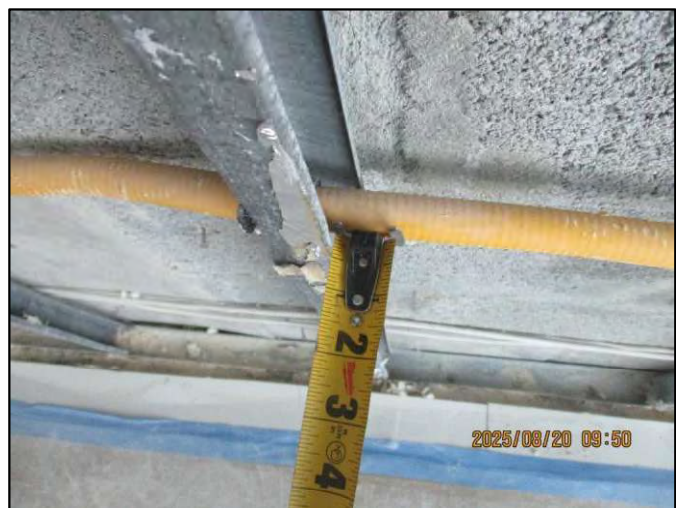
**Observation:** The corrugated stainless-steel tubing (CSST) utilized for the gas distribution piping within the residence was found improperly installed. The vertical and horizontal tubing is supported by the drywall framing. No protection plates were observed installed where the tubing passes concealed behind the wall/ceiling and where it crosses framing. The tubing does not have the required 3-inch distance to the outer edge of the framing or wall/ceiling finishes for installation without any protection plates. The owner had reported smelling gas fumes at the Kitchen. When the CSST was exposed, there were pinholes observed in the CSST due to drywall installation. P&A understands that the CSST in the Kitchen has since been abandoned. The installation of the CSST throughout the property deviates from the manufacturer’s installation requirements and poses a Life Safety issue.

*Installation of the CSST missing protection shield at the Kitchen wall*

**Criteria:** The existing condition is a Life Safety issue as the improper installation of the CSST can result in gas leak and potential fire/explosion. The existing installation deviates form the manufacturer’s installation instructions and is a Code violation.

**Recommendation:** All the CSST piping installed for the gas distribution system must be reinstalled following the manufacturer’s installation requirements and provided with the necessary protection at the required locations to avoid damage of the CSST. The entire system must be tested to ensure no leaks are present.

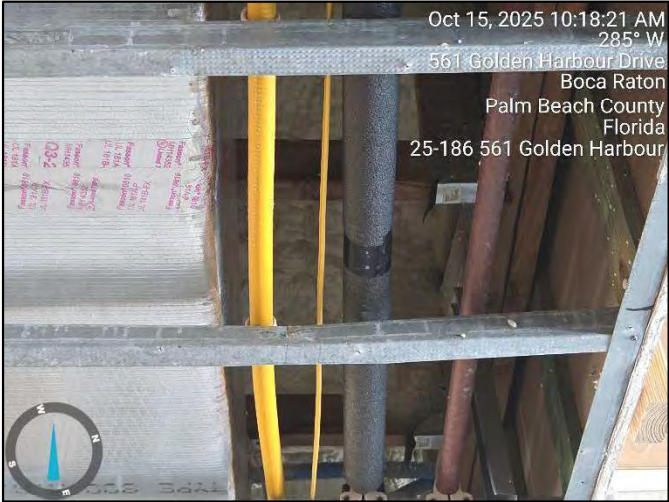
*Installation of the CSST missing protection shield*

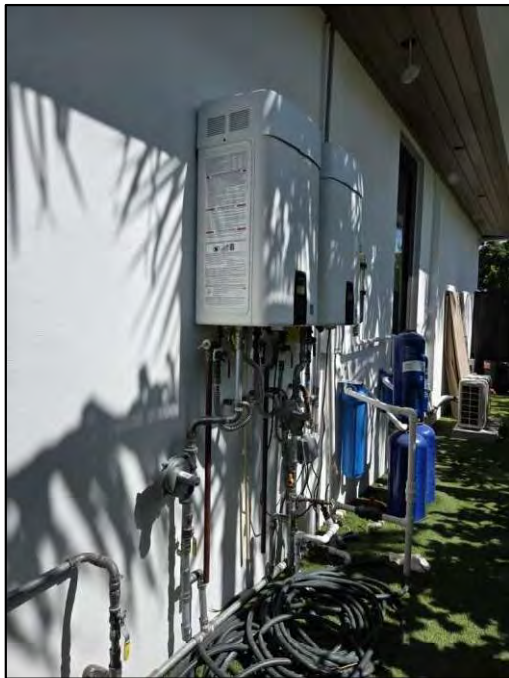
**Observation:** The installed gas-fired water heaters are manufactured by Navien model NPE240A2 and NPE240S2. The installation of this equipment deviates from the manufacturer's installation instructions. The manual for this equipment indicates that it is not suitable for installation outdoors near coastal environments without being enclosed. The property is located within three miles from the coast and is immediately adjacent to a canal which provides ocean access. The water heater equipment is not provided with the necessary enclosure to protect it from the corrosive coastal environment. Additionally, there are no check valves installed on the water supply piping to the water heater equipment. A check valve is required according to the manufacturer's installation instructions.

*Gas-fired instant water heaters exposed to coastal environment*

**Criteria:** The existing condition deviates from the manufacturer's installation instructions and is a Code violation.

**Recommendation:** The water heater equipment must be provided with the required enclosure to protect the equipment from the coastal environment as required by the manufacturer’s installation instructions. All venting and intake installations must be

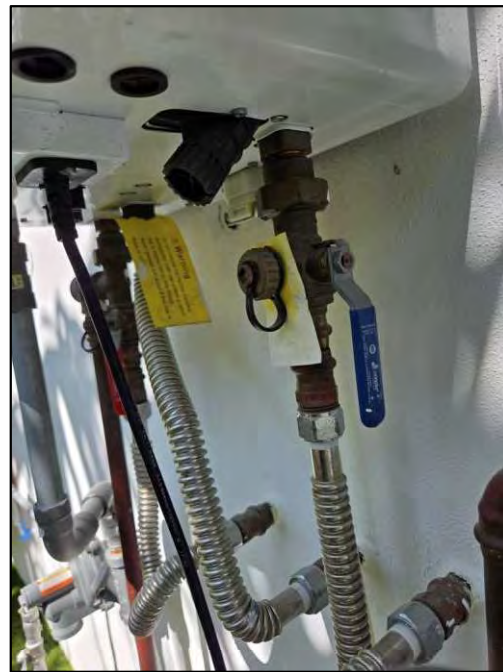
*Water supply connection to the water heater missing required check valve*

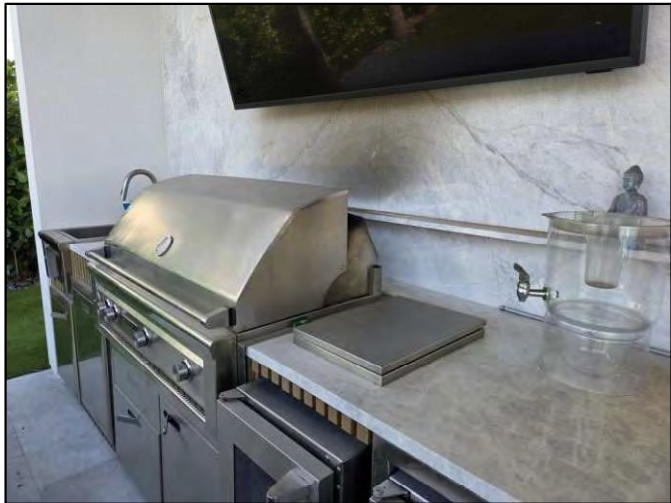
required service and maintenance. Additionally, this location poses a life safety/fire hazard issue as it is located near a gas supply line and gas burning equipment.

Outdoor, gas-burning cooking equipment at the backyard areas

**Recommendation:** The steam generator equipment must be relocated out from behind the gas-burning cooking equipment and installed in the location that is specified on the Plumbing Drawings and is Code compliant. Until this is complete the steam generator equipment must be completely disconnected to avoid a fire hazard.

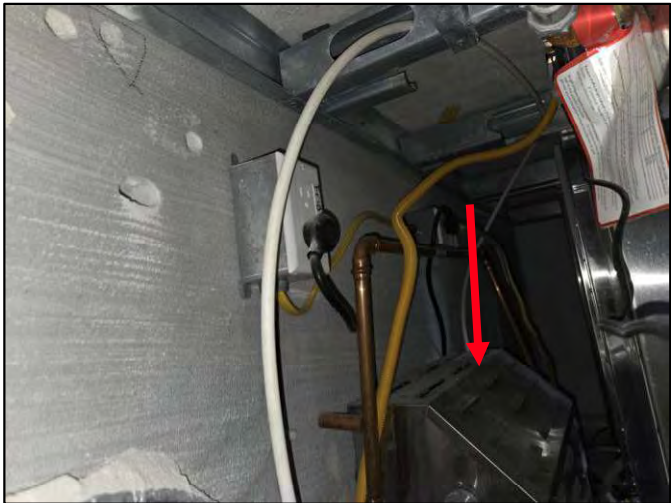
Steam generator equipment installed behind the gas burning cooking equipment.

**Criteria:** The existing condition creates a life safety/fire hazard condition, deviates from the manufacturer's installation instruction, deviates from the Plumbing Drawing P-01, and is a Code violation.

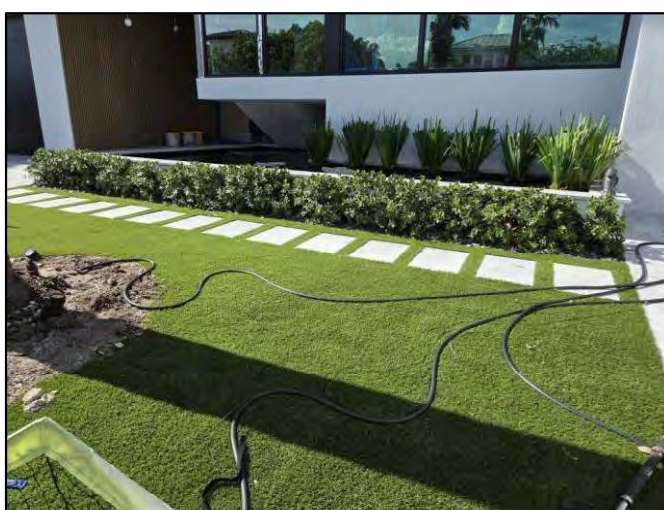
**Observation:** The 4-inch cleanout on the main sanitary building drain/sewer was not observed installed at the front of the property. This cleanout fitting is specified on the Plumbing Drawings and required by Code.

*Missing sanitary cleanout*

**Criteria:** The existing condition deviates from the Plumbing Drawing P-01 and is a Code violation.

**Recommendation:** The 4-inch cleanout must be installed as required by Code and as specified on the Plumbing Drawings.

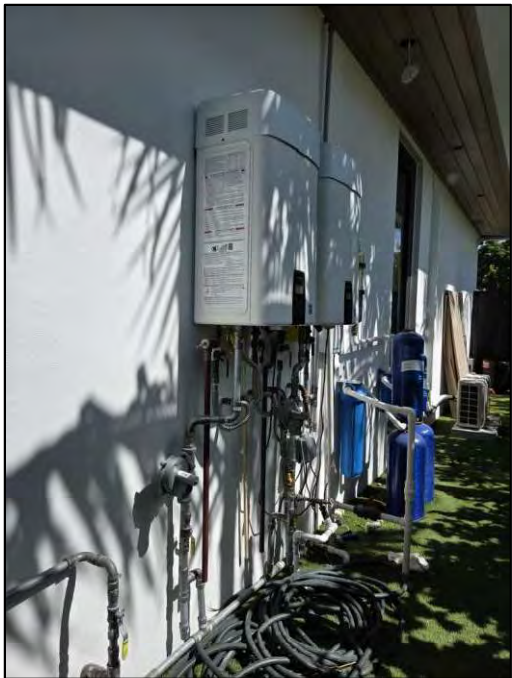
**Observation:** There are two gas-fired instant water heaters installed supplying the residence with hot water. This completely deviates from the Plumbing Drawings which specify for several electric instant water heaters. Additionally, a whole-house water filtration system is installed on the water distribution system. There is no whole-house filtration system specified to be installed on the Plumbing Drawings. Similarly, there is a mini split air conditioning system installed servicing one of the Garage's. This mini split is not specified on the Mechanical Drawings.

*Gas-fired instant water heaters*

**Criteria:** The existing condition deviates from the Plumbing and Mechanical Drawings and is a Code violation.

**Recommendation:** Provide the revised signed and sealed Plumbing drawings from the Engineer of Record reflecting the as-built conditions and installed systems. The revised as-builts must be submitted to the city for review and approval.

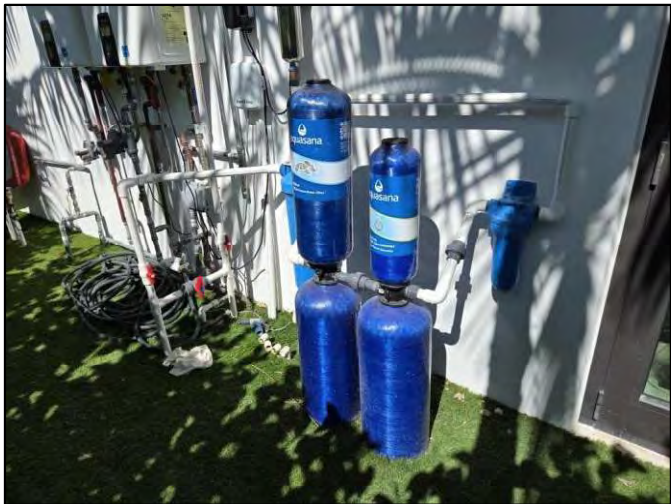
*Whole-house water filtration system*

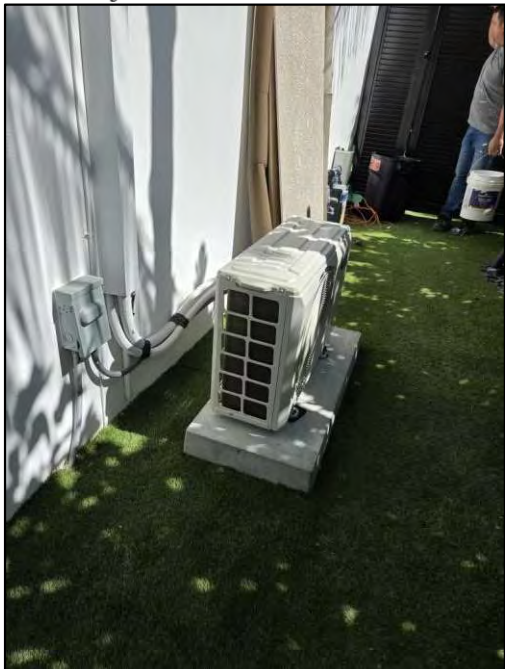
*Condenser unit for the mini split system*

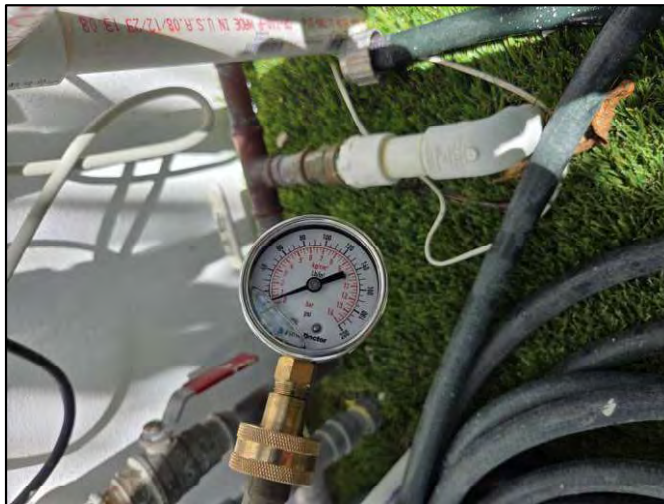
**Observation:** The property owner has reported that there is poor water pressure available at the property. This is especially noticeable when there are multiple fixtures operating at once (dishwasher, washing machine, sinks, etc.) During P&A's inspection this condition was apparent when the irrigation system was operated. The irrigation system is supplied water from the property's domestic water system. When the irrigation system is on the available pressure for the building drops to almost zero. There does not appear to be sufficient water pressure and service to operate the irrigation system and the plumbing fixtures within the building.

*Domestic water supply pressure drops to near zero when irrigation system is operating.*

**Criteria:** The existing condition is a deviation from the approved Plumbing Drawing P-05 which is a Code violation.

**Recommendation:** The irrigation system must be separated from the building's water supply and provided with its own connection for a water source for nonpotable water system. The entire irrigation system must be evaluated for proper operation.

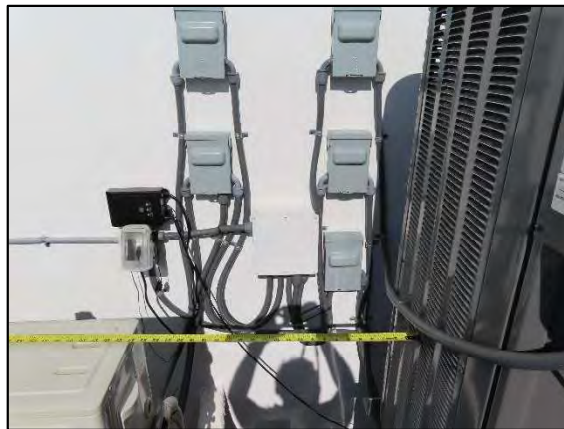
**Observation:** There is electrical equipment with less than the required clear working spaces.

*Condensing Unit Disconnects*

**Criteria:** The existing condition is in violation of **NEC 110.26 (A) Spaces About Electrical Equipment:** *“(A) Working Space. Working space for equipment operating at 600 volts, nominal, or less to ground and likely to require examination, adjustment, servicing, or maintenance while energized shall comply with the dimensions of 110.26(A)(1), (A)(2), and (A)(3) or as required or permitted elsewhere in this Code”. (1) Depth of Working Space: “The depth of the working space in the direction of live parts shall not be less than that specified in Table 110.26(A)(1)...”; NEC 110.26 (A)(2) Width of Working Space: “The width of the working space in front of the electrical equipment shall be the width of the equipment or 762 mm (30 in.), whichever is greater. In all cases, the work space shall permit at least a 90 degree opening of equipment doors or hinged panels.”; NEC 110.26 (A)(3) Height of Working Space: “The work space shall be clear and extend from the grade, floor, or platform to the height required by 110.26(E). Within the height requirements of this section, other equipment that is associated with the electrical installation and is located above or below the electrical equipment shall be permitted to extend not more than 150 mm (6 in.) beyond the front of the electrical equipment.”;*

**Recommendation:** Provide the required working spaces for the electrical equipment as per the referenced criteria.
