IN THE CIRCUIT COURT OF THE 15TH JUDICIAL  
CIRCUIT IN AND FOR PALM BEACH COUNTY, FLORIDA

**COMPLAINT**

<sup>4</sup> The three independent reports include: Structural Construction Defect Evaluation – Prepared by Summit Design and Forensics, Inc. (attached hereto as **Exhibit C**); Forensic Investigation Report – Prepared by ECS Florida, LLC (attached hereto as **Exhibit D**); Property Evaluation Report – Prepared by Pistorino and Alam Consulting Engineers, Inc. (attached hereto as **Exhibit E**); J.R. Inspections Services, Inc. – Mold Inspection Report (attached as **Exhibit “F”**) (collectively, the “**Engineering Reports**”)

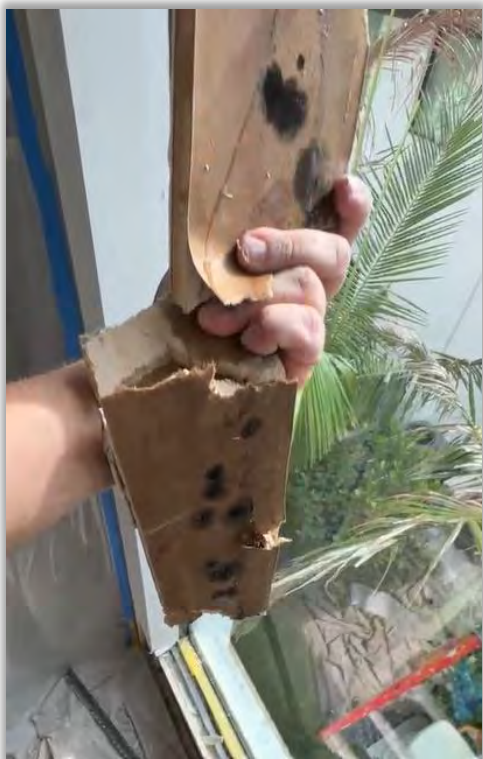
*Figure 3: Black mold growing on drywall in daughter's room.*

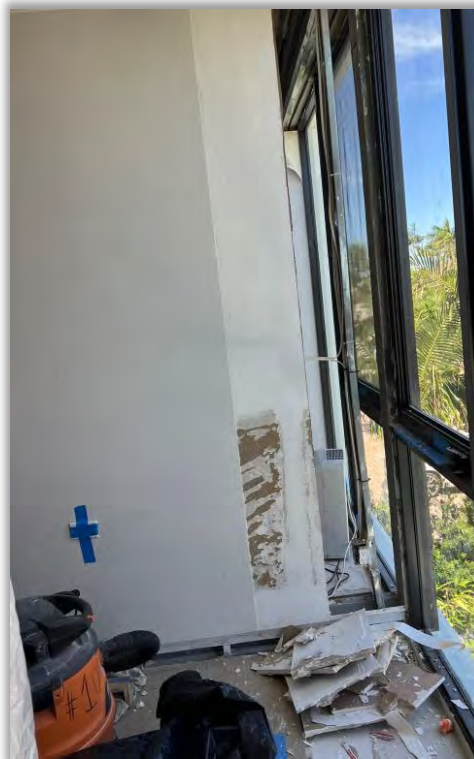
*Figure 4: Damage to children's rooms by water intrusion through windows.*

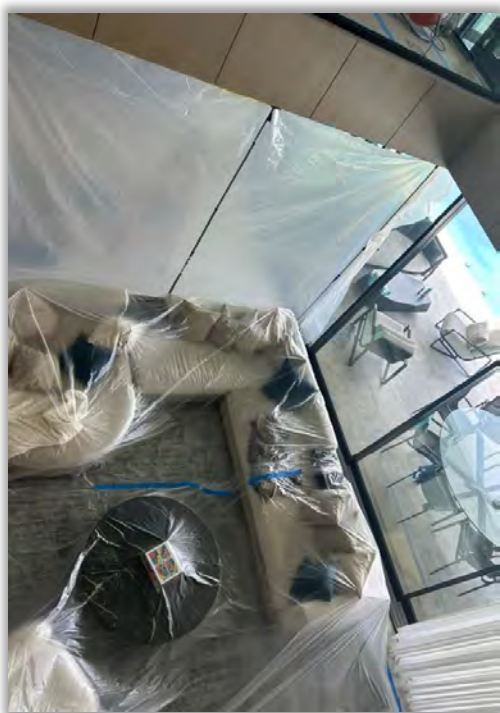
*Figure 5: Tarp covering entire living room.*

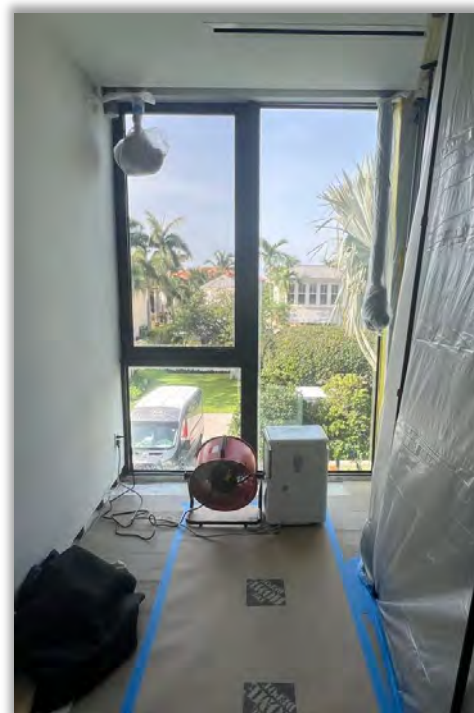
*Figure 6: Dehumidifiers and tarp covering child's room.*

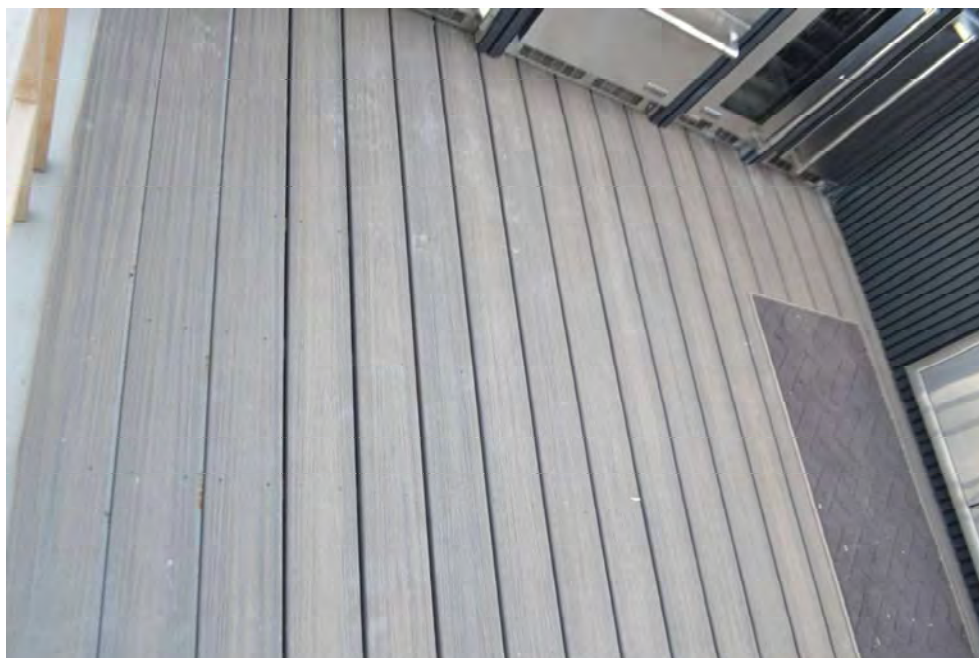
- According to Mr. Villa, there is no roof drain below the outdoor kitchen deck and a concrete curb prevents water from draining from this area (**Figure 14**) which is a defect.
- Portions of the pavers were removed along the sliders and windows prior to Summit's site inspection.
- Portions of the pavers are installed above the slider track weep holes (**Figure 15**), which does not allow rainwater in the track to properly drain and is a defect.
- Portions of the pavers are installed above the lower window frame portion causing water to pond against the window (**Figure 16**) and is a defect.
- It was reported to Summit that portions of the pavers do not adequately slope to the roof drains.

Figure 14) View of the outdoor kitchen deck at the third floor rear balcony.

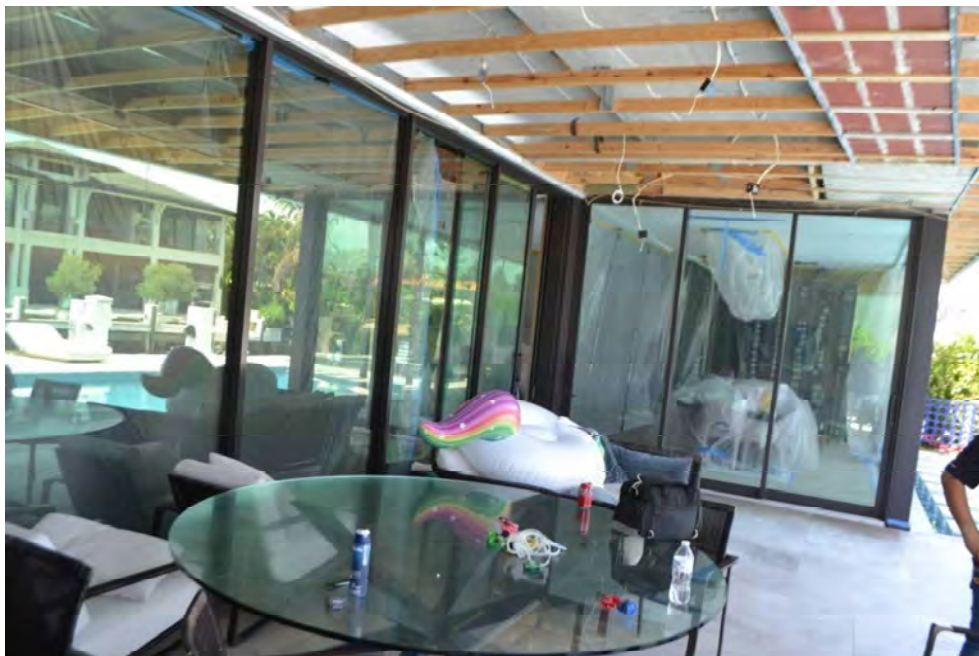
**Figure 54** is an overview of the rear porch. The following observations were made and conclusions have been derived at the rear porch.

Figure 54) Overview of the rear porch.

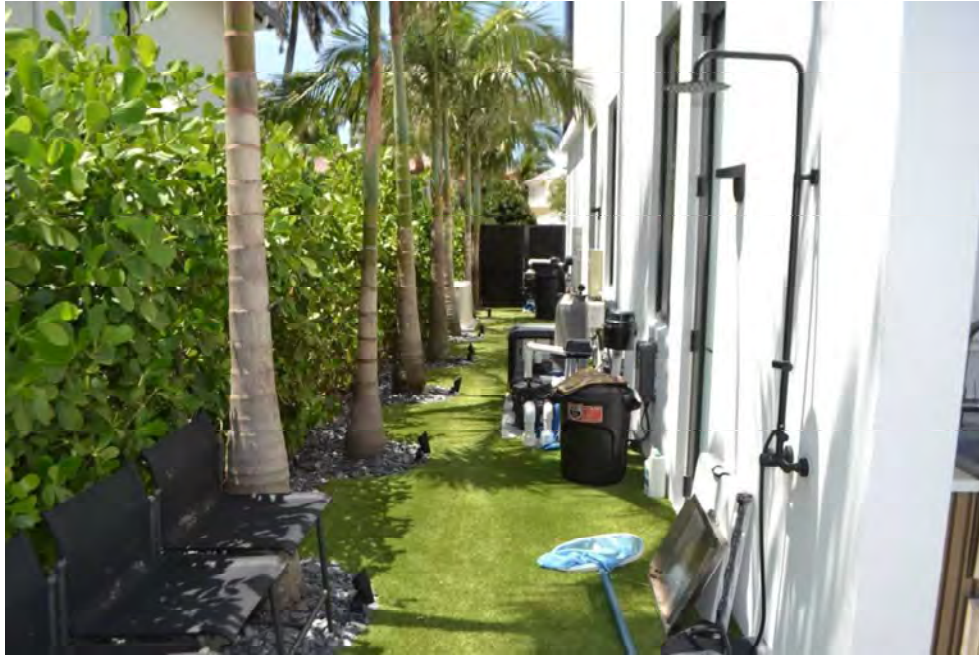
**Figure 61** is a view of the partial right elevation of the home. The following observations were made and conclusions have been derived at the right elevation of the home.

Figure 61) Partial view of the right elevation of the home.

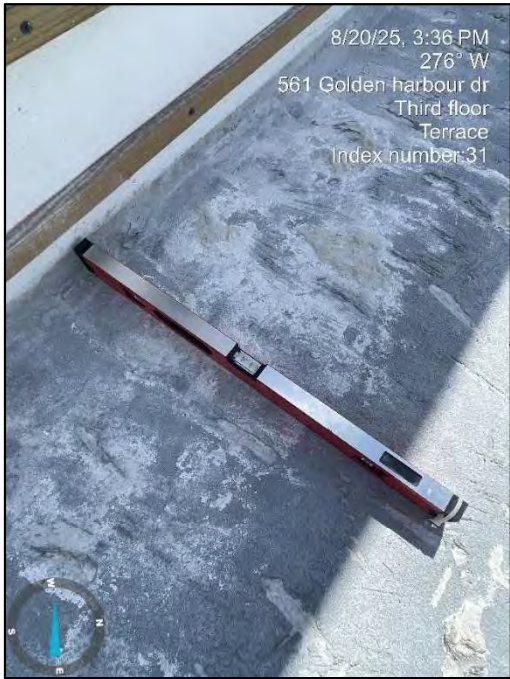
**Photo 31:** *Third Floor Terrace – General view of the north terrace without any slope.*

**Recommendation:** Provide slope and install waterproofing systems at floor slabs in compliance with the permit/record set of drawings and waterproofing manufacturer's recommendations. Professional of Record shall provide a protocol for remedial work.

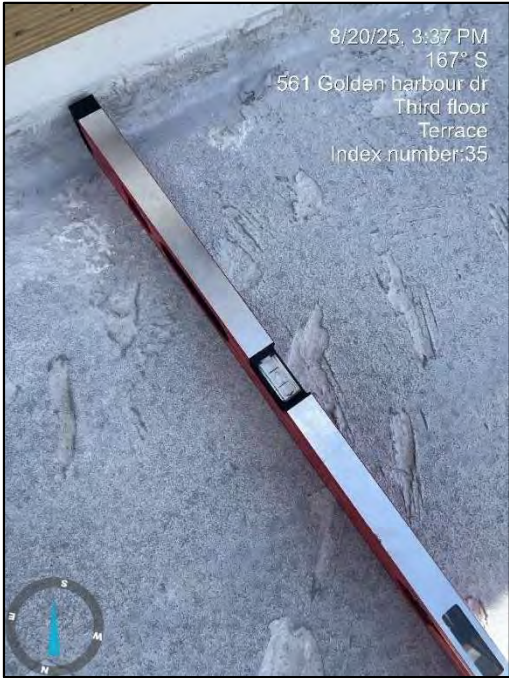
**Photo 35:** *Third Floor Terrace – General view of the north terrace without any slope.*

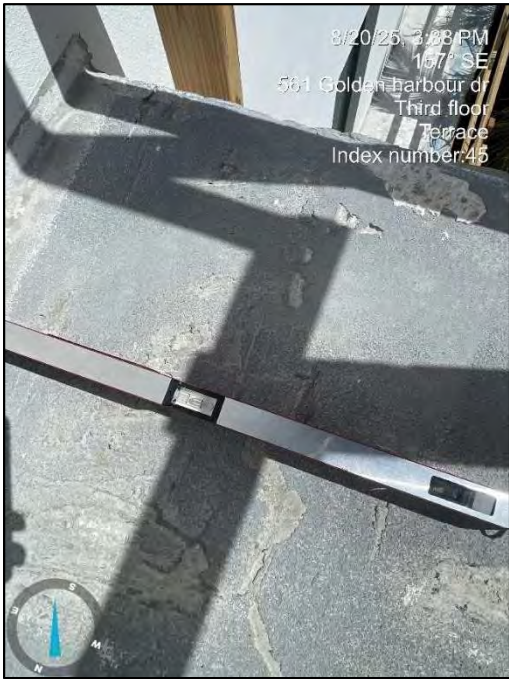
**Photo 45:** *Third Floor Terrace – General view of the north terrace without any slope.*

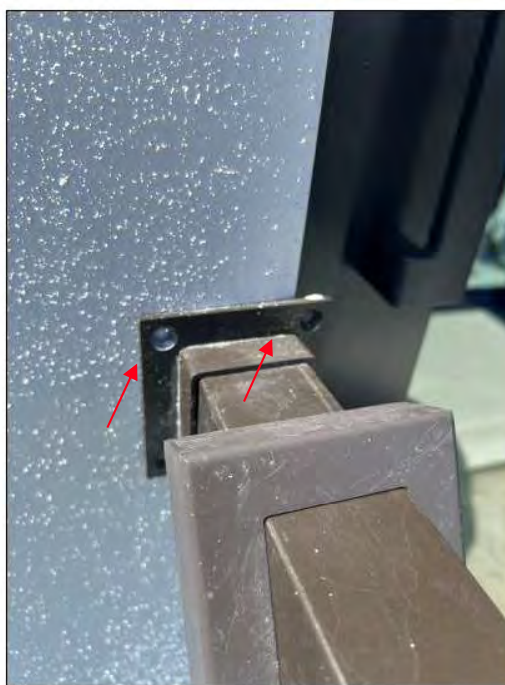
**ECS Photo 24** – Missing fasteners at railing system. Also, railing end location is incorrect as it is not completely supported by the structural substrate.

Missing and or inadequately installed fasteners and improper support of the railing components reduce the load resisting capacity of the railing system. The unsealed penetrations have created conditions allowing for water intrusion into the structure and behind stucco thereby causing stucco cracking and delamination. Refer to article-2.1 for details regarding stucco deficiencies.

**Recommendation:** Missing post fasteners must be provided and inadequately installed components of railing system must be remediated to ensure that the installation of railing system is in compliance with the permitted documents.

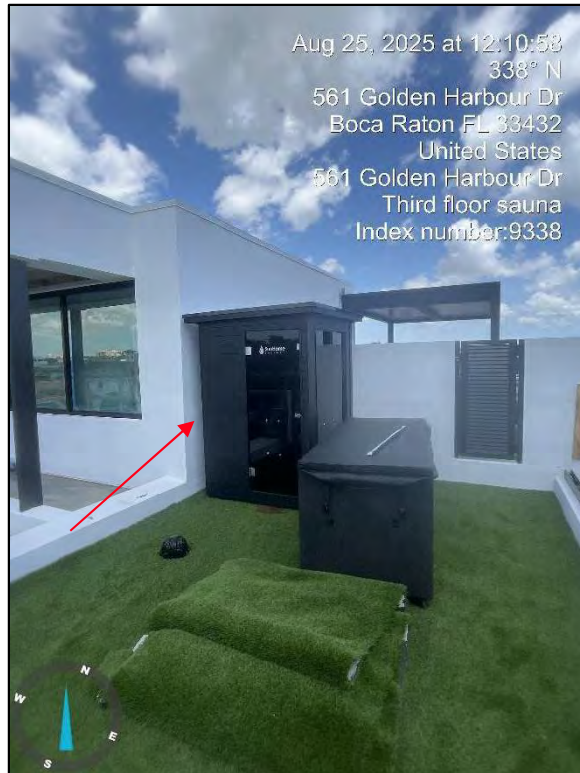
**Observation:** At the third level a sauna was observed on top of the roof at East side of the building, however the sauna is not shown on the architectural and structural drawings. P&A reached out to the manufacturer of sauna, and they have confirmed that their equipment has not been accredited for exterior installation on HVHZ. In addition, there was no documentation found that the sauna is UL certified, and how the sauna was wired into the house electrical system.

**Photo TC\_09338** – Sauna and cold plunge located at Level-3.

**Recommendations:** The request for information must be submitted to the Engineer of Record (EOR) for verification of design capacity of existing structure with inclusion of loads induced by sauna and a letter must be issued to the Home Owner confirming the adequacy of structure with additional load. Additionally, request for information must be submitted to other design professionals for confirmation for compliance of sauna with the applicable FBC requirements.

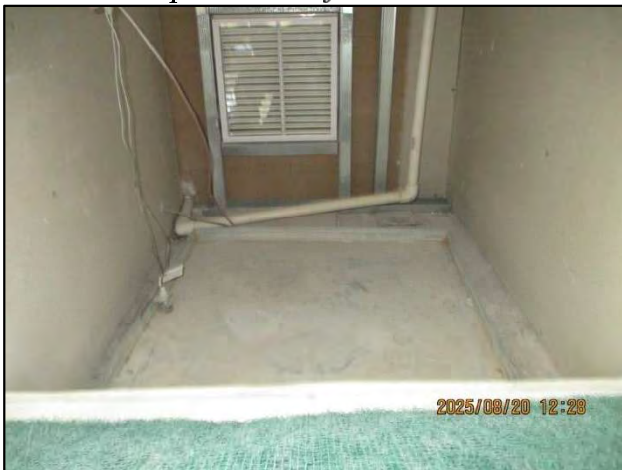
**Observation:** The air handling equipment (AHU) #1, 2 and 4 are installed on top of return air plenum boxes constructed out of metal stud wall framing and drywall panels. This installation completely deviates from the support system specified on the Mechanical Drawings. Drawing M4 specifies that the equipment are to be supported by 5/8” thick plywood sheets with 2x4 wood studs and iron angle supports welded to metal plates. The existing installation is relying on very thin gauge metal studs to support the equipment.

*Typical construction of the return air plenum box support with drywall and metal wall studs.*

**Recommendation:** The plenum boxes supporting the AHU #1, 2, and 4 must be reconstructed and installed as specified on the Mechanical Drawing M4 to properly support the equipment and installation.

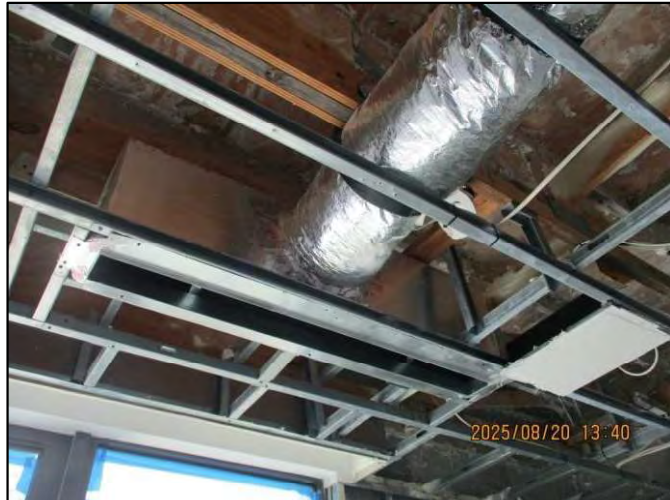
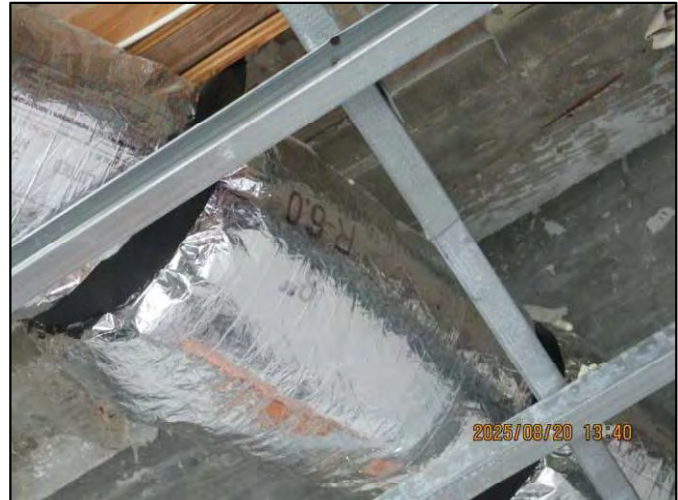
**Observation:** There are several locations where the installed duct sizes and number of duct connections deviate from the Mechanical Drawings. For example, in the 3<sup>rd</sup> guest Bedroom the return air duct is specified to be 10-inch diameter, but instead an 8-inch duct was installed. The register is also in the incorrect location. Similarly in the 1<sup>st</sup> Guest Bedroom the supply air register is specified with two 6-inch ducts and the return air register is specified with a 10-inch duct. Instead a single 10-inch duct is installed for the supply air and 8-inch duct installed for the return air. These deviations in the specified duct sizes may affect the amount of airflow reaching the spaces and affect the cooling of those spaces.

*3<sup>rd</sup> Guest Bedroom RA duct 8-inch size*

**Criteria:** The existing condition deviates from the Mechanical Drawings and is a Code violation.

**Recommendation:** Ductwork configurations and sizes must be installed as specified to ensure that the proper CFM airflow rates are being realized in the services spaces and to ensure proper cooling of spaces and operation of the air conditioning system.

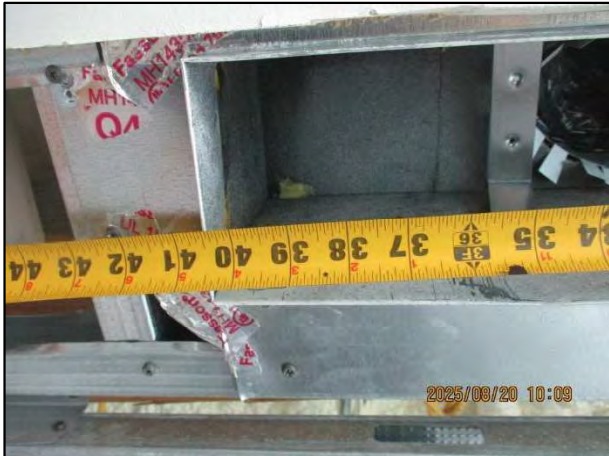
**Observation:** The air diffusers servicing the Dining Room area are smaller than specified. The diffusers are measured to be 41-inches long whereas the Mechanical Drawing specifies them to be 48-inches long. This can affect the system from properly cooling the Dining Room area.

*Length of diffuser measures 41-inches*

**Recommendation:** The supply air diffuser must be replaced matching the size that is specified on the Mechanical Drawings.

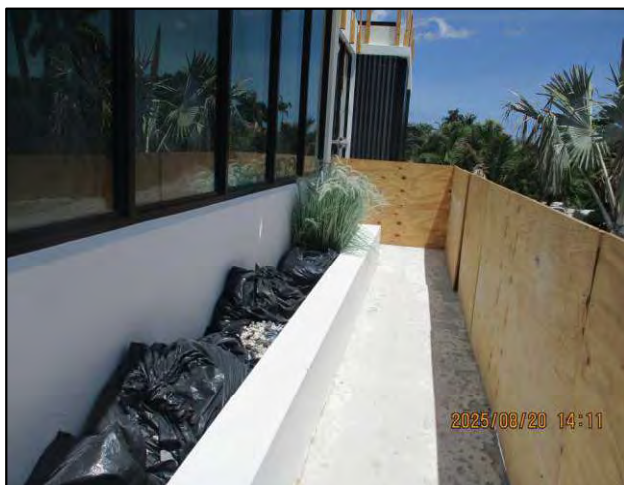
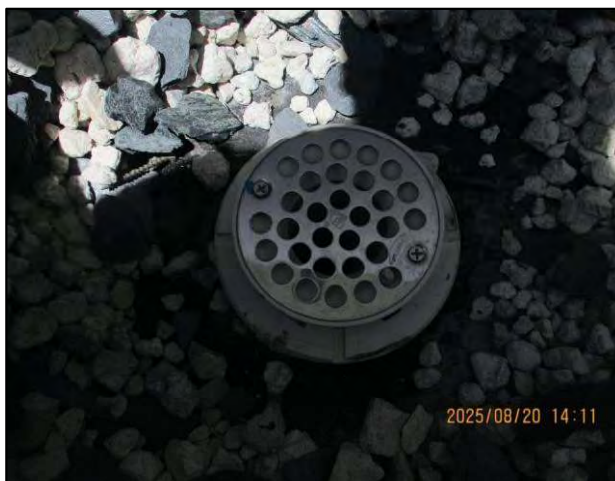
**Observation:** The drains installed at the planter on the 2<sup>nd</sup> floor wrap-around balcony and the 3<sup>rd</sup> floor outdoor terrace are not of the appropriate type. The installed drain is a typical plastic shower drain with no provisions for overflow drainage. The installed drain can easily get clogged and fail allowing for water to accumulate in the planter. A flooded planter will add unintended load to the structure and improper drainage can harm the plants. Plastic bodied drains can become brittle over time and cracking can occur due to thermal expansion. Additionally, without overflow drainage provisions there is no way to easily service the drain without entirely removing the soils out of the planter. The Plumbing Drawings do not have drainage specifications for these planters. Planter drains are typically specified for three stages of drainage: 1) overflow dome, 2) perforated standpipe, and 3) weep holes at the drain clamping collar.

*Improper drains installed in the planter*

**Criteria:** The existing condition is a deviation from industry standards and will not allow the storm water drainage system to operate as the design intended.

**Recommendation:** The plastic planter drains must be replaced with new drains with galvanized cast iron bodies and components. Overflow perforated standpipes with a dome (see example picture below) must be provided at all installed planter drains for proper operation of the storm drainage system and access to service the planter drains. Standpipes must be installed with coarse rock and filter fabric around the standpipe to prevent soil from intruding and clogging the drain. The Engineer of Record must specify the overflow standpipes and domes that are compatible with the installed planter drains.

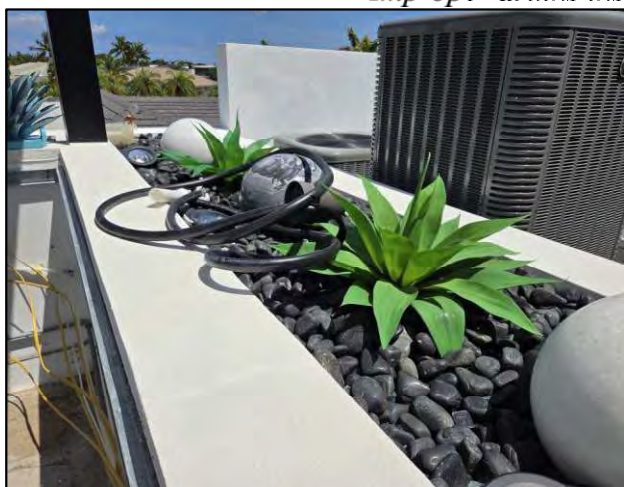
*No provisions of overflow drainage in outdoor terrace planters*

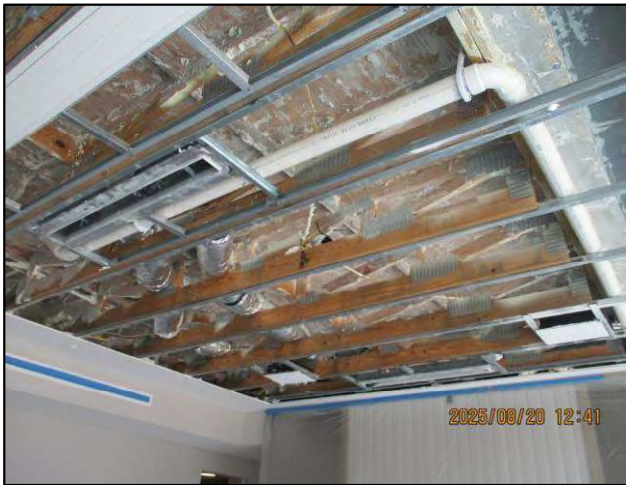
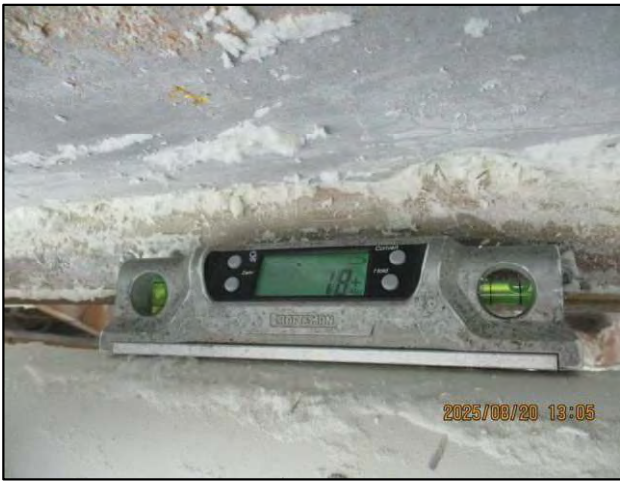
**Observation:** Storm drainage piping installed above the ceiling in the Master Bedroom was found to have a reverse slope on the piping. This condition can cause water to stand in the pipe and backups to occur from the storm drain on the 3<sup>rd</sup> Floor Terrace.

*Reverse pitch observed on the storm drainage piping*

**Criteria:** The existing condition is an improper installation and a Code violation.

**Recommendation:** The storm drainage piping must be reinstalled with a positive uniform slope in the direction of discharge.

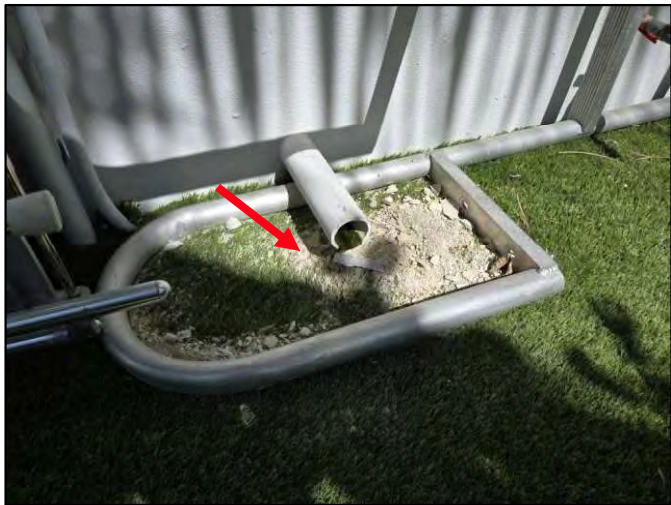
**Observation:** The rainwater drainage piping is installed to discharge over the ground at 1<sup>st</sup> level. The specified splash blocks were not installed at the pipe discharge points. Additionally, some of the rainwater discharge piping are installed lower than the grade level causing partial obstruction of the piping. This condition restricts the waterflow to discharge from the piping and can cause backups and water ponding during rain events.

*Typical conditions of rainwater drainage piping missing splash block and obstructed*

**Criteria:** The existing condition deviates from the Plumbing Drawings which specify for the rainwater pipe to discharge over a splash block and is a Code violation.

**Recommendation:** Splash blocks must be provided at the rainwater drainage pipe discharge locations as specified on the Plumbing Drawings. The obstructed drainage piping must be raised so that they discharged without restriction over the top of grade.

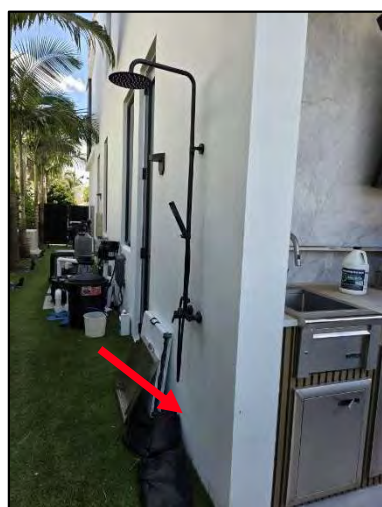
**Observation:** There are hose bibs specified on the Plumbing Drawings which are not installed on the 1<sup>st</sup> floor exterior backyard area.

*Locations where hose bibs are specified and not installed*

**Criteria:** The existing condition deviates from the Plumbing Drawing P-05 which is a Code violation.

**Recommendation:** Hose bibs must be installed as specified on the Plumbing Drawings.

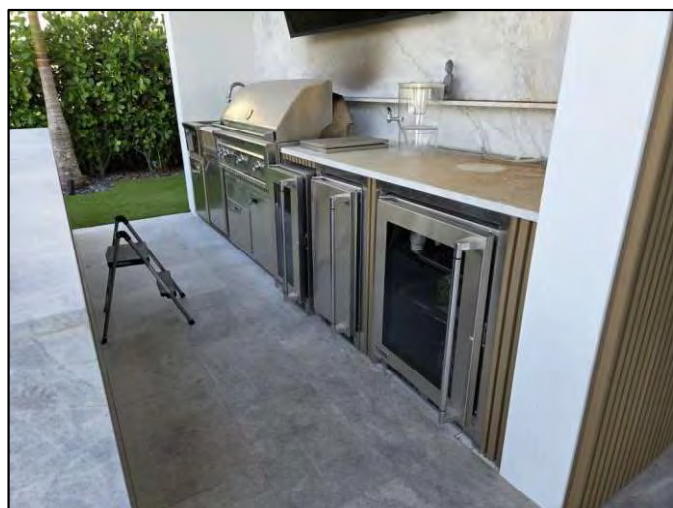
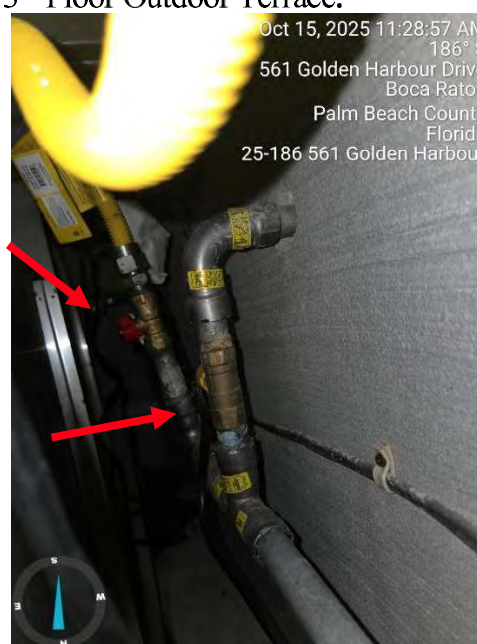
**Observation:** There is no access to the gas shutoff valve for the outdoor cooking equipment at the 1<sup>st</sup> Floor backyard area. The shutoff valve is located behind the cabinetry and appliances where it is not accessible. This condition was similarly reported for the interior gas stove in the Kitchen and the outdoor cooking equipment on the 3<sup>rd</sup> Floor Outdoor Terrace.

**Criteria:** The existing condition is a Code violation.

**Recommendation:** The shutoff valves must be relocated to ensure proper access for operation and servicing as required by Code.

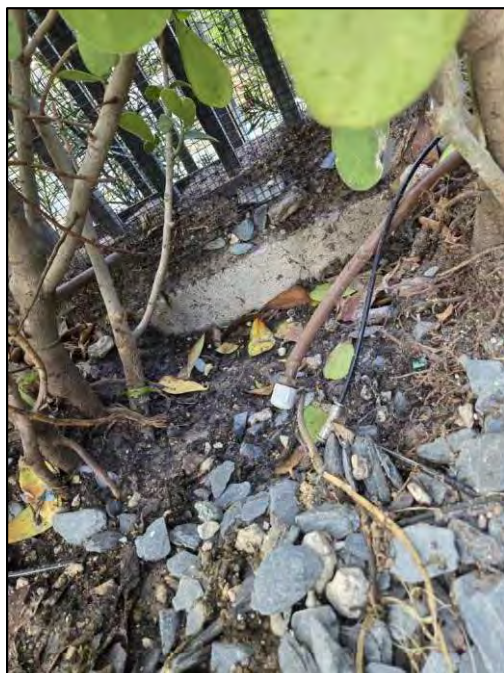
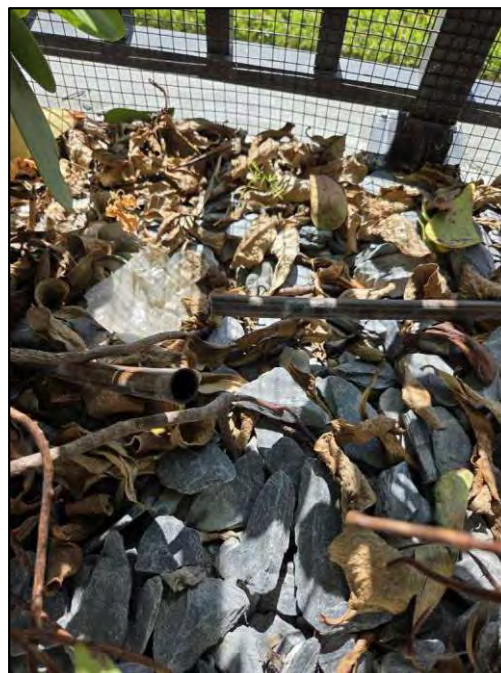
**Observation:** Some sections of the irrigation system appear to be disconnected or cut. Drip line piping was found cut and disconnected along the perimeter planting areas. This can be contributing to the dying landscaping.

*Disconnected irrigation drip lines at the perimeter planters*

**Criteria:** The existing condition is preventing the irrigation system from operating as intended and contributing to the planting dying.

**Recommendation:** The entire irrigation system must be evaluated and repaired where the zone sections are disconnected.

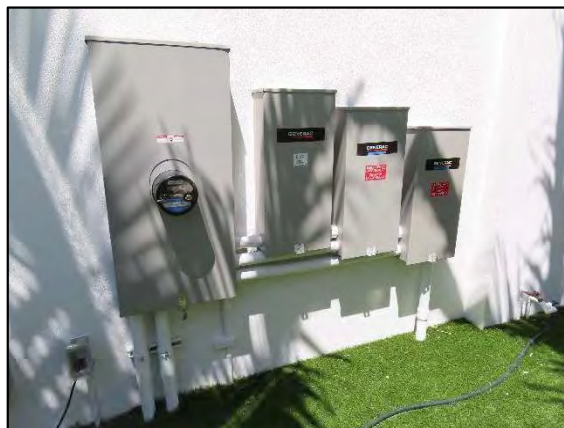
**Observation:** There is electrical equipment which was not installed as per the electrical drawings.

*Automatic Transfer Switches*

**Recommendation:** Install the referenced electrical equipment as per the referenced criteria. Provide approved as-built drawings to include additional equipment.

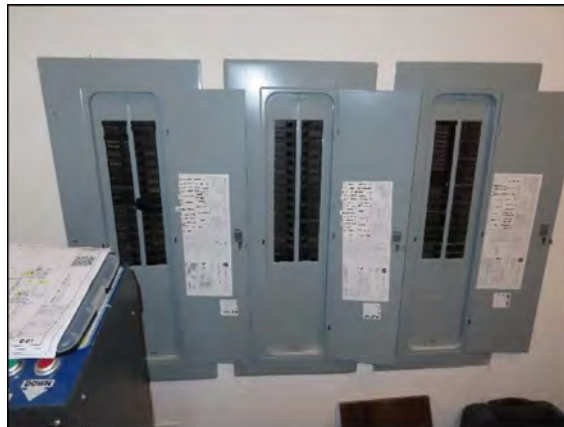
**Panels**

**Observation:** Arc-Fault Circuit-Interrupter (AFCI) protection was not installed for any of the required branch circuits of the interior panels.

**Criteria:** The existing condition is in violation of **Drawing E-04 Panel**

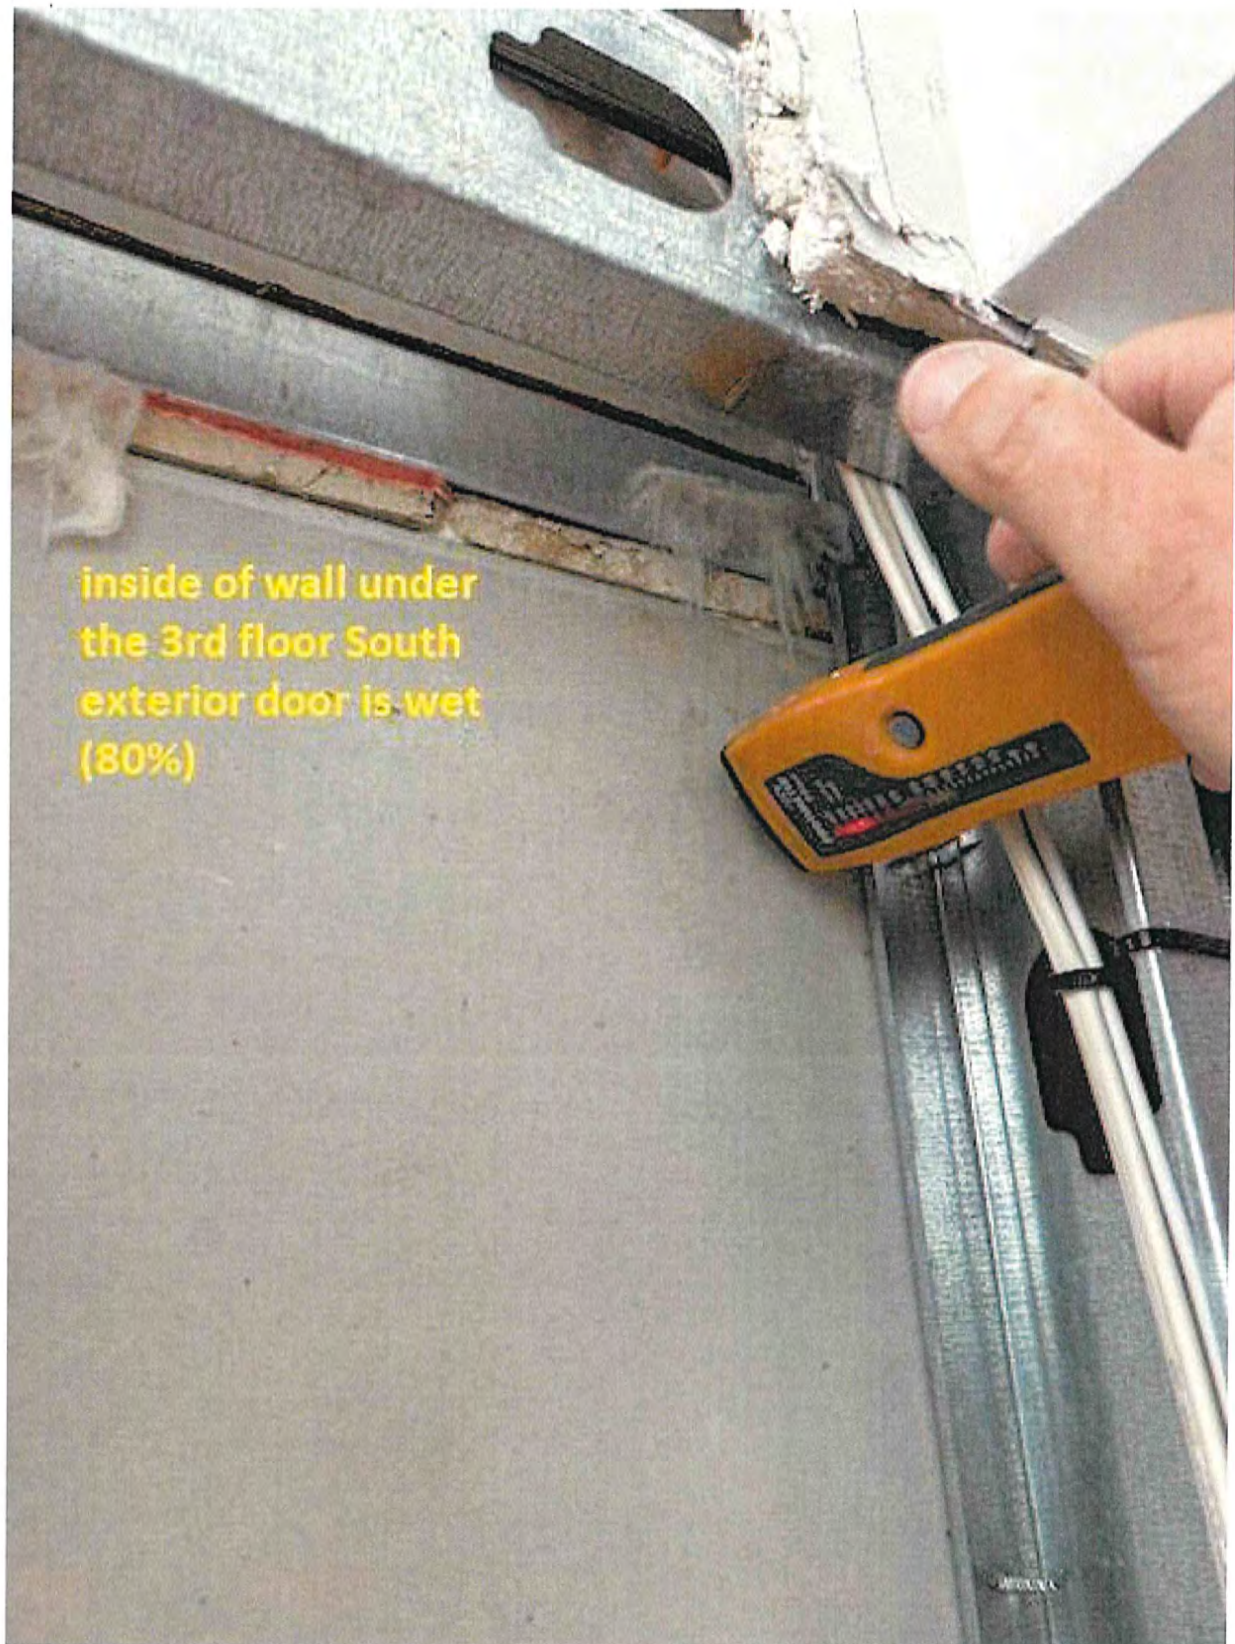
inside of wall under  
the 3rd floor South  
exterior door is wet  
(80%)

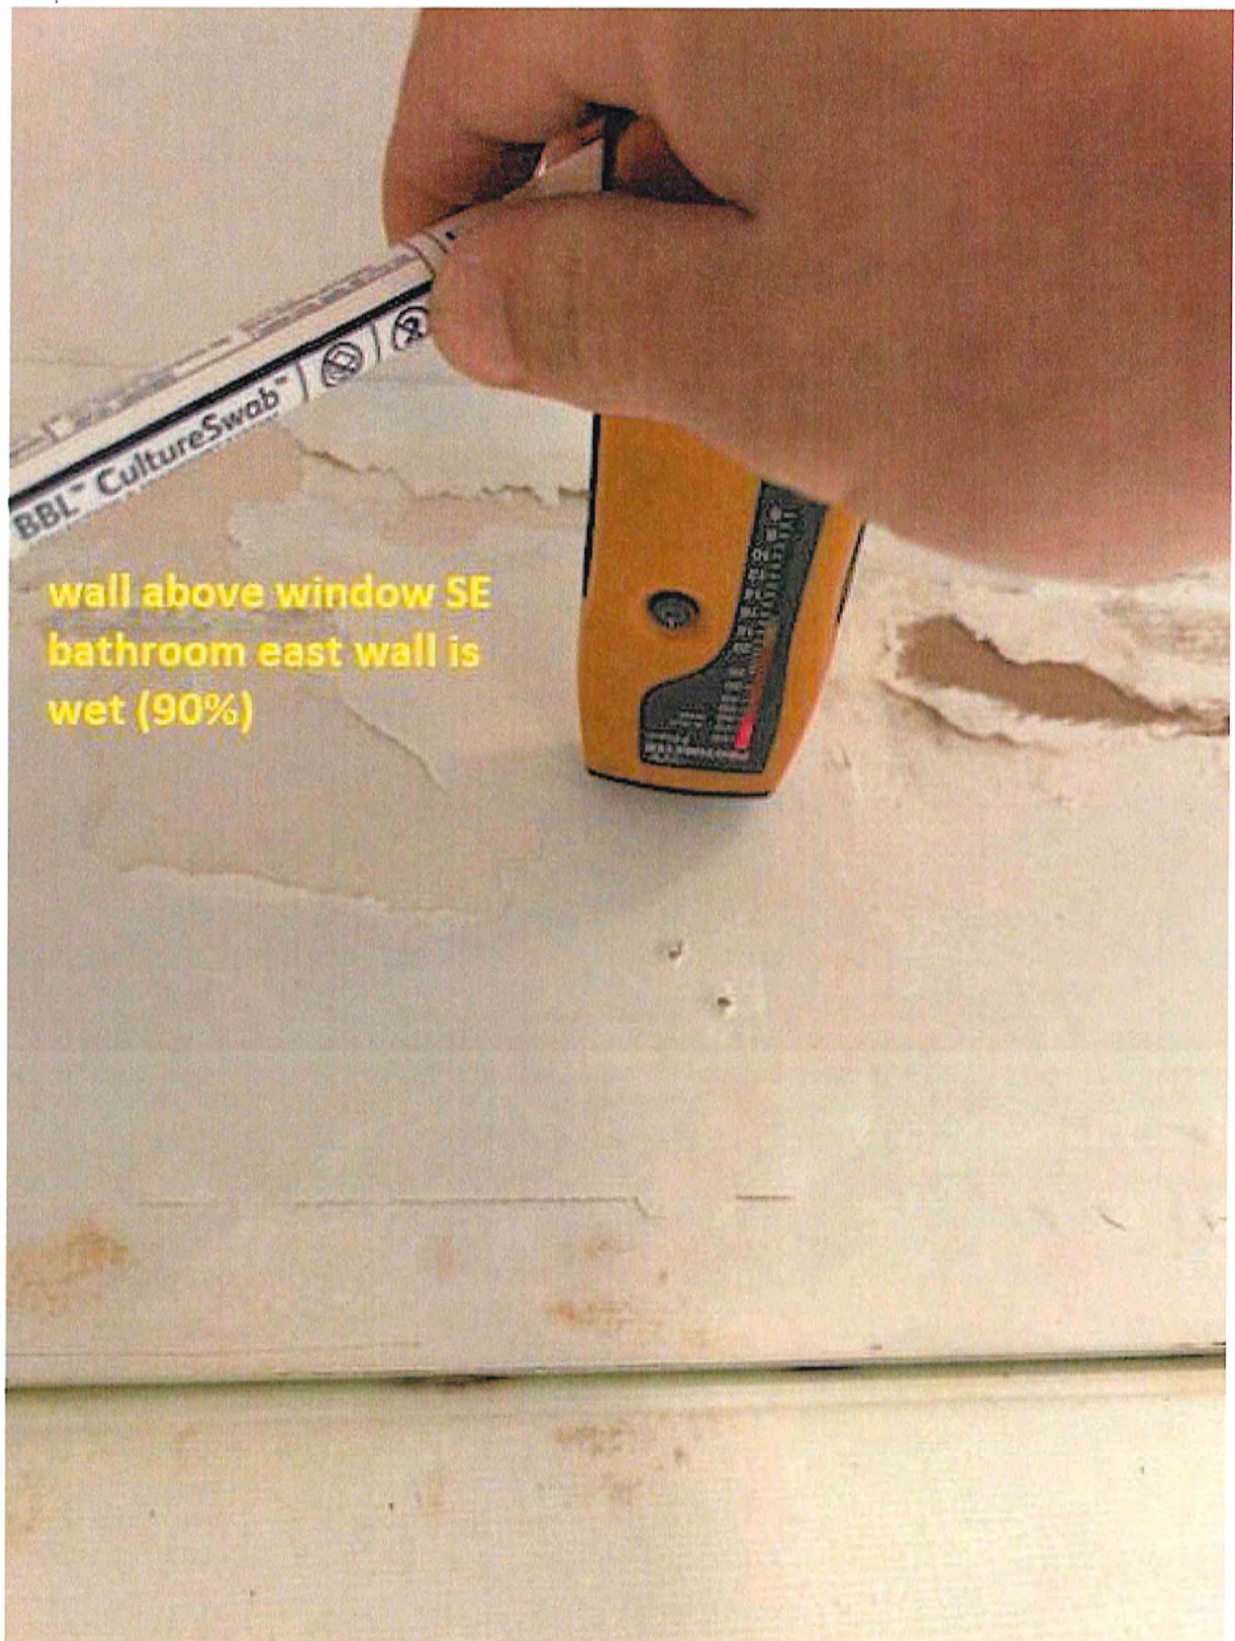
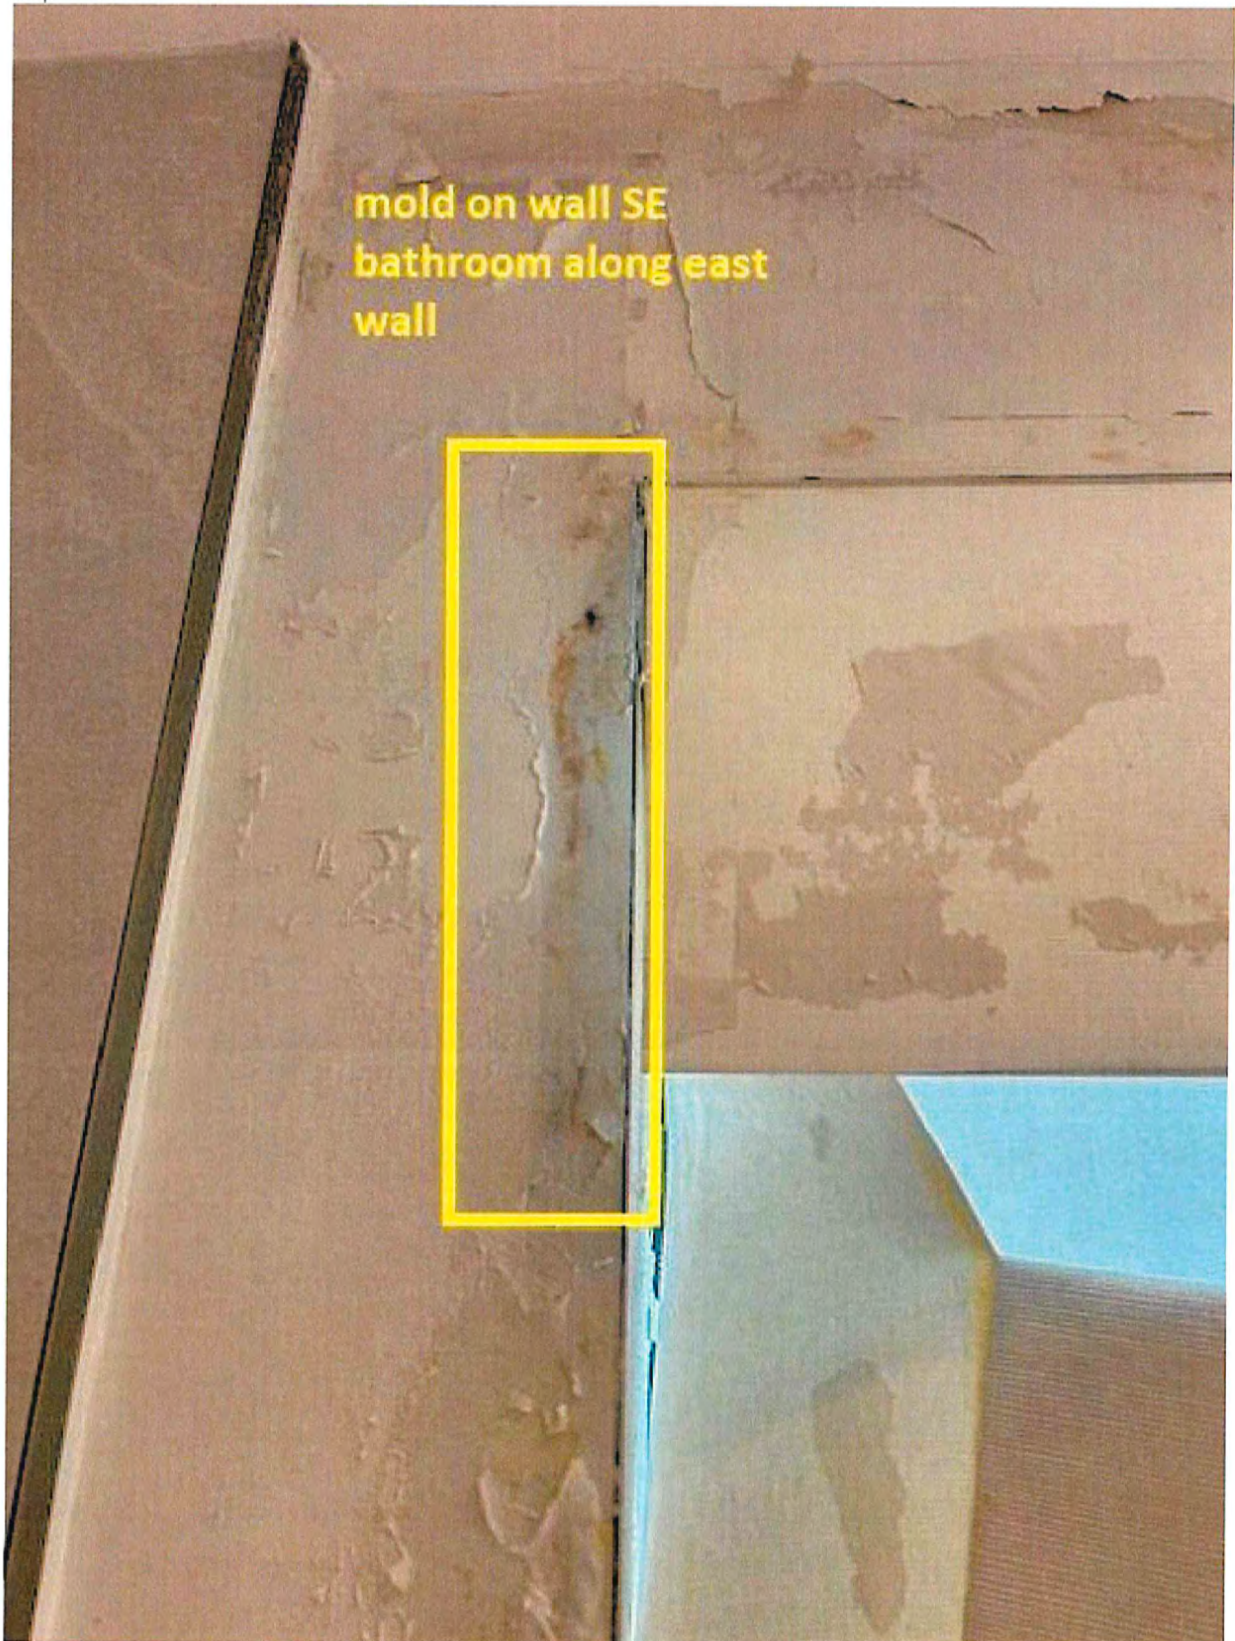
walls in SE bathroom  
are wet (east wall)  
below the window  
24%

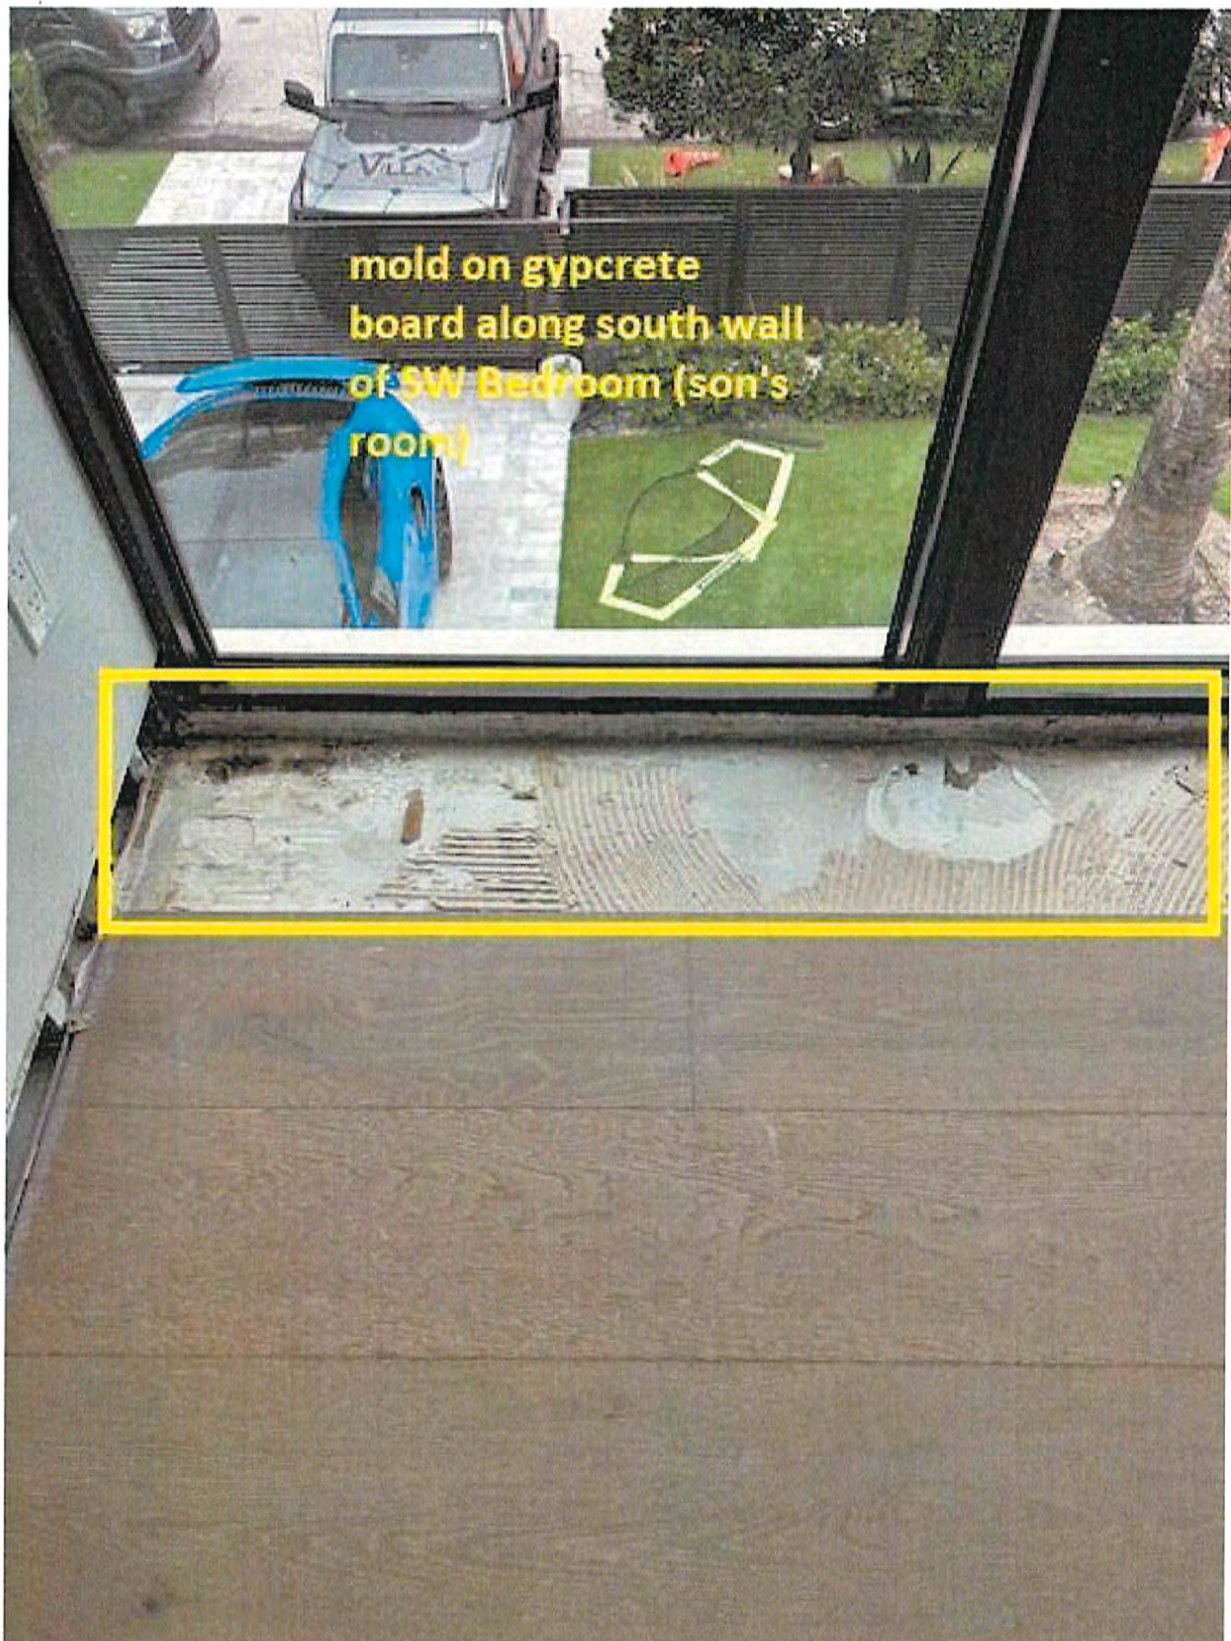
mold on gypcrete  
board along south wall  
of SW Bedroom (son's  
room)
