IN THE CIRCUIT COURT OF THE 15TH JUDICIAL  
CIRCUIT IN AND FOR PALM BEACH COUNTY, FLORIDA

**COMPLAINT**

<sup>4</sup> The three independent reports include: Structural Construction Defect Evaluation – Prepared by Summit Design and Forensics, Inc. (attached hereto as **Exhibit C**); Forensic Investigation Report – Prepared by ECS Florida, LLC (attached hereto as **Exhibit D**); Property Evaluation Report – Prepared by Pistorino and Alam Consulting Engineers, Inc. (attached hereto as **Exhibit E**); J.R. Inspections Services, Inc. – Mold Inspection Report (attached as **Exhibit “F”**) (collectively, the “**Engineering Reports**”)

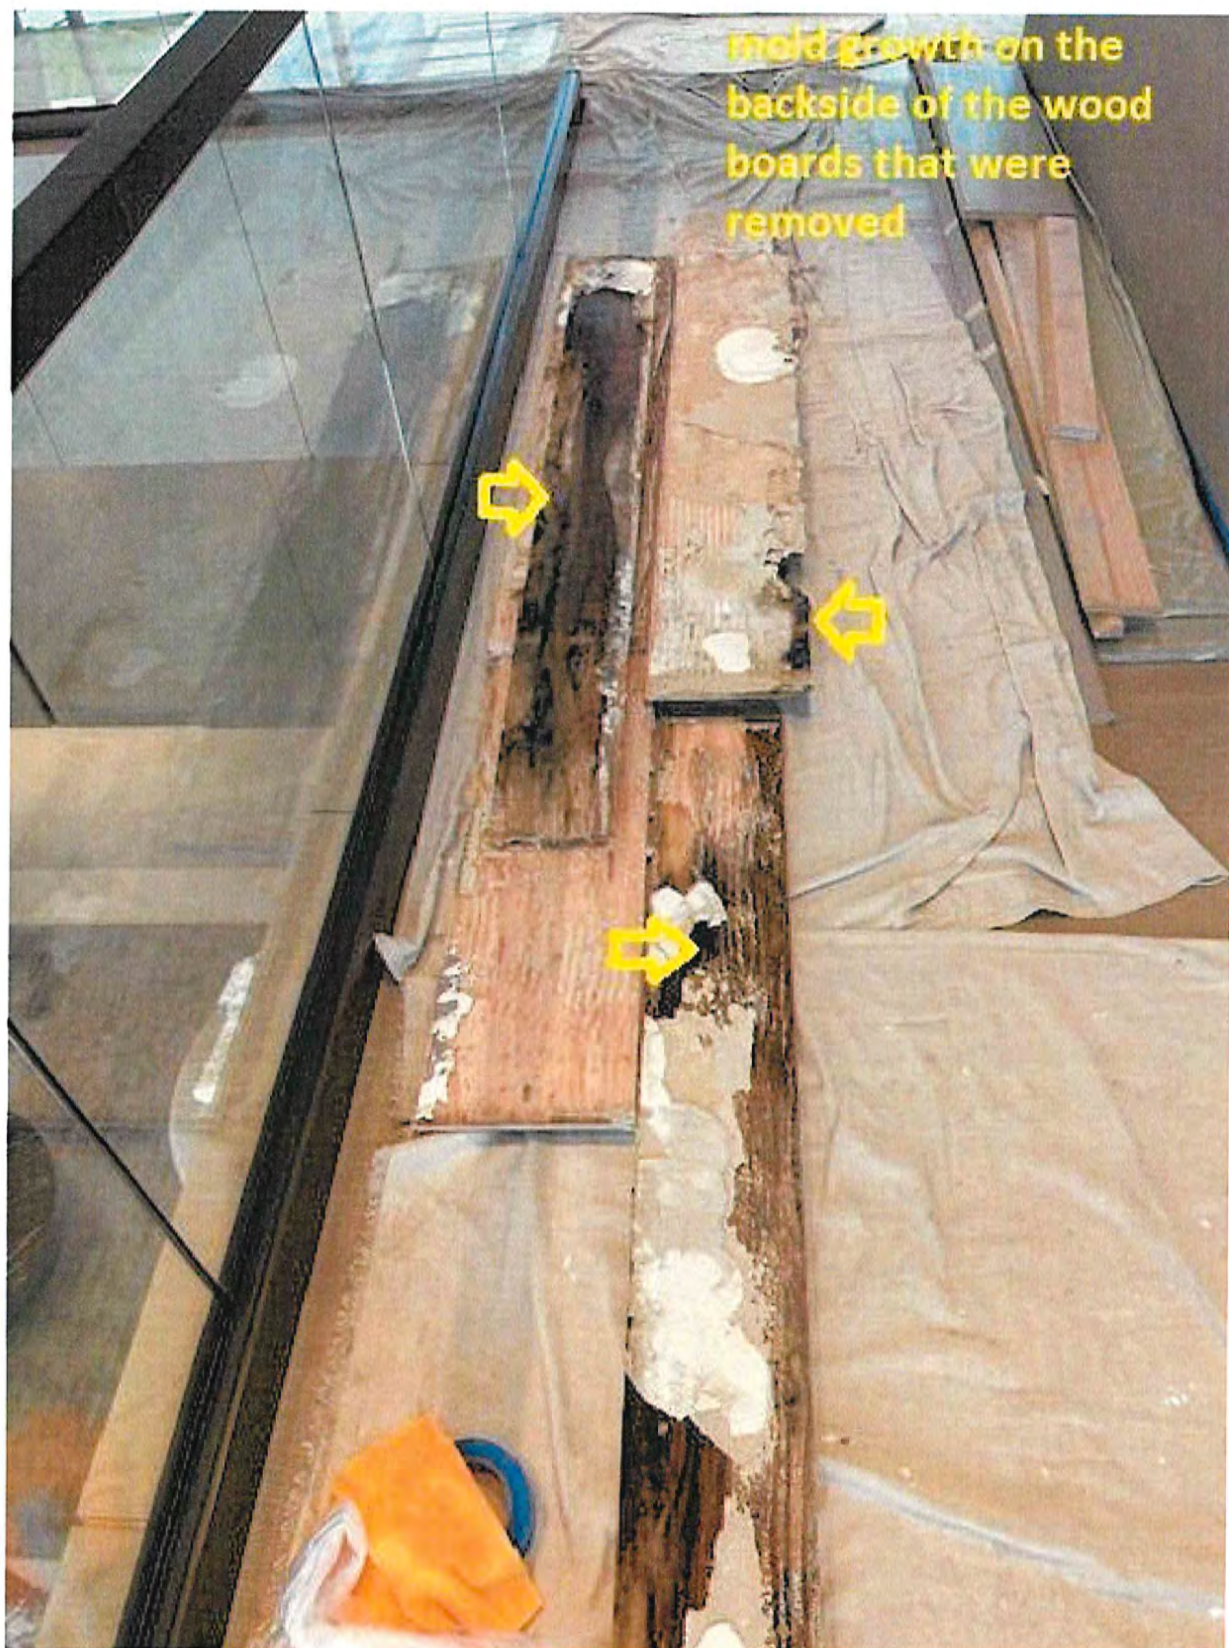
mold growth on the  
backside of the wood  
boards that were  
removed
